# Construction: Main Wing

# Mounting: Main Wing

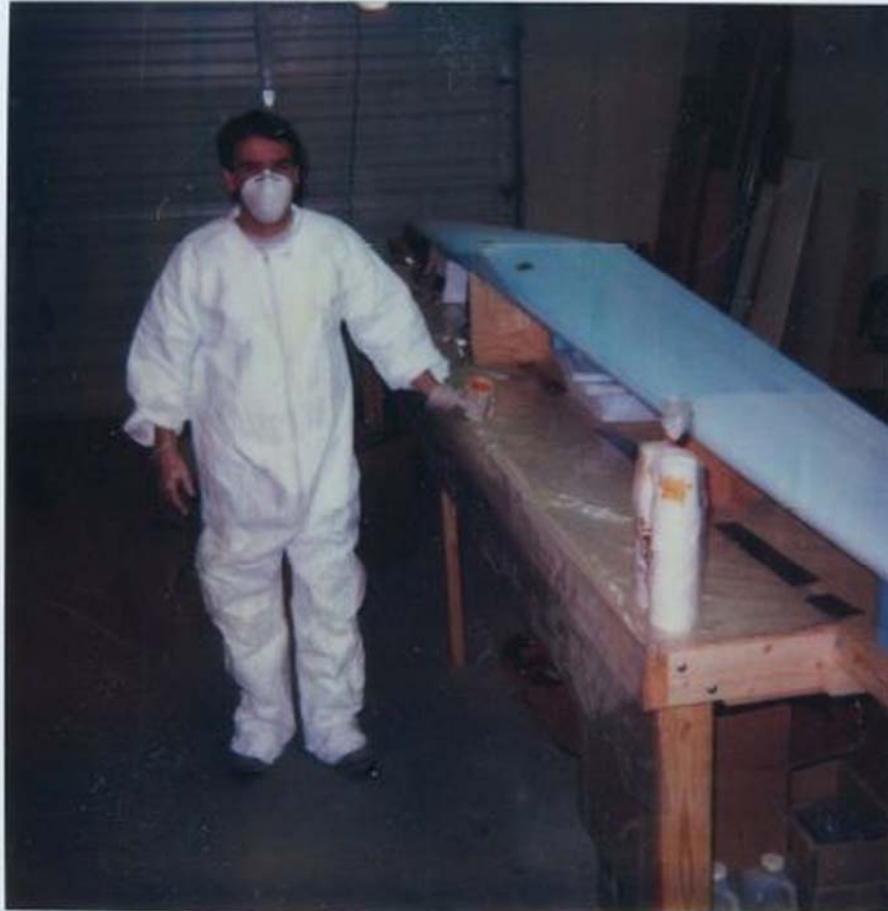
WAYNE IN ANTI-EPOXY OUTFIT  
W/ WING-CORES READY TO GLASS  
2/16/85 SHOULDER HARNESS SUPPORTS ARE  
FLOXED IN PLACE

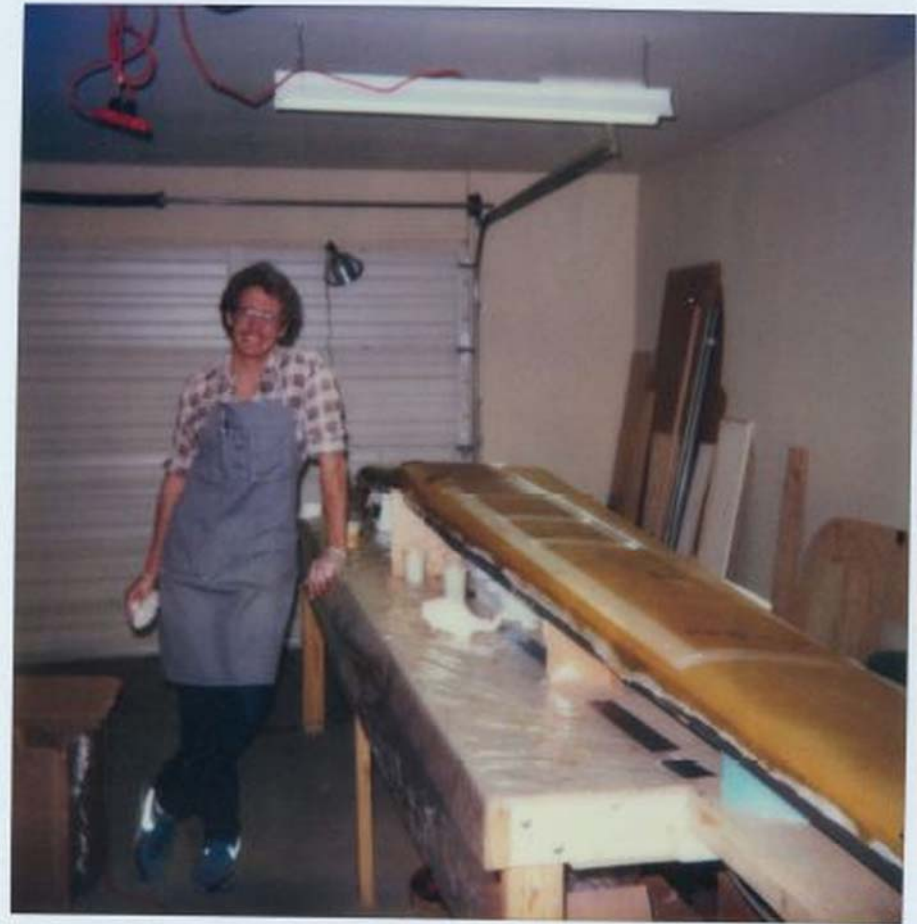
COMPLETED GLASSED LOWER WING SKIN  
2/16/85

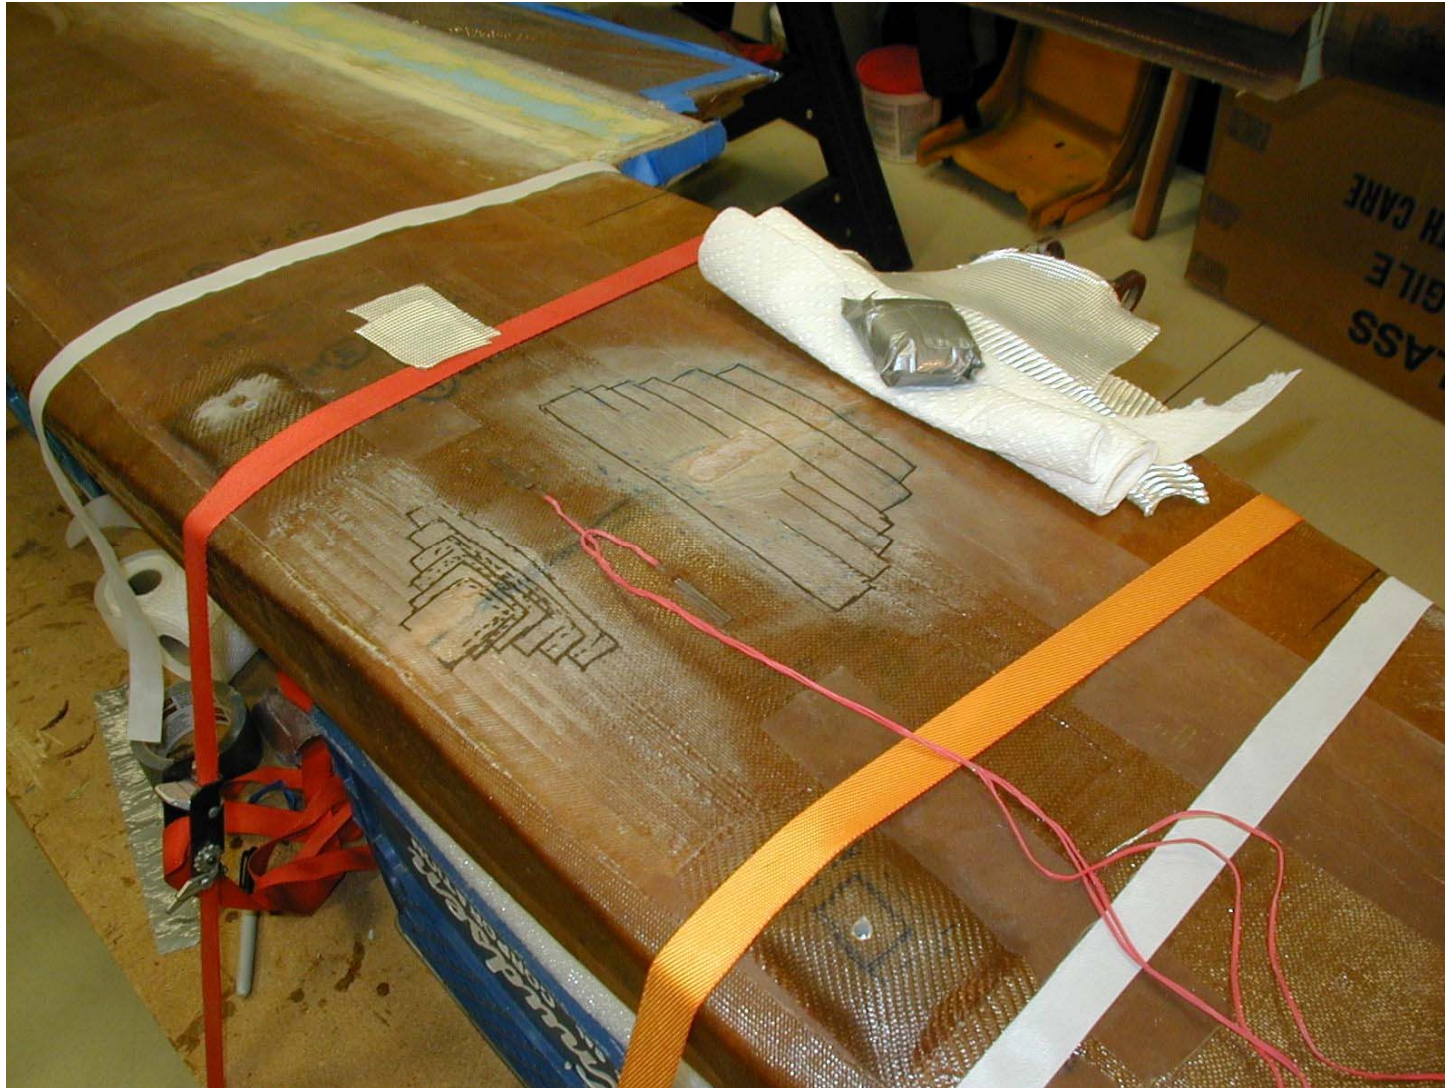
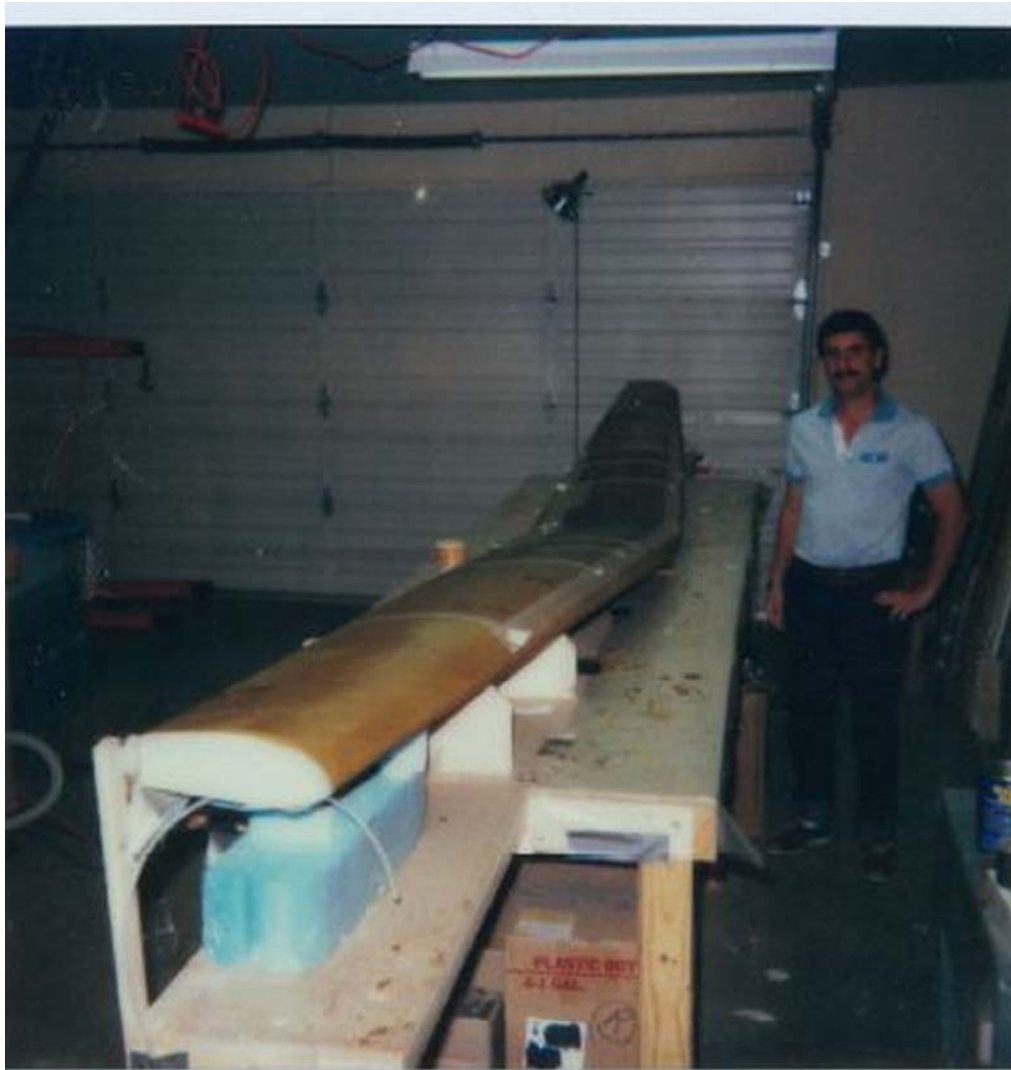
Wing glassing notes. Inspection at bottom noted non-straight plies that need repair. See next page for repair

Air bubbles noted in weave of shear web after top-skin cure are below 10% concentration do not require repair  
Kinks noted at BLOO in at least 4 spar caps on bottom - require repair as called out in plans by feathering appropriately and re laminating with a replacement.

Wing root repair per approved method in Composite Education: inspection and repair methods section of Q-2 plans. Problem plies are sanded and feathered back then correct number of UNI plies are applied. (Black outlines show repair areas and taper and overlap of UNI plies to be applied consistent with acceptable repair methods). Note that seatbelt mounts have been drilled and tapped per plans. December, 2011. Inspected by Jay Scheevel repair OK

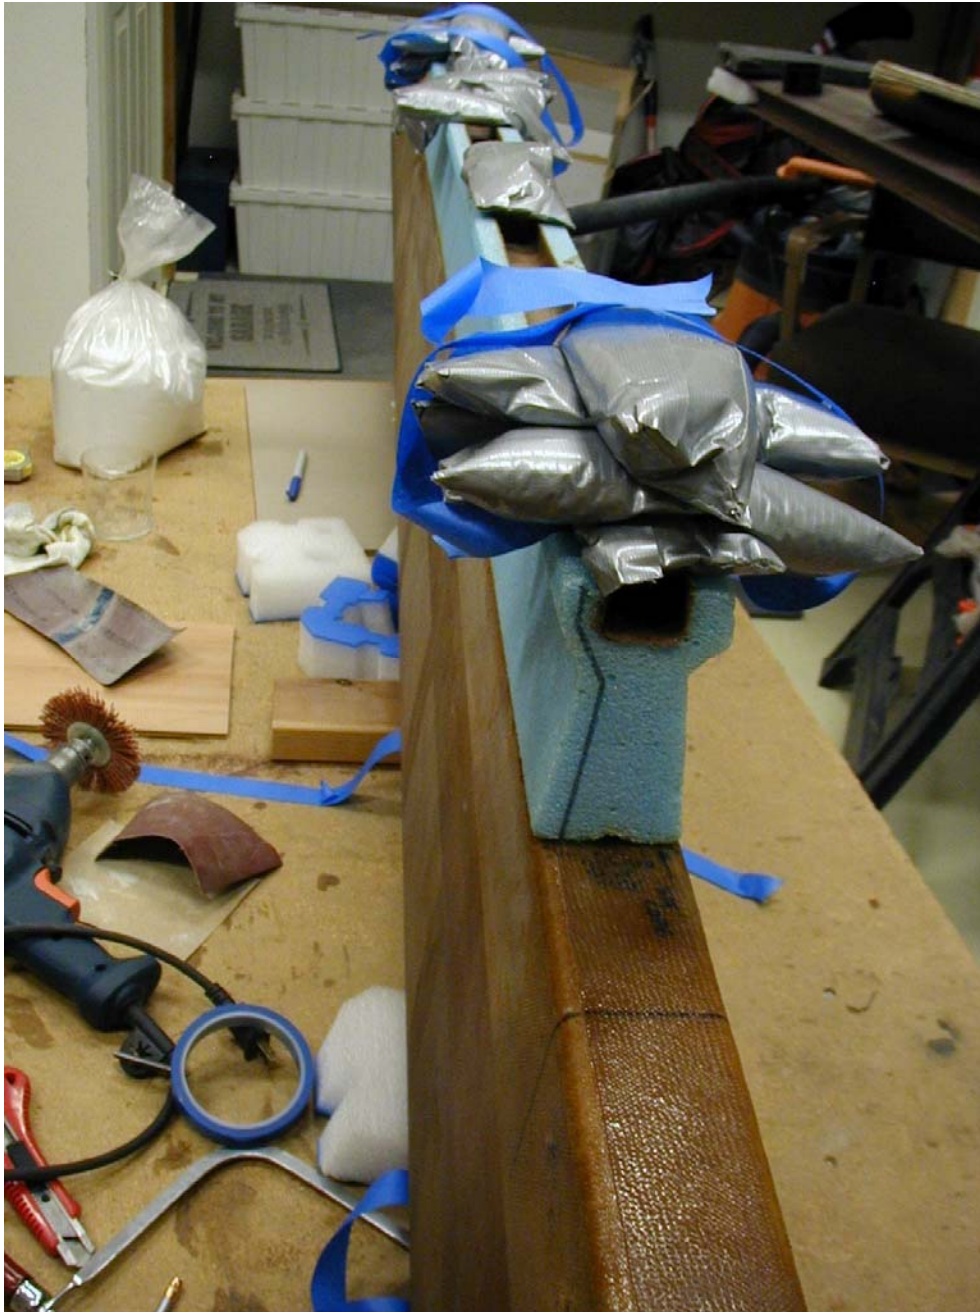
Main Wing is inverted and prepared for glassing, then glassed per Q-2 Plans section 9-4. All spar caps properly wetted out and fibers verified straight, Jay Scheevel, March, 1985

FINISHED GLASSED-TOP WING SKIN.  
w/CO CONSPIRATOR WAYNE JOHNSON  
3/9/85

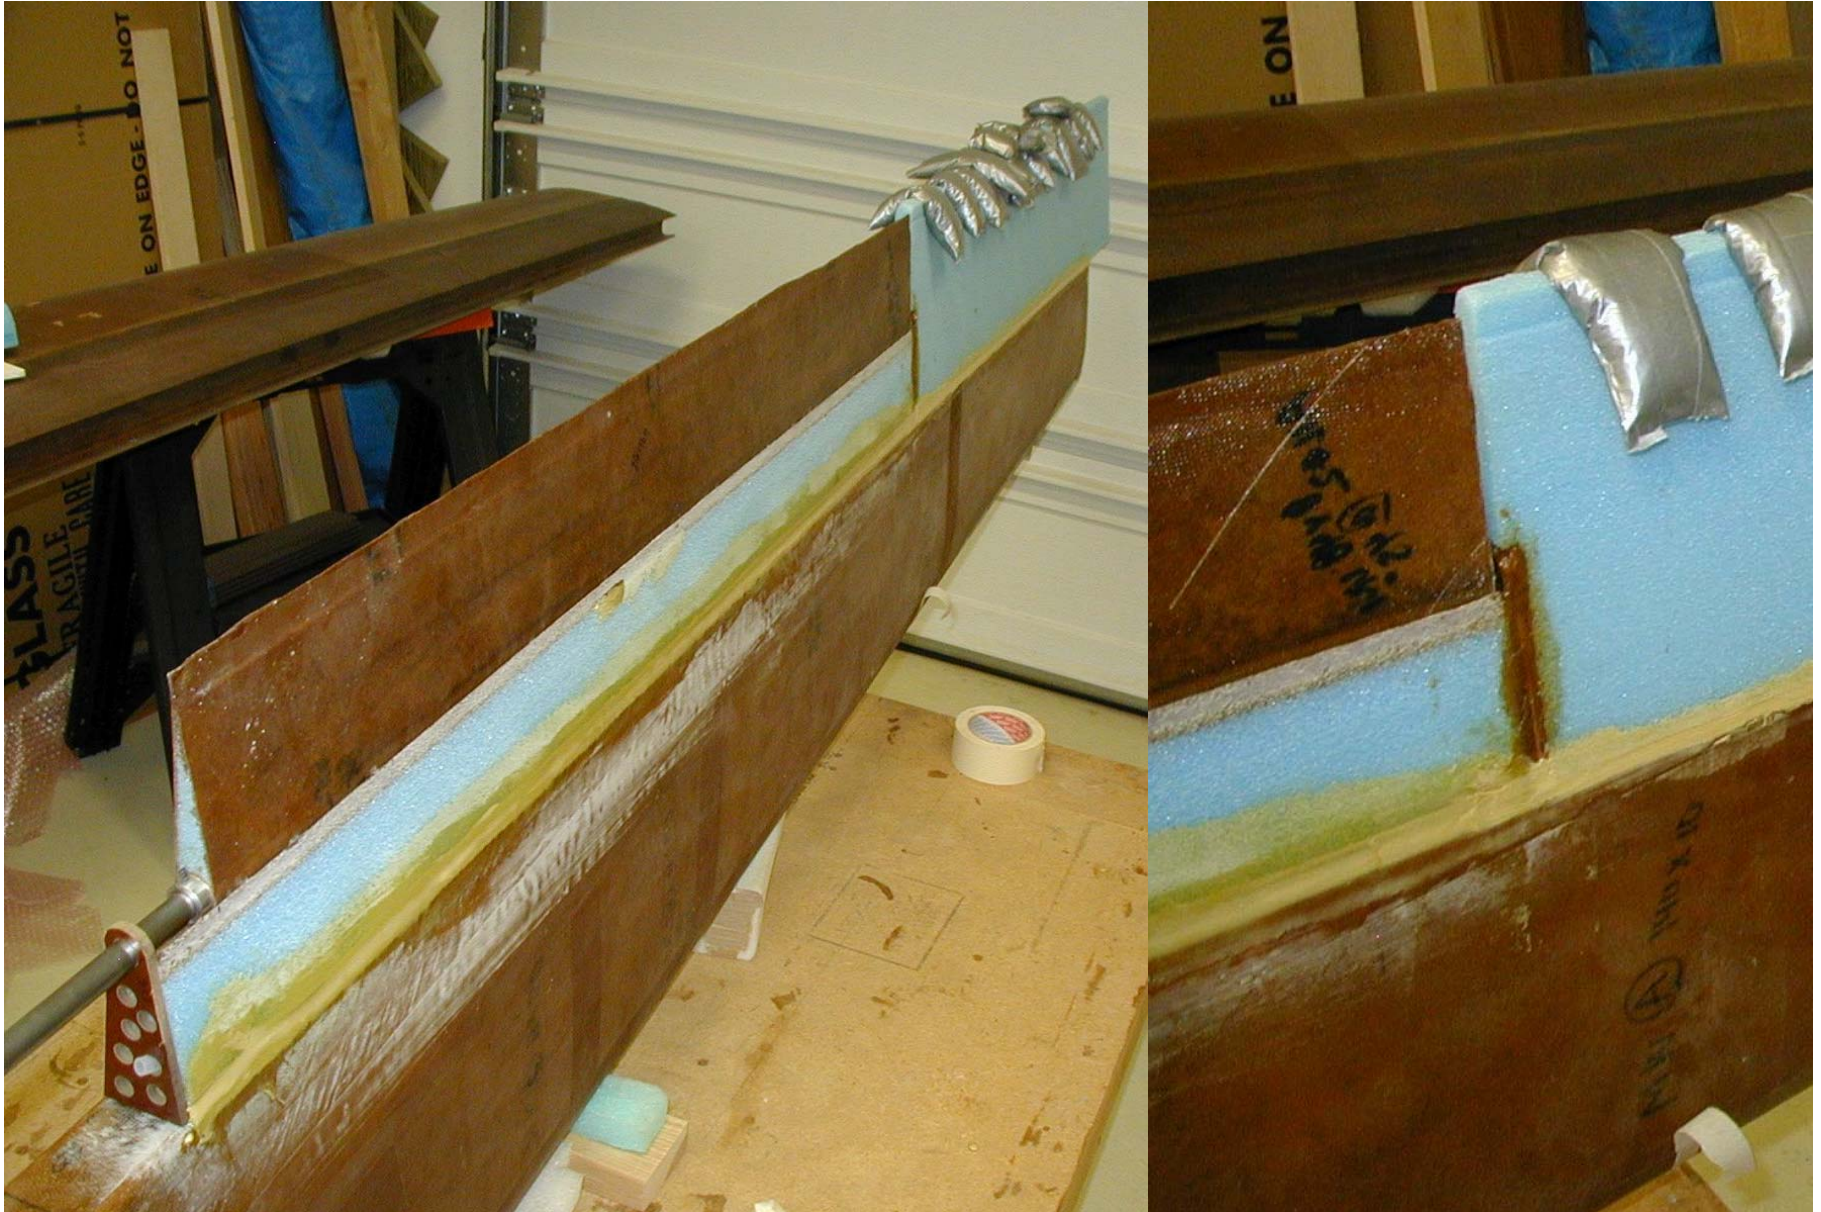
Verify alignment during cure of micro. Note the nylon wire conduit end through hole in CS6. Note installation of CS10 outboard aileron pivot, and trim of foam and sanding of slot core for glass to glass contact with out skin. October, 2011

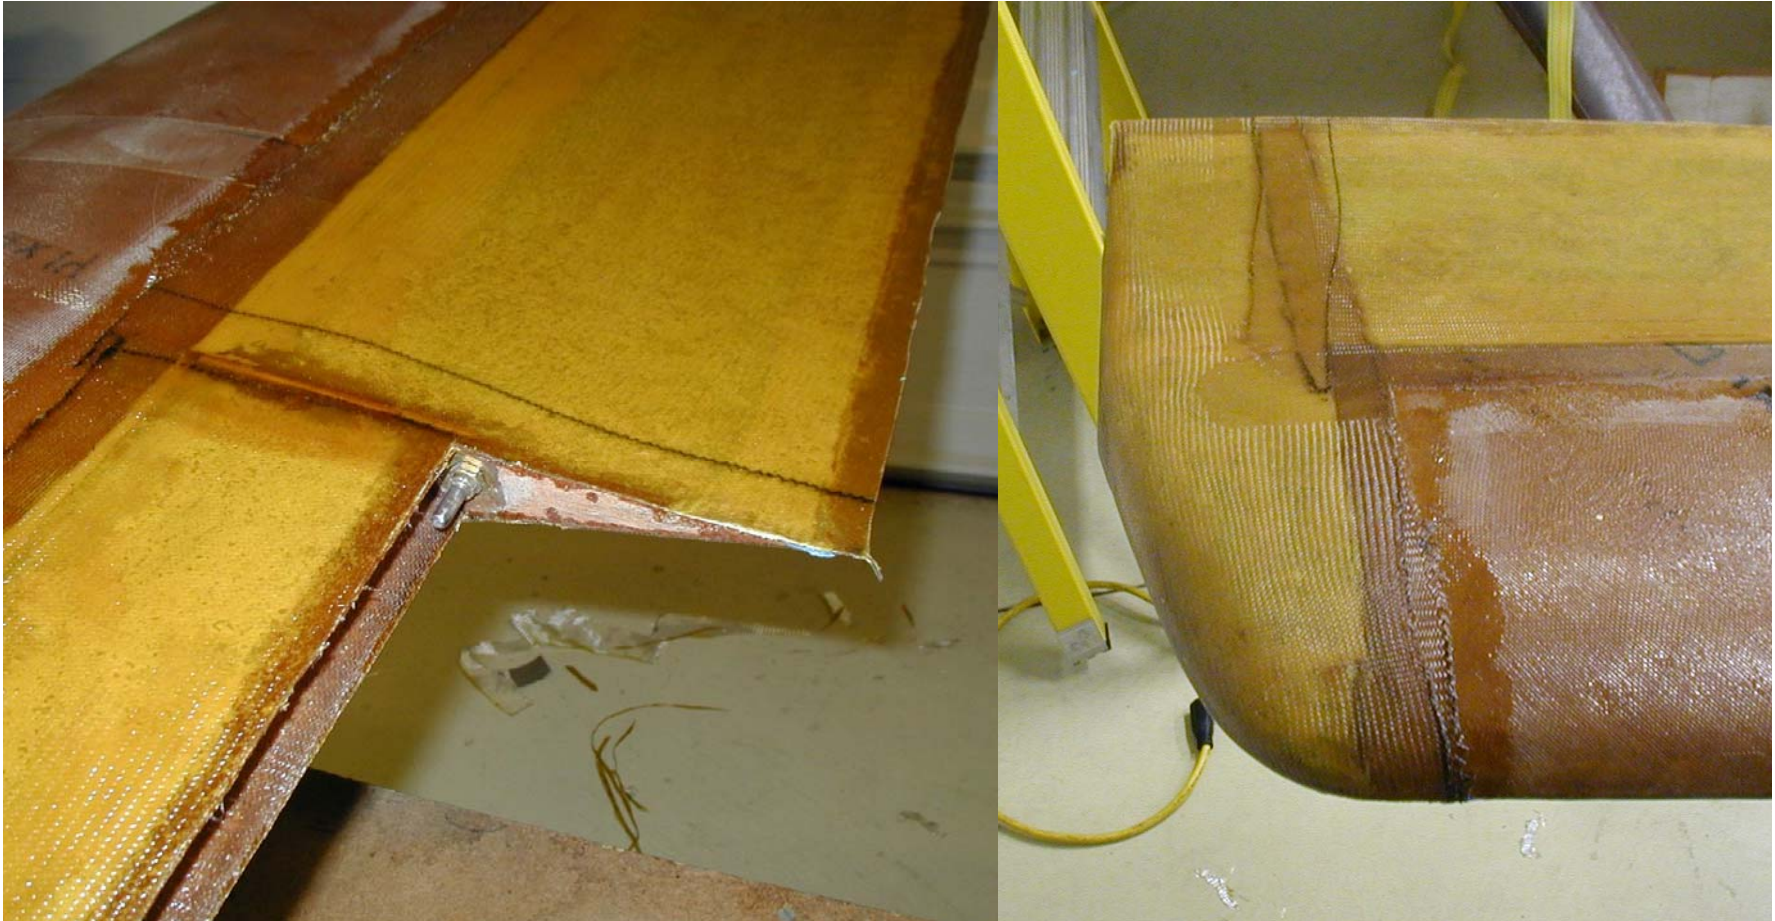
Verify glass layup on slot core and trailing edge and wingtips. Note 1/8" plywood closeout of trailing edge core for strength and rigidity. All OK, Jay Scheevel. December 2011

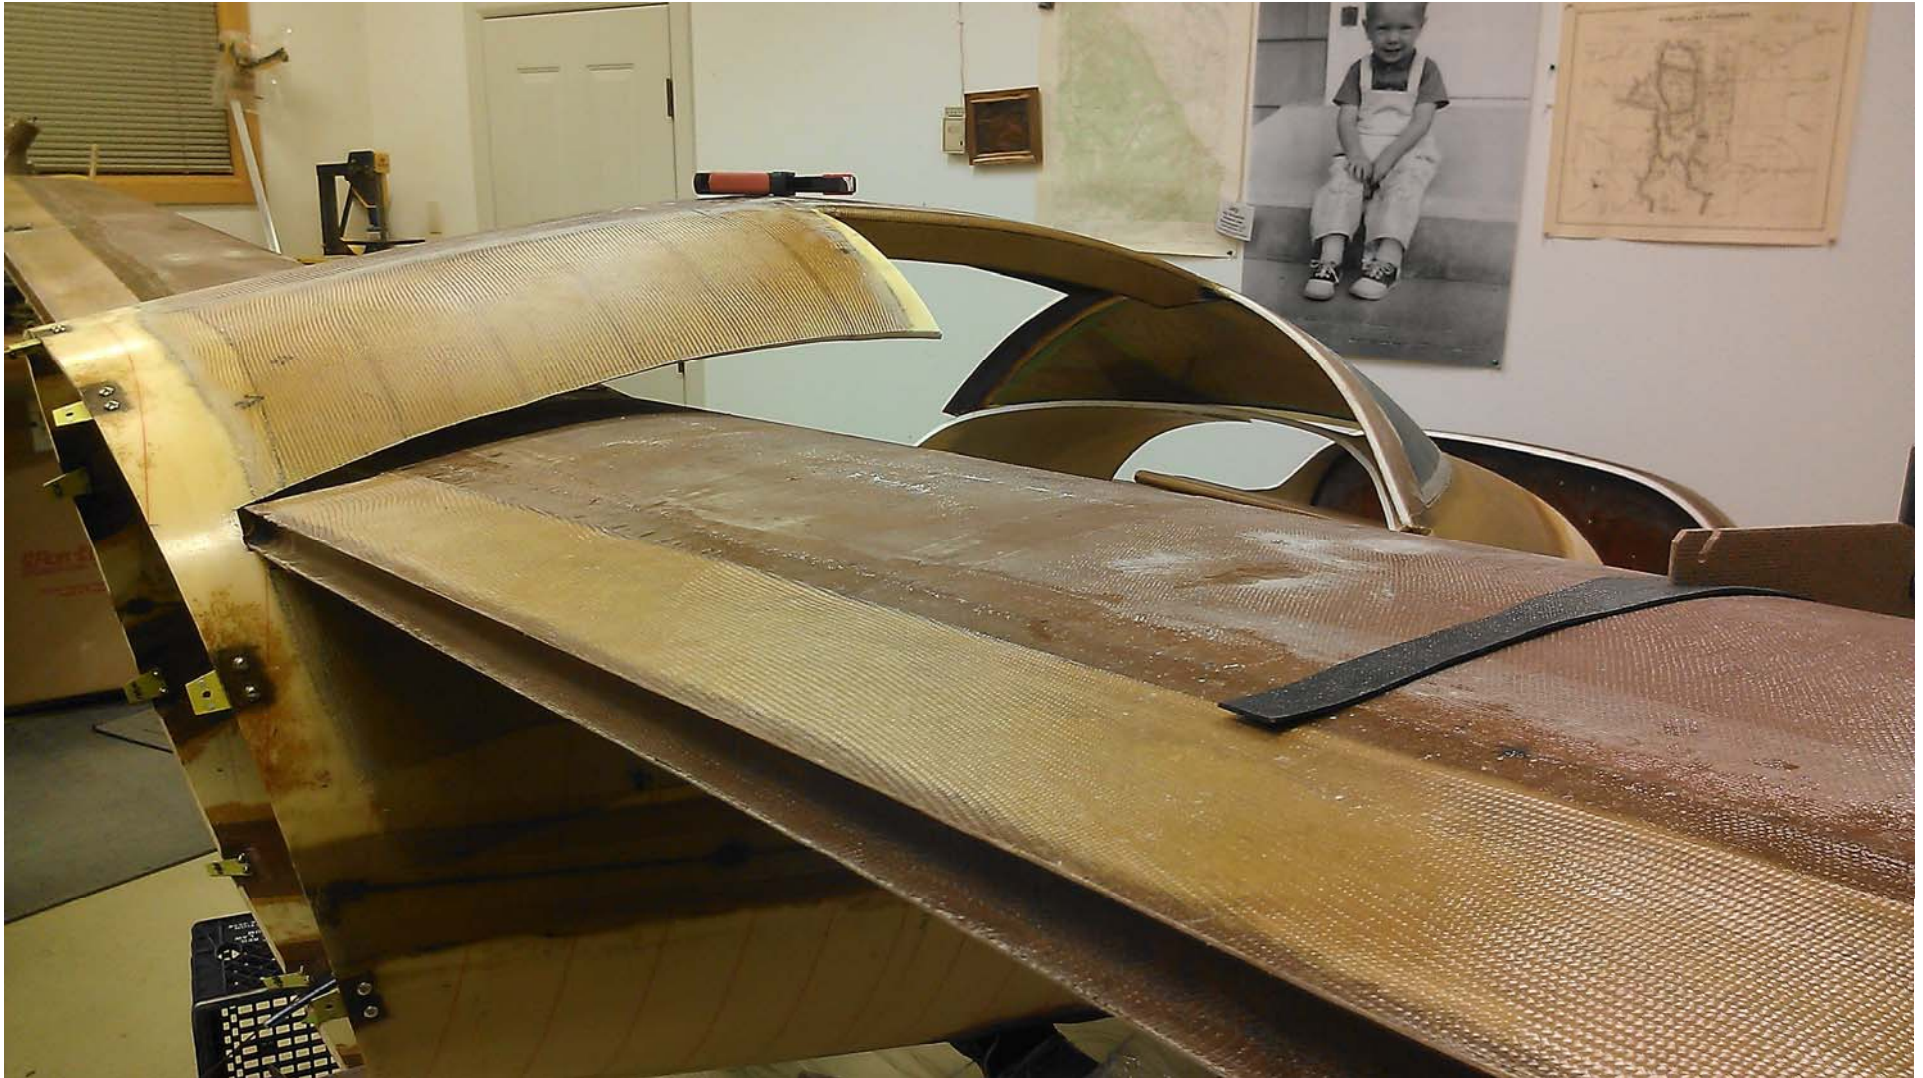
Aileron support and pivot (CS6) was milled out to 7/8" to accommodate Rulon shoulder bearing with 5/8" ID. Additional plies of glass were added to the outer perimeter of CS6 to add more strength. 3 plies of UNI were wrapped around the perimeter, with one ply of BID at 45 degrees to closeout the perimeter assembly. Photo below shows this prior to knife trim. This layup was done prior to floxing the main wing in place.

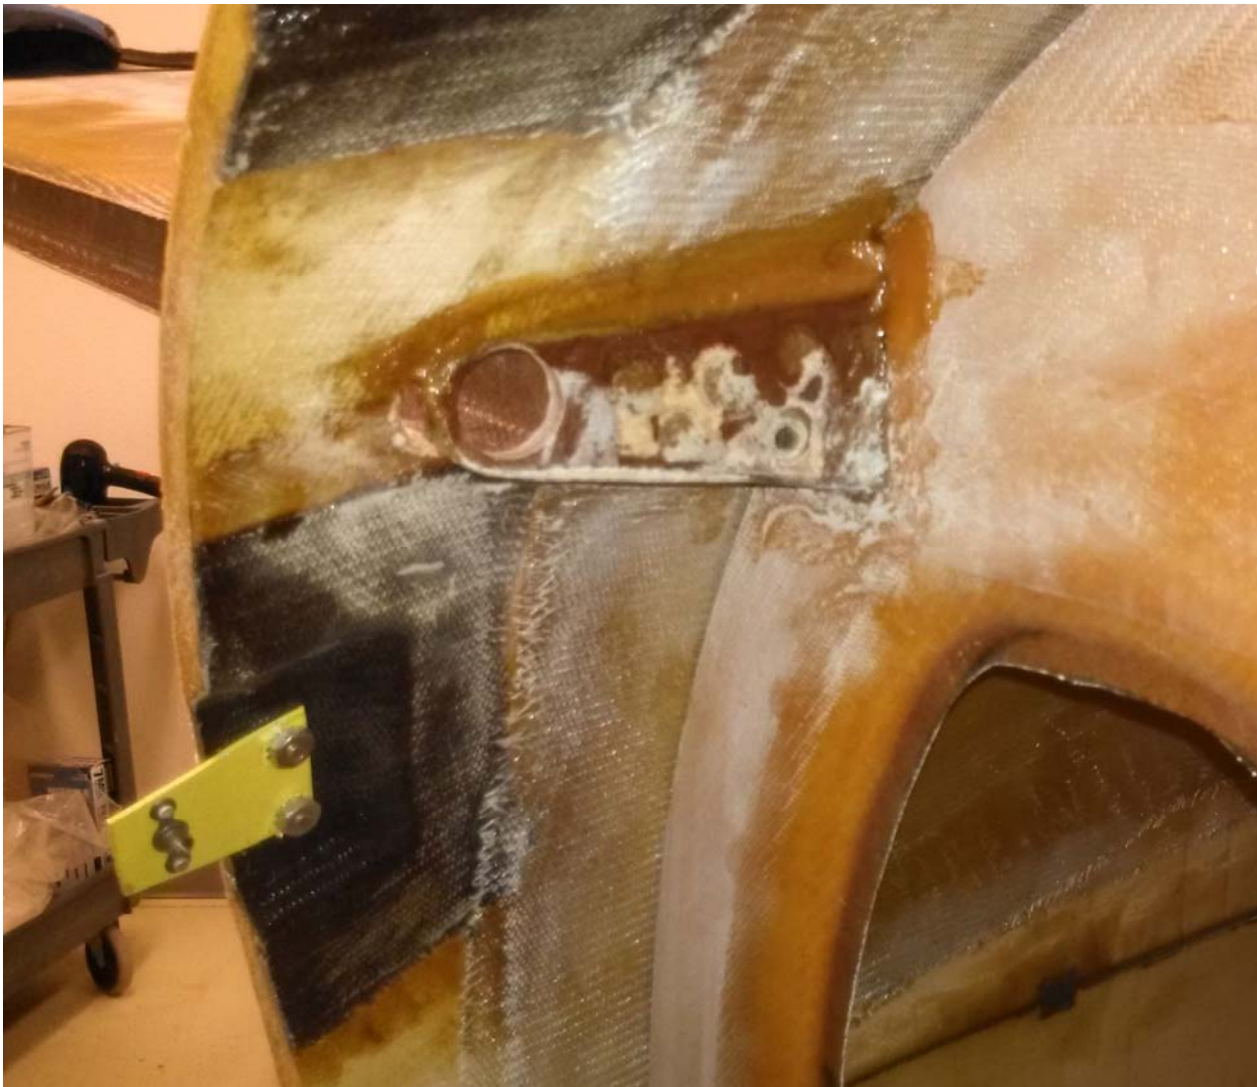
Gap between CS6 assembly and outer fuselage is closed out with 2 BID to give additional support to CS6 and also seal out any leakage of weather from the exterior into the /fuselage. The 7/8" milled opening in CS6 is clearly shown in this photo. The rulon bushing fits into this opening, reducing to 5/8" ID to accept the aileron torque tube.
