Construction: Control Systems

Builders Log--Quickie Q-200 S/N 2868

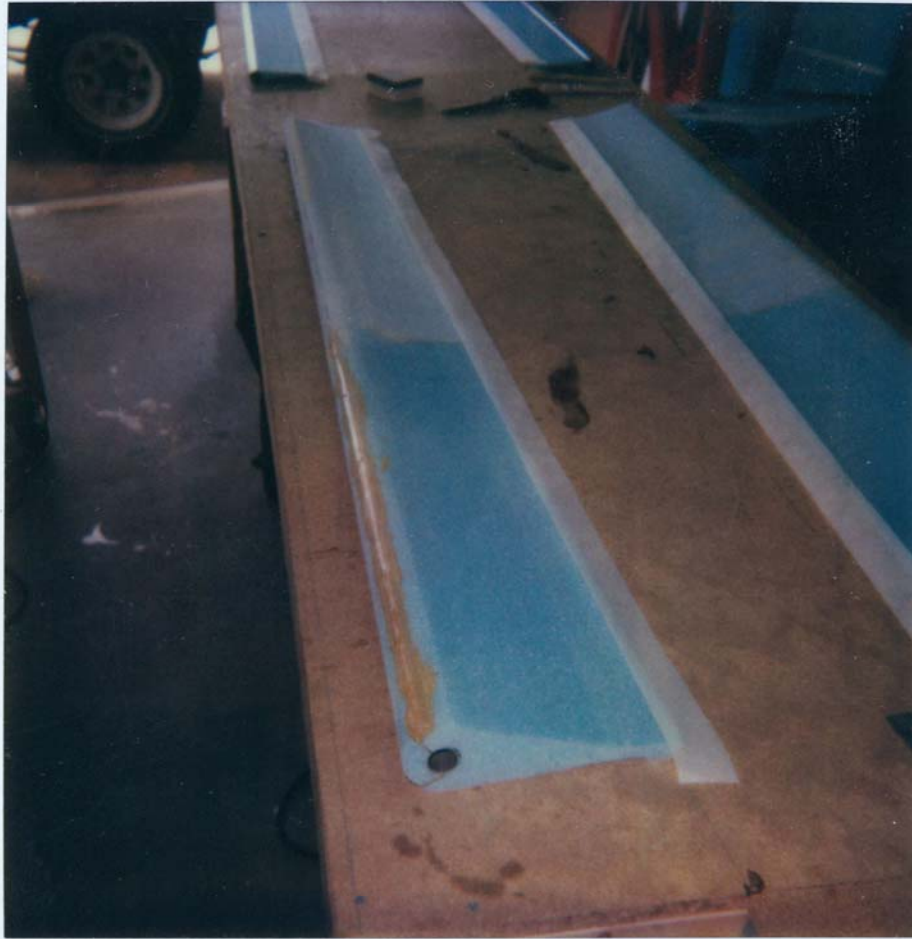
*tops of elevator core microed and prepped
for glossing 8/11/85*

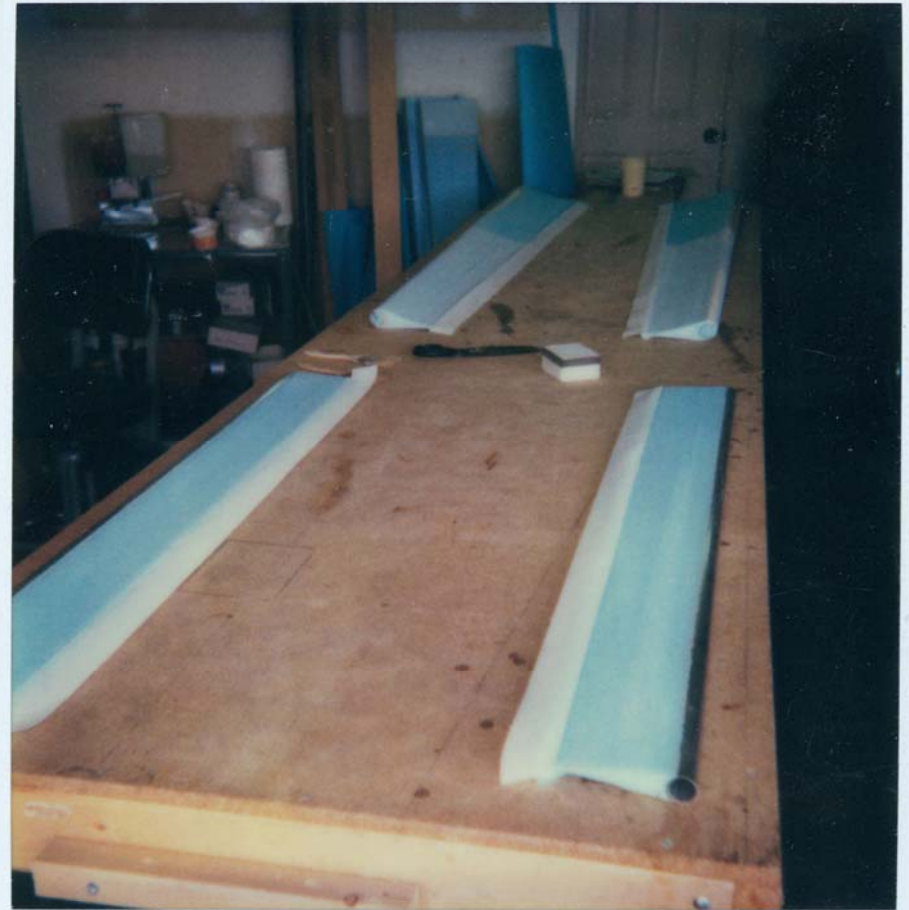
*Tops of elevator and aileron cores
prepped for glossing - leading and trailing
edges bonded to flat surface 8/11/85*

Layout previously cut foam cores for ailerons, elevators and rudder on flat jigging table.
Sand torque tubes and bond to foam cores per Q2 plans section 6-1, 6-2, 6-3.

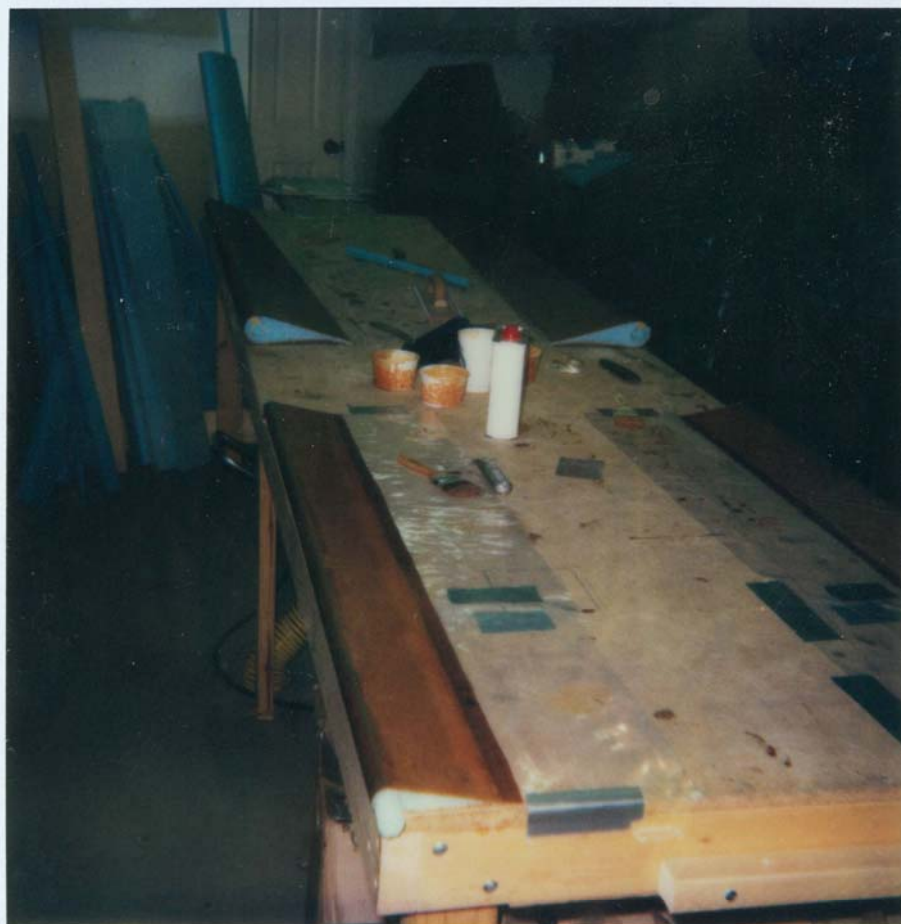
GLASSED BOTTOMS OF ELEVATORS AND
AILERONS 8/13/85

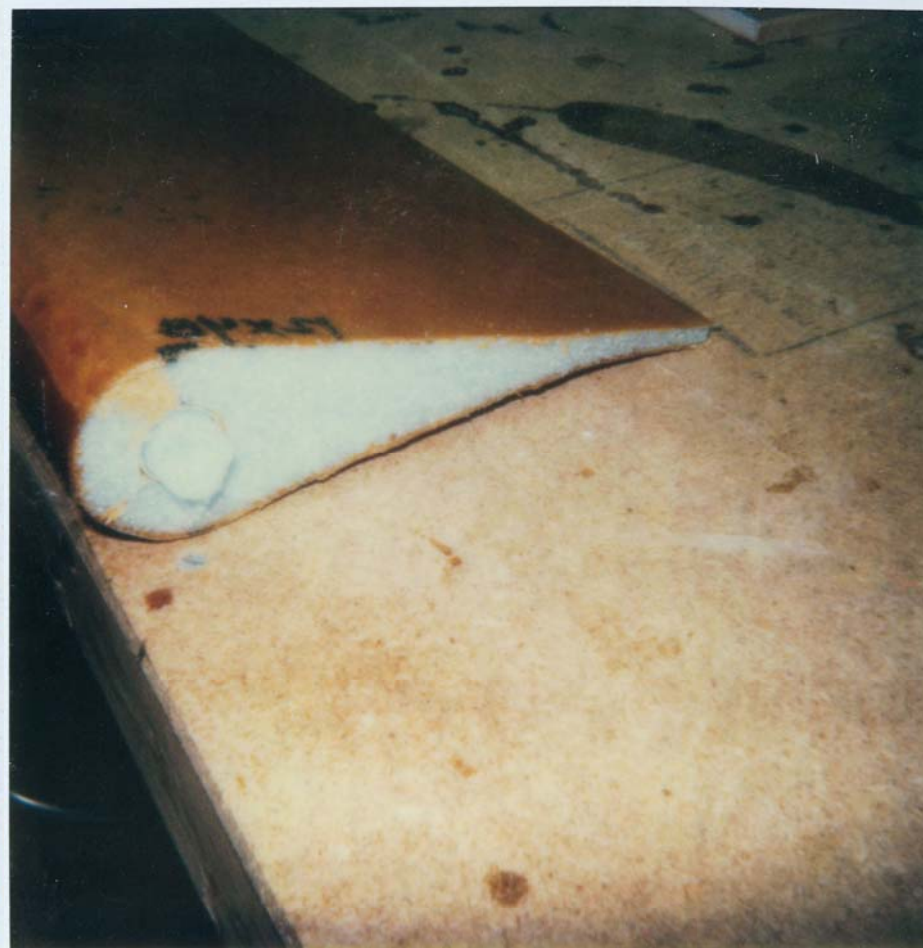
DETAIL - GLASSED ELEVATOR CORE
8/13/85

Glass both top and bottom of both ailerons and elevators per Q2 plans section 6-2-, 6-3 and Q200 supplements (original canard construction, Quickhead's updated construction supplement)

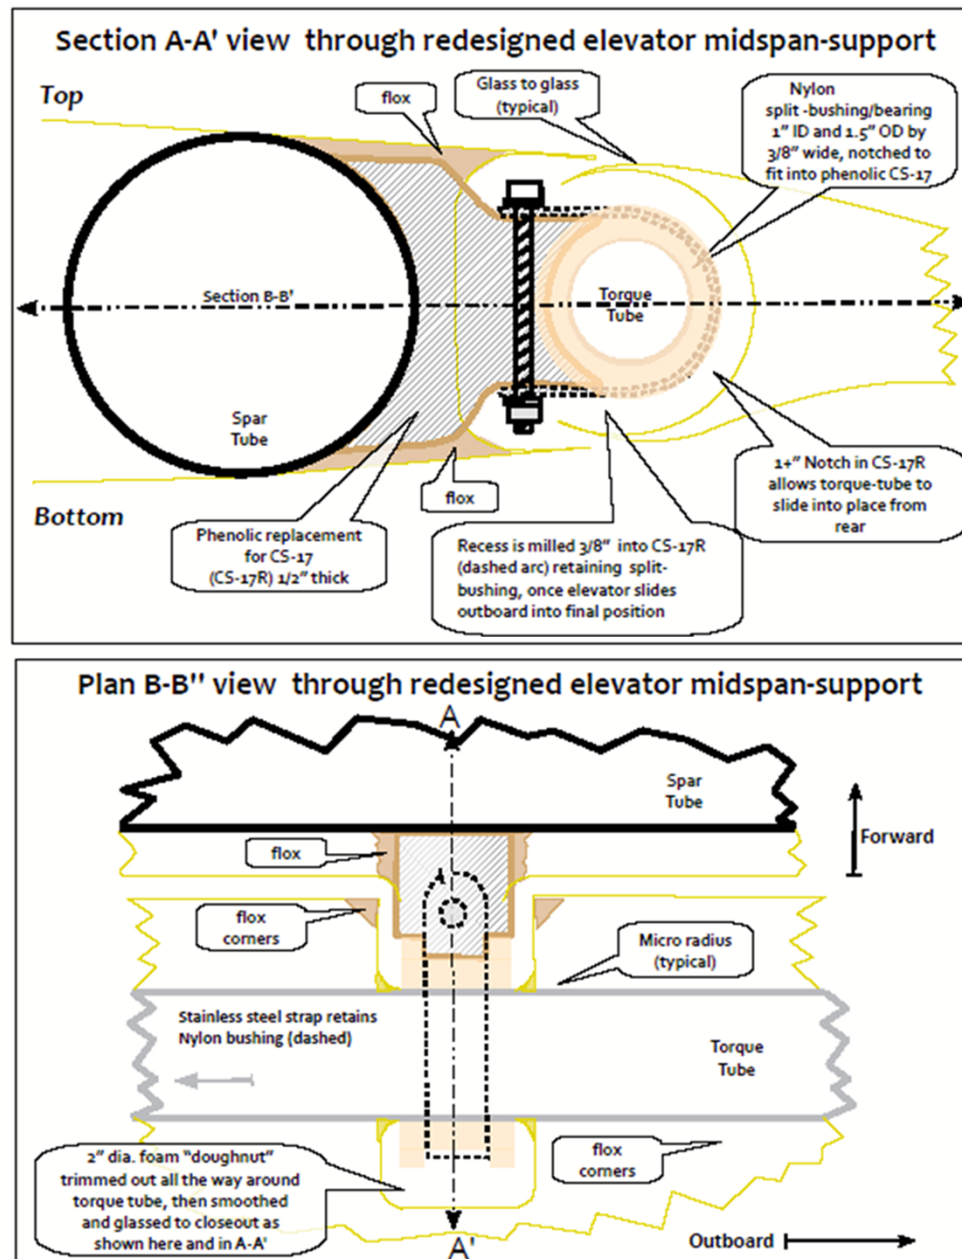
Original design was replaced with a more robust design that both increases the strength of the center of the torque tube and eliminates any critical corrosion issues. The design is similar to the hinge assemblies for elevator torque tubes on all models of Waco biplanes, a proven reliable hinge geometry. The redesigned hinge section views are shown to the left. Full range of motion as well as strength of the revised design were verified by manual testing after installation. This assembly replaces assemblies outlined on pages 10-7 and 10-8 in Q-2 plans. Details of installation are shown on the following pages.

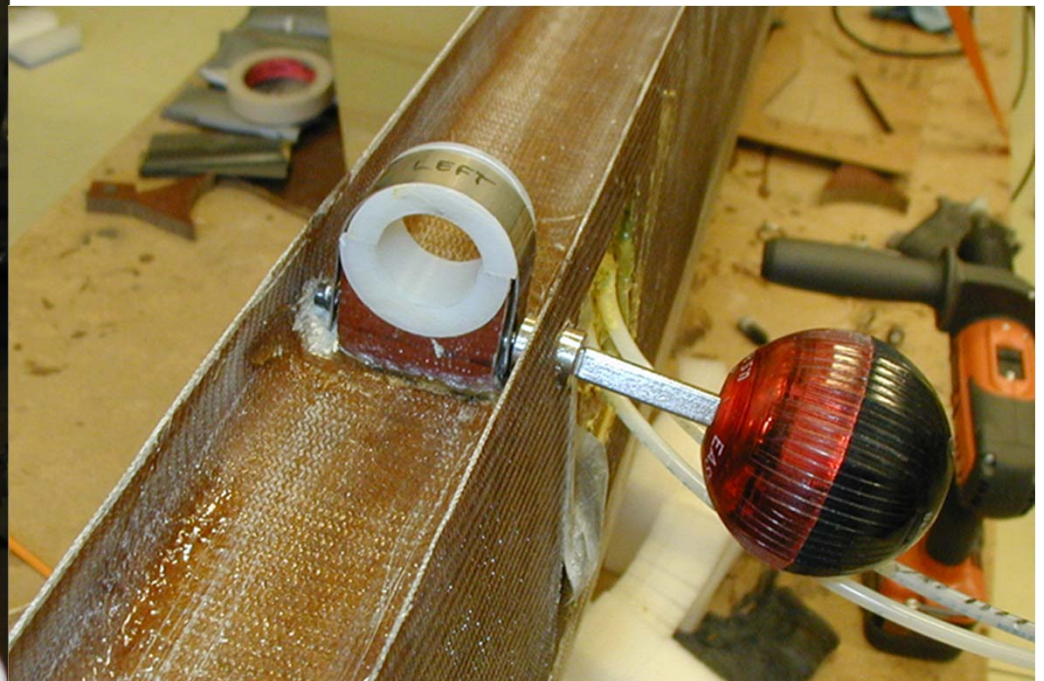
The CS17/18 replacement is shown bonded into position. Flox bond to the spar is internal to the slot core, then one half of the nylon-bearing "split donut" is secured to CS17/18 with flox and a recessed securing screw. Then 2 BID's are laid up to secure to the internal slot core. Total support assembly is shown in mounted position in the lower left photo, and access is demonstrated in lower right photo April, 2012

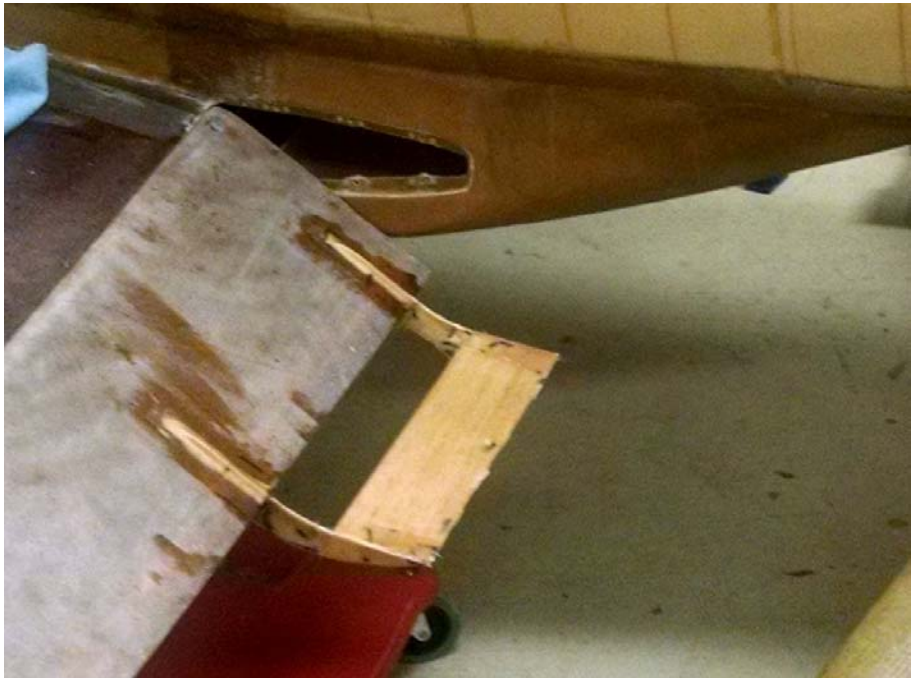
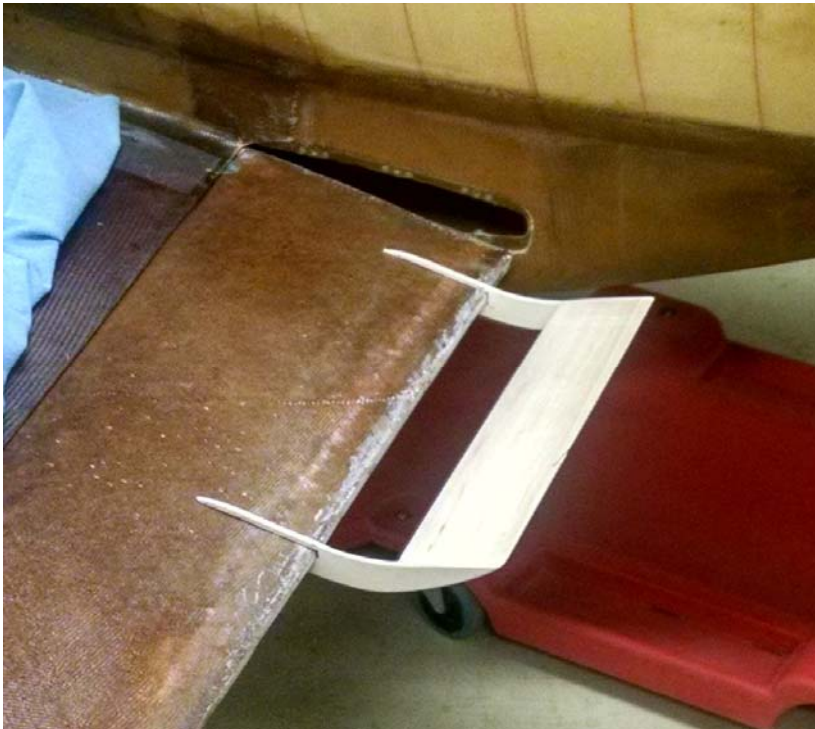
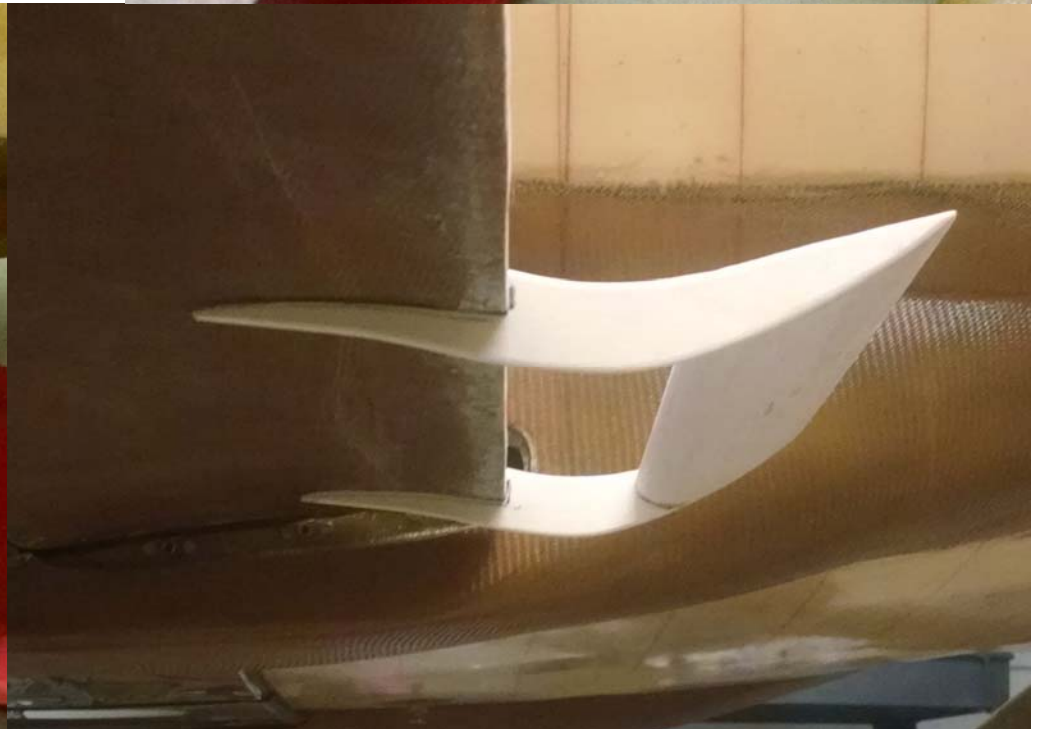
“Sparrow strainer” servo tab is fabricated, assembled and installed per Q-200 plans per Q-200 plans supplement page 4. Support arms were reinforced with additional UNI plies to give strength. This change was added after discussion with a builder who experience on breaking off at the support arm junction with the trailing edge of the elevator while in flight.

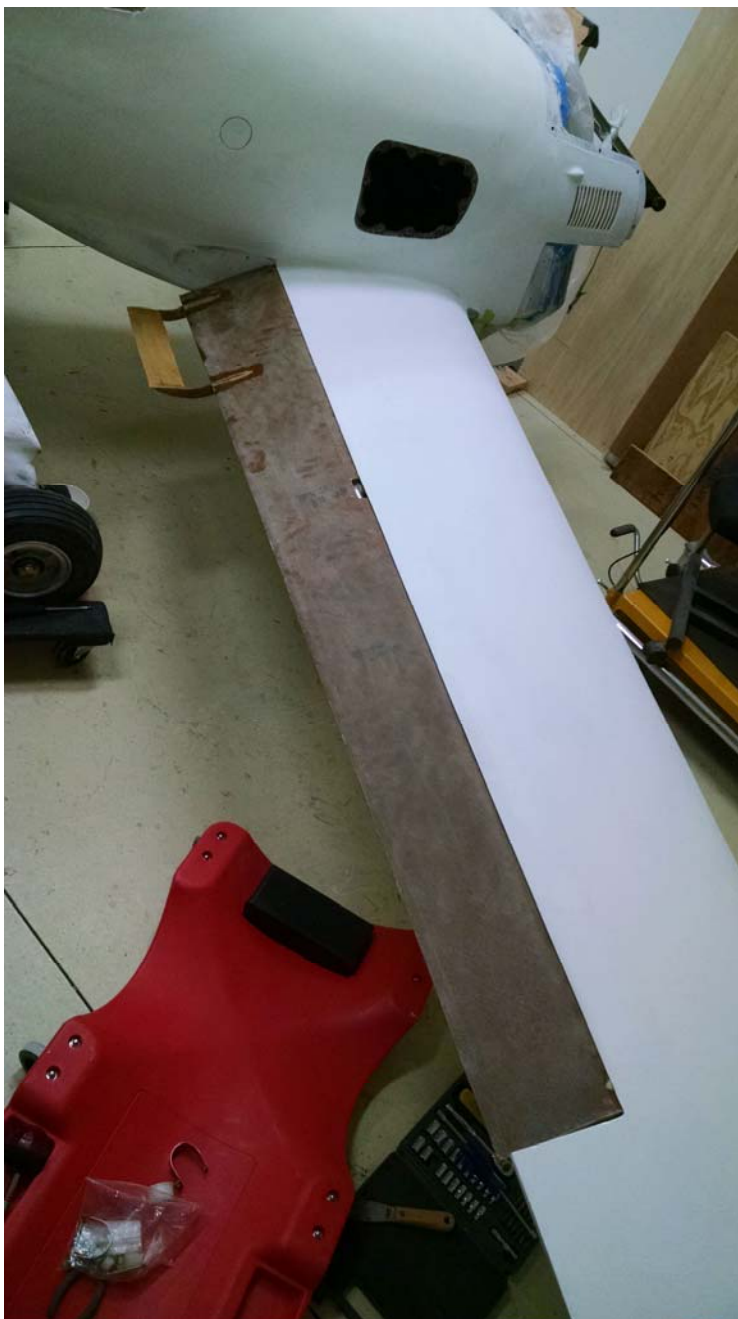
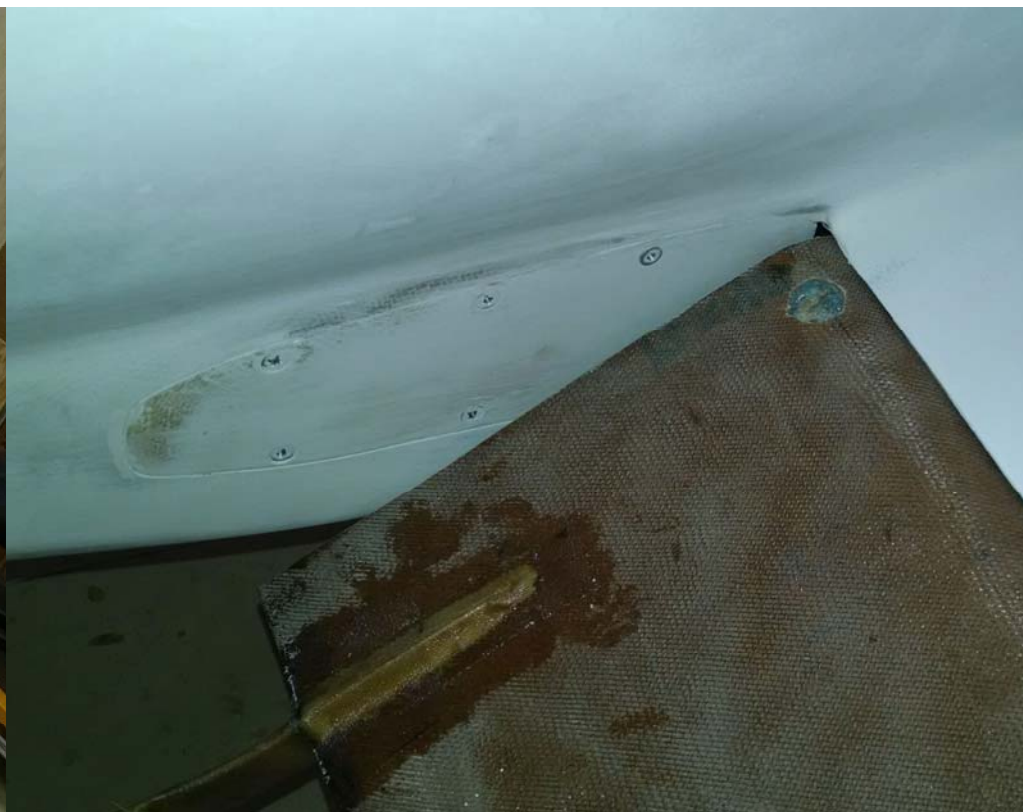
Trim inside edges of elevators to assure clearance through range of motion near strake access closure panel. October 2017

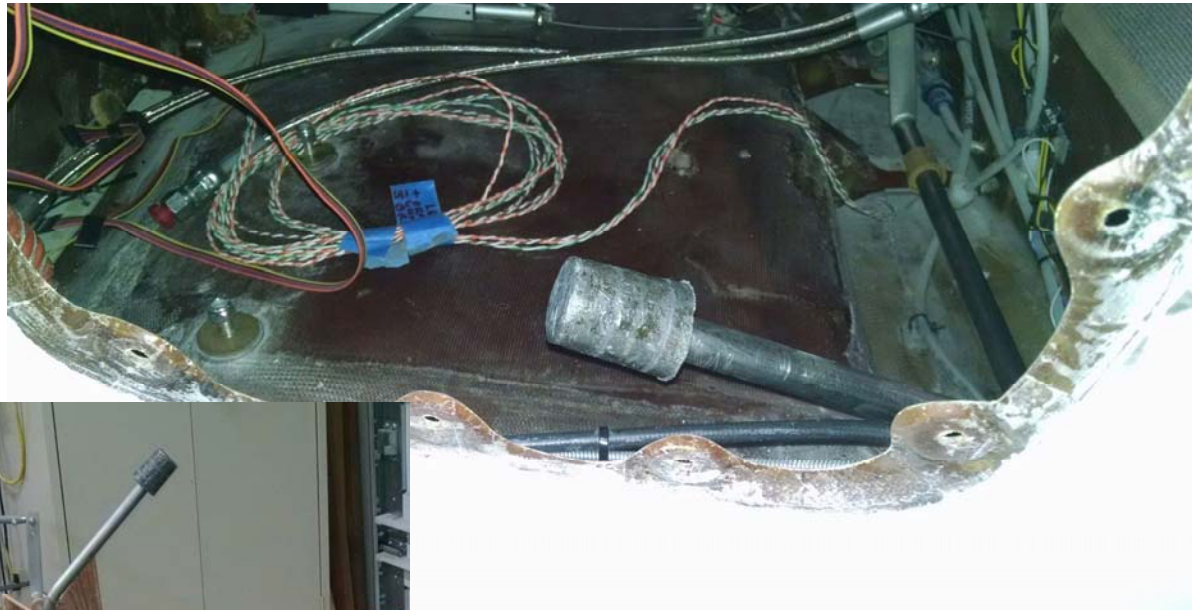
Layout and test mass balance through range of deflection of elevator on bench, then install in aircraft and test same, verifying non-interference of mass balance arm with existing controls and fuselage side. November 2017.

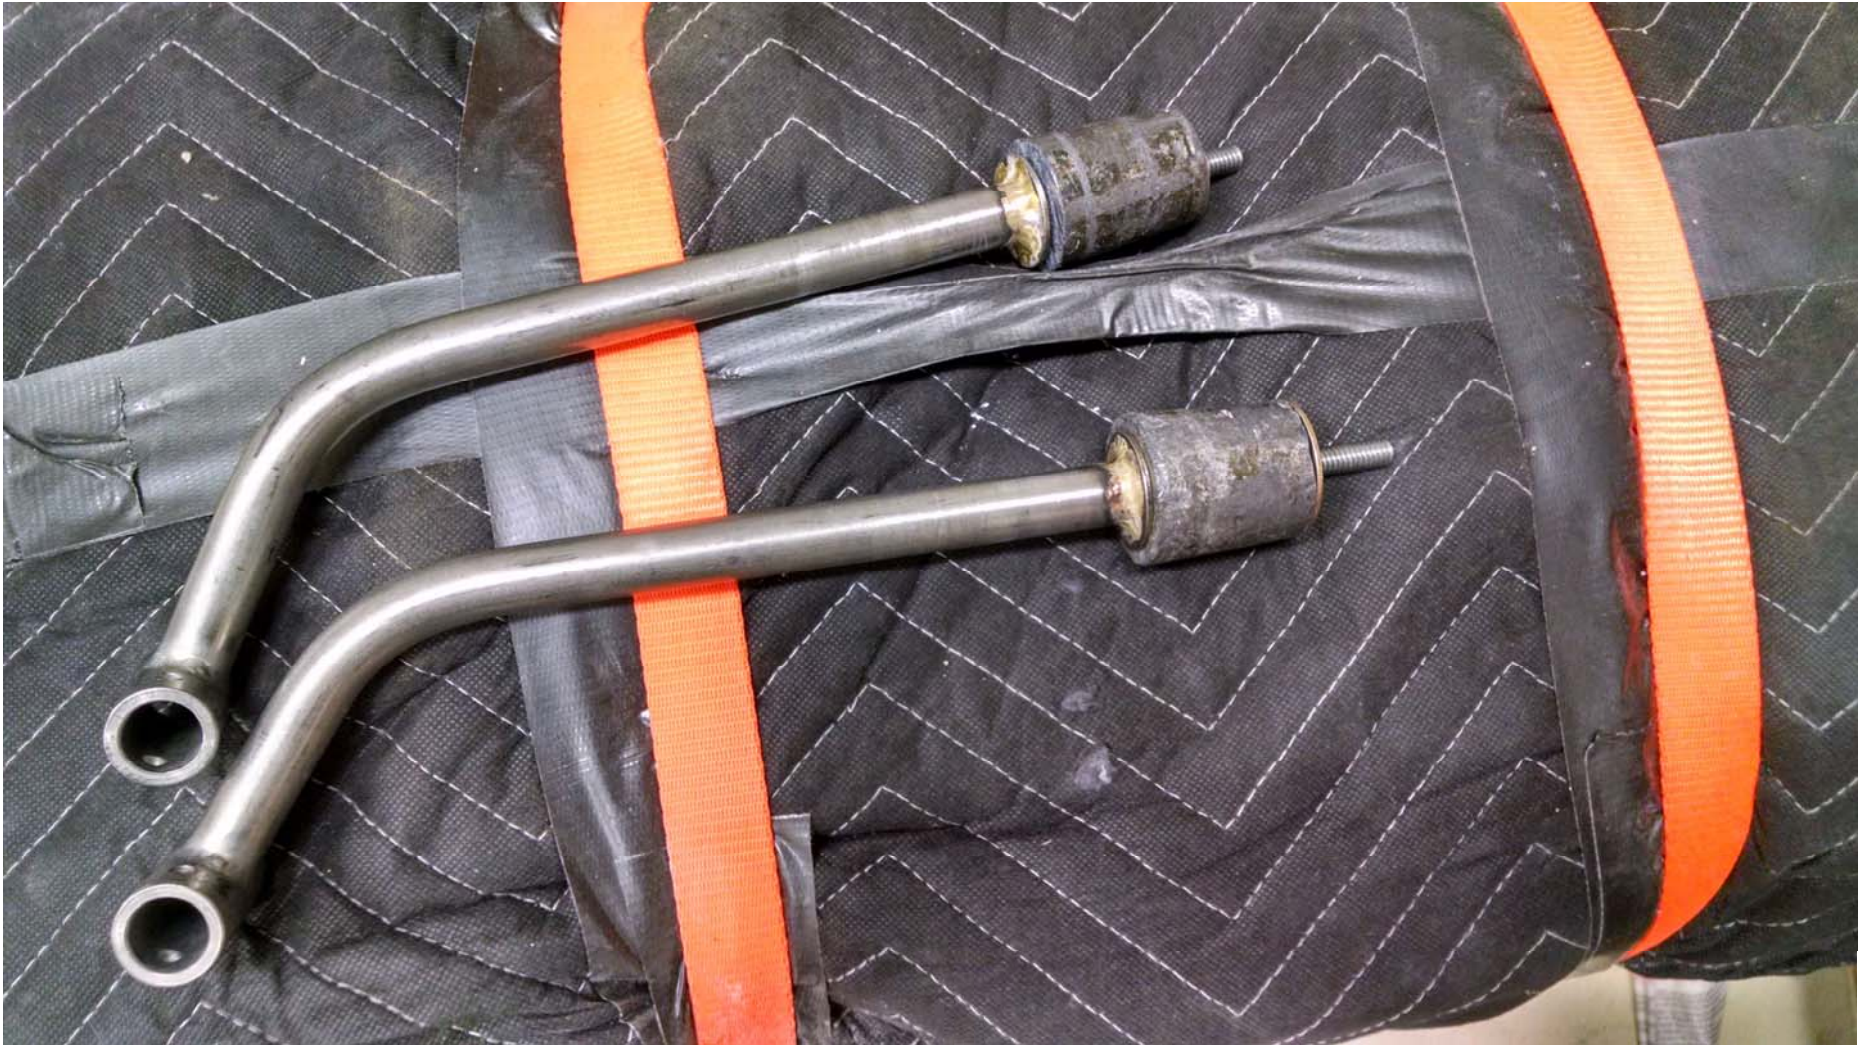
Braze attachment hardware onto mass balance arms and install weights with retention bolts braised into end of arm. Verify security and clearance in aircraft. January 2018.

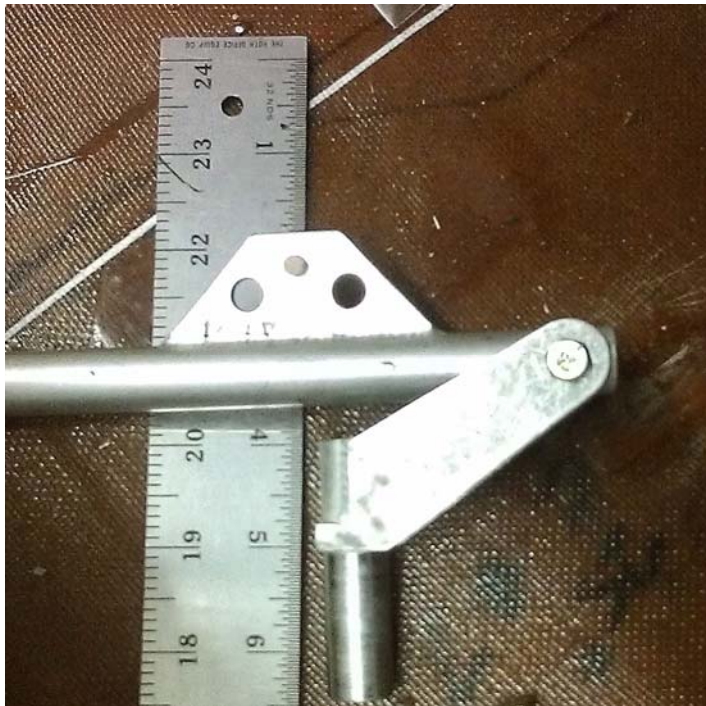
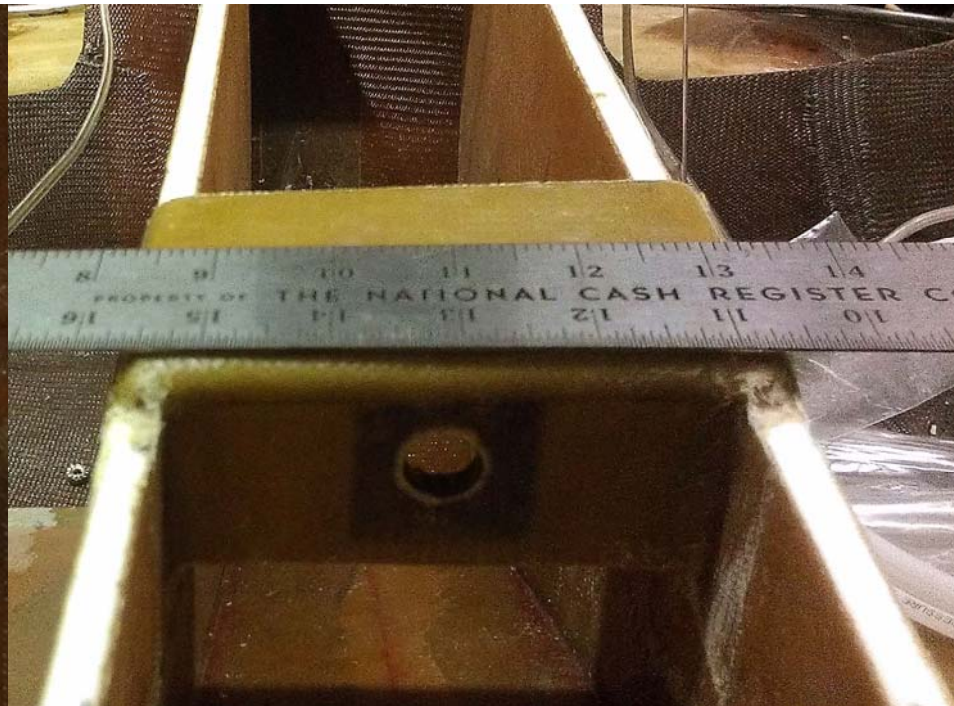
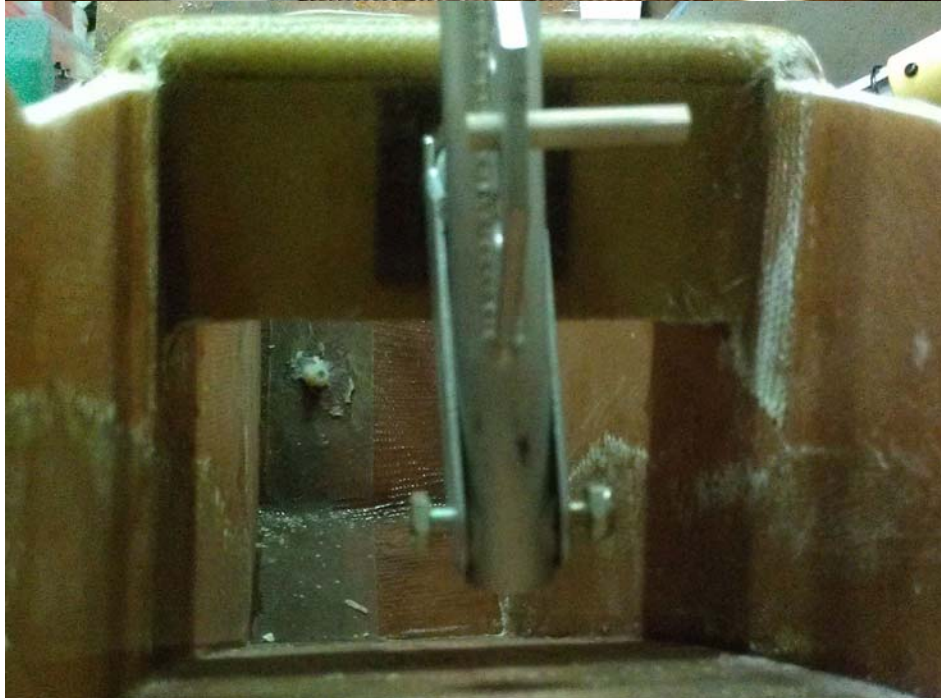
Mounting of CS1 bearing and associated assembly in center console per Q-2 plans section 14-8. QCSA2 was modified to allow for more rearward travel of control stick.

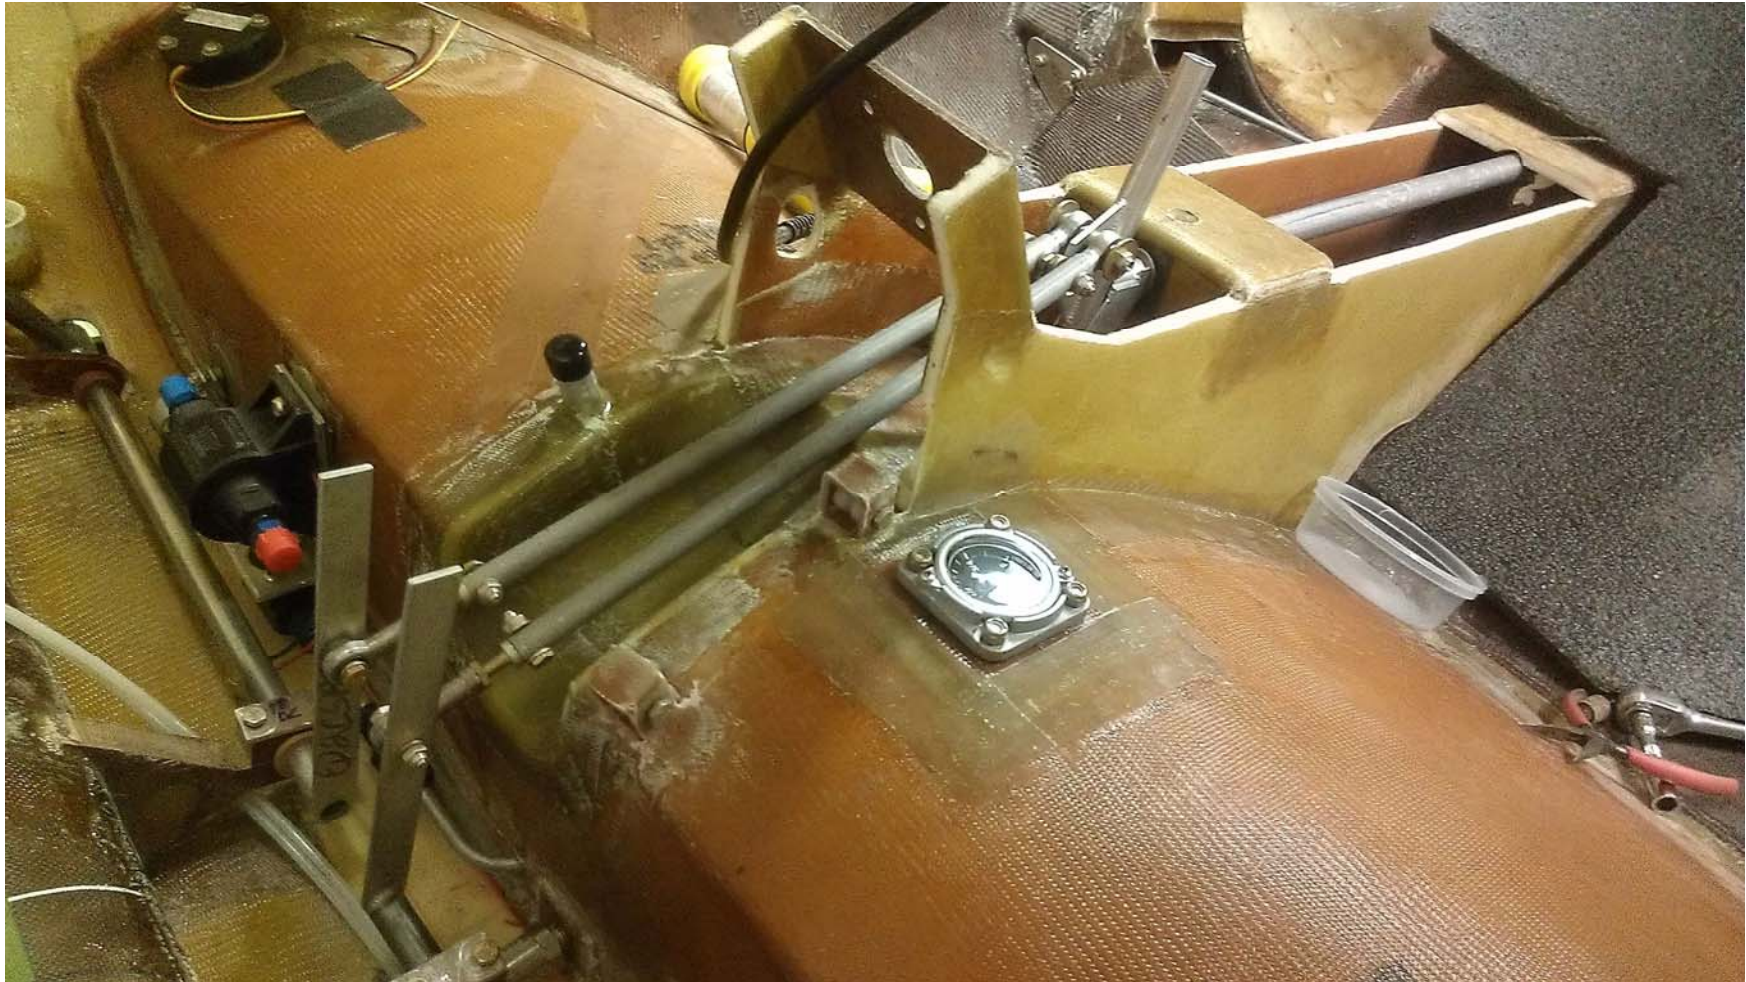
Elevator and aileron/control stick assembly test-fit and travel limits and clearance verified

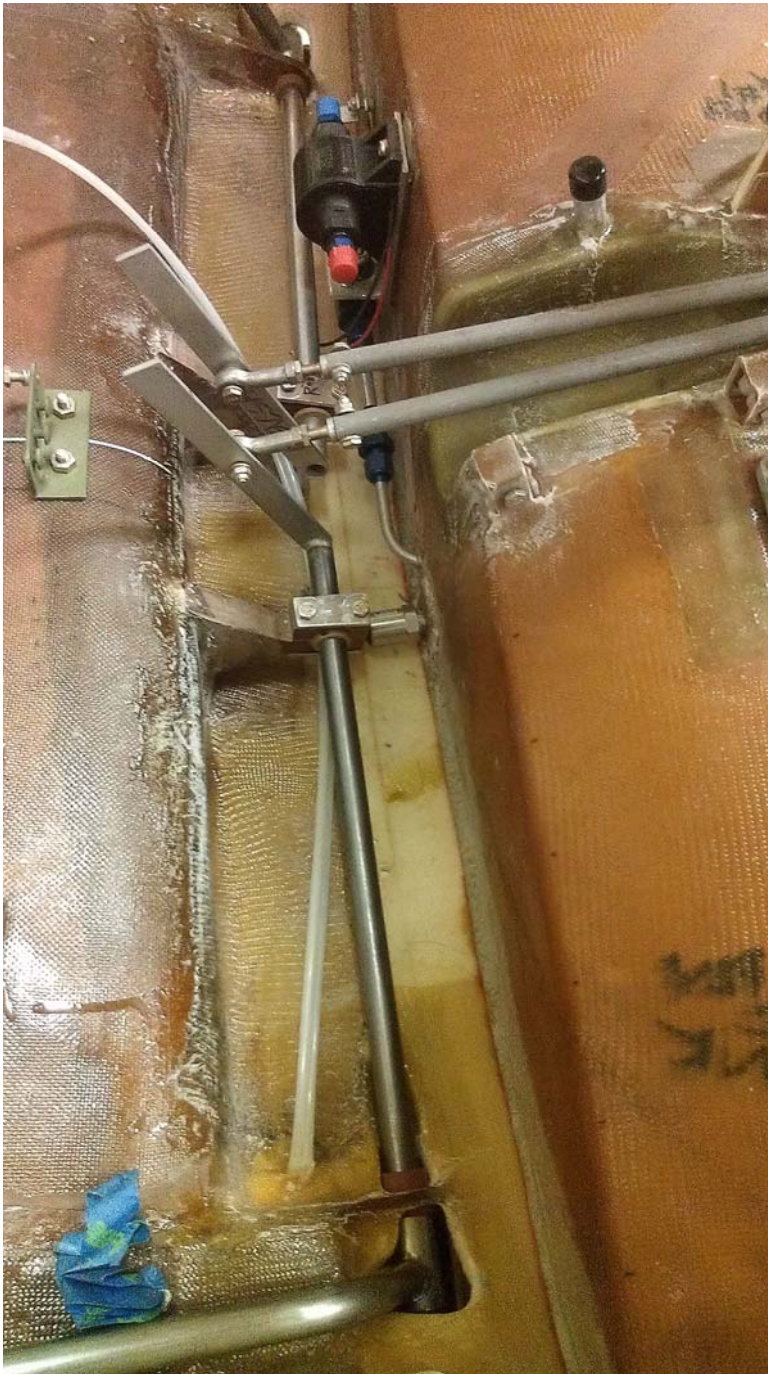
Push rods and torque tubes for elevators installed and test for clearance and range of motion. Note that left and right torque tubes each have a mass balance arm installed. The Mass balance arm is flush against the Rulon shoulder bearing installed in CS15. The mass balance arm replaces the spacer shown on page 10-10 in the Q2 plans and prevents inboard travel of elevator assembly. Right side is mirror image of left side.

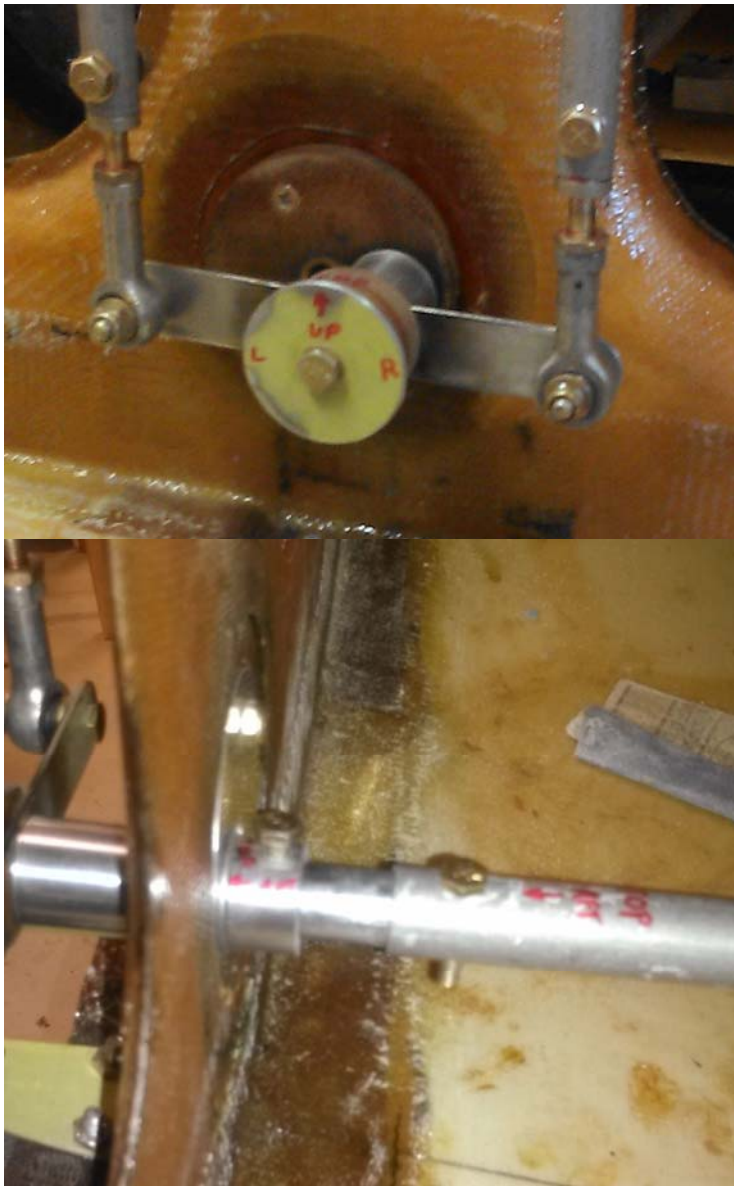
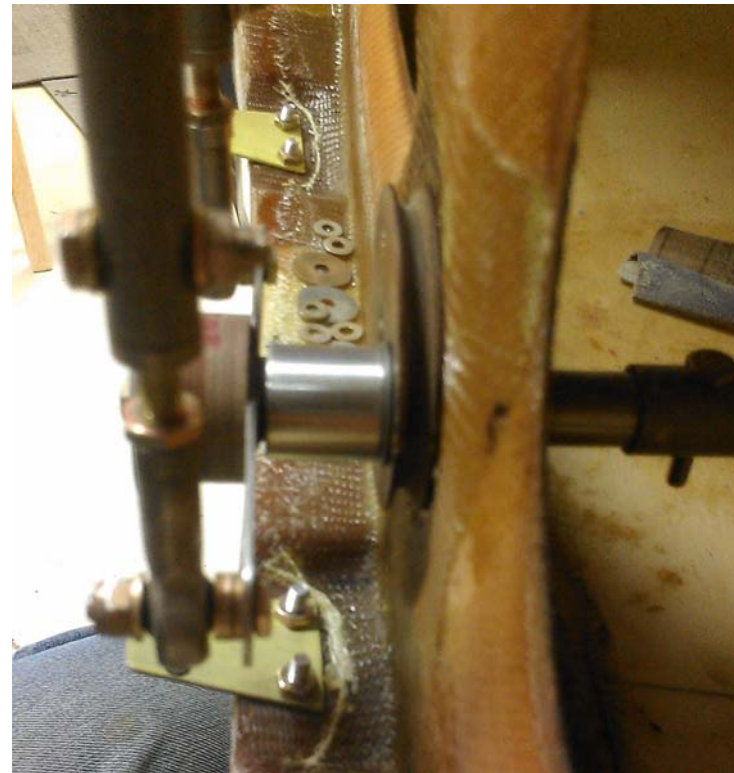
QCSA3 is installed through the rotating phenolic reflexor-body assembly in FS 95 bulkhead. Lengths of aluminum spacer are cut to fit over the shank of QCSA3 on both front and back with a oil-embedded thrust bearing between those spacers and the reflexor-body retainer plate (forward side) and reflexor pulley (aft side). These spacers serve to square up QCSA3 as it passes through the reflexor. The CS2 torque tube and CS3 spacer are assembled and drilled per plans to accommodate AN3 bolt.

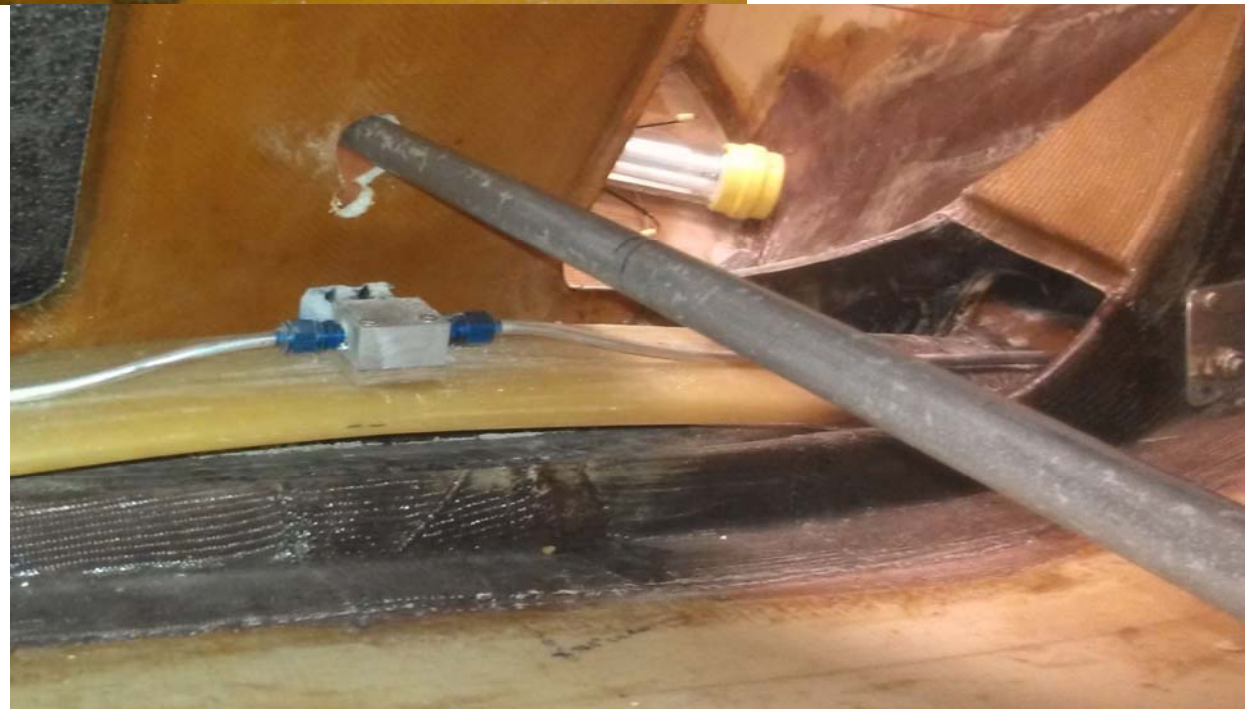
Additional view of assembled control and reflexor system and aileron torque tube CS2 passing through the seat back bulkhead

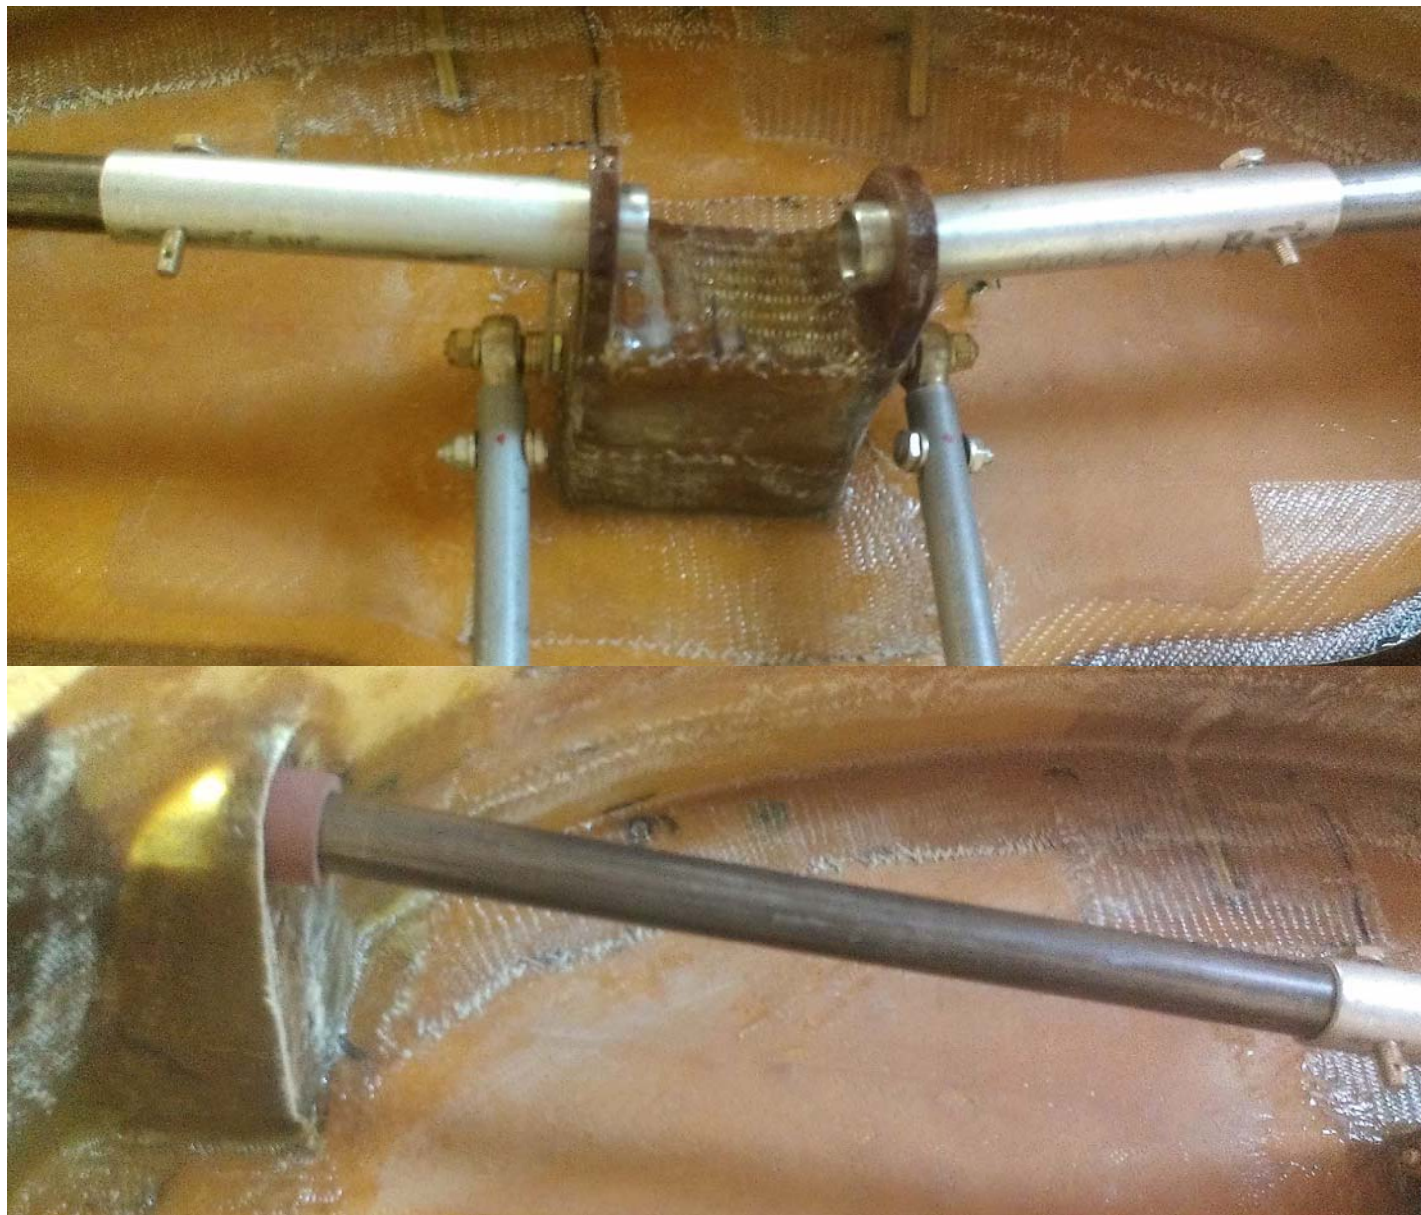
Views of upper torque tube assembly Q2CSA4's (upper photo). The left torque tube is shown projecting through the rulon bearing (chalky red color, lower photo). This shoulder bearing has the shoulder on the outboard side of CS6. The spacer which prevents inboard travel of aileron seats against a oil impregnated thrust bearing located between it and the shoulder of the rulon bearing.

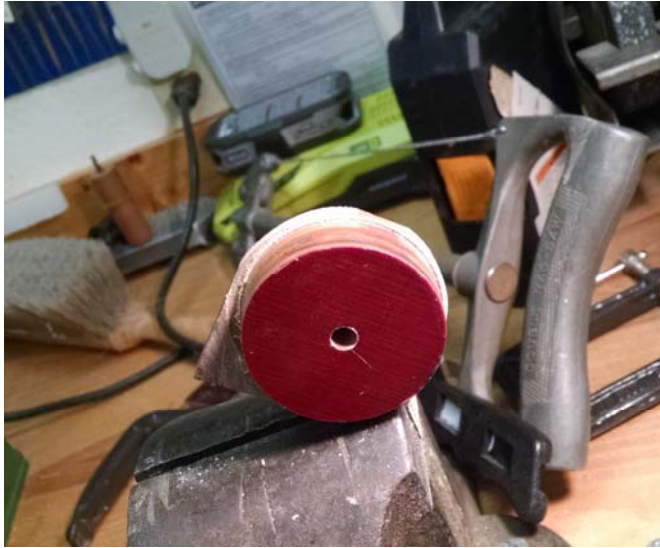
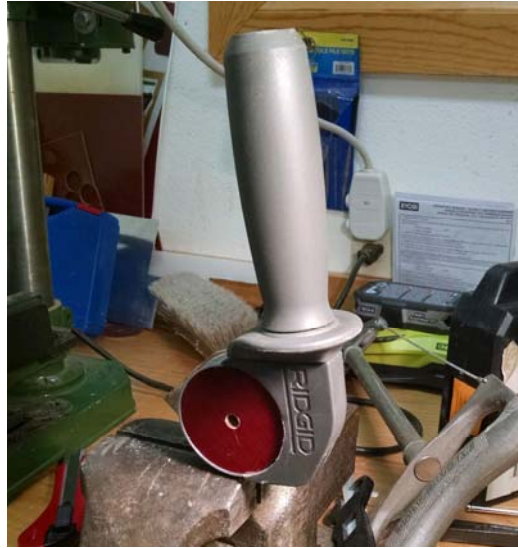
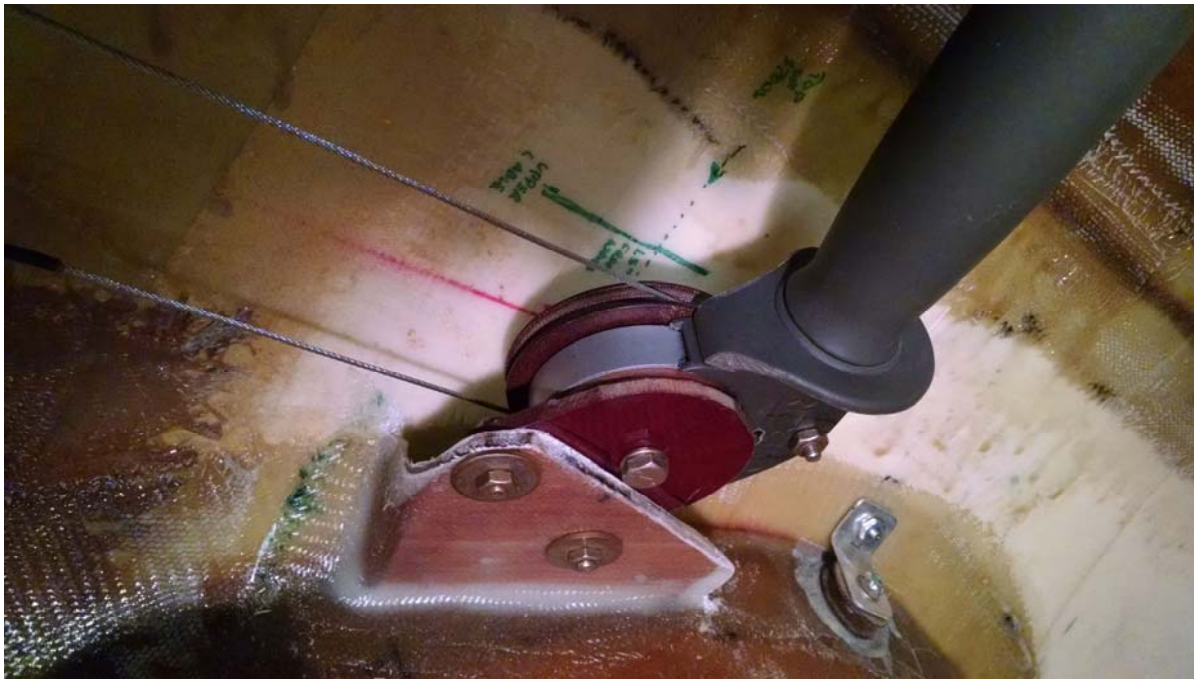
Photos of reflexor control handle being fabricated. Center of control is phenolic, cut as a disk with an integral attach flange. A steel clamping strap is incorporated into the control lever. Twisting the control handle tightens a clamping bolt to serve as a friction lock. A pulley is modified and bolted to the control handle assembly. To adjust the reflexor the control handle is moved forward (nose down) or back (nose up), which rotates the reflexor mechanism mounted on the FS94 bulkhead.
