Construction: Control Systems

Builders Log--Quickie Q-200 S/N 2868

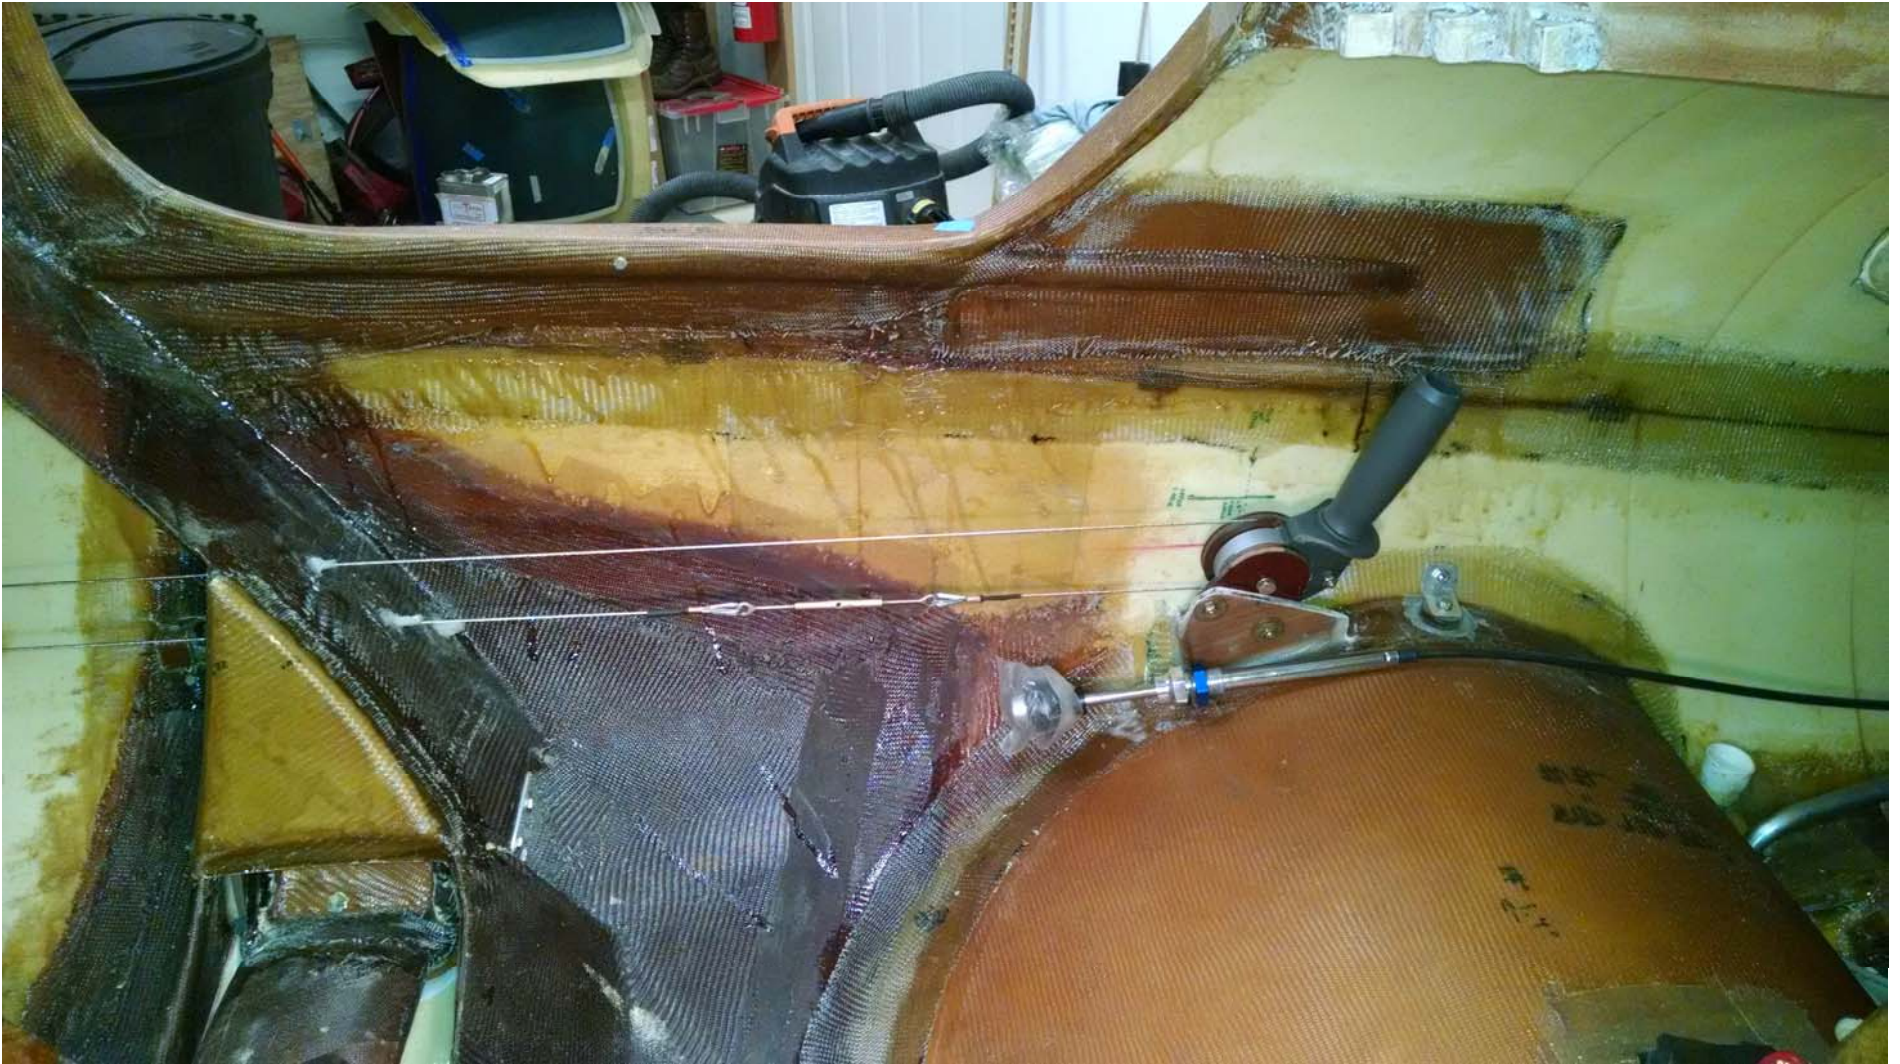
Photo shows the connected reflexor operating mechanism (control lever). The assembly is mounted with two AN3 bolts through a reinforced plywood support that is glassed to the fuel tank and fuselage wall by 3 BID on either side of the plywood. Glass is laid over a floc fillet at base of the plywood. A turnbuckle controls the tension of the control cable. Cables pass through the seat back and landing gear bulkheads via fairleads made of nylaflo tubing pieces, floced in place.

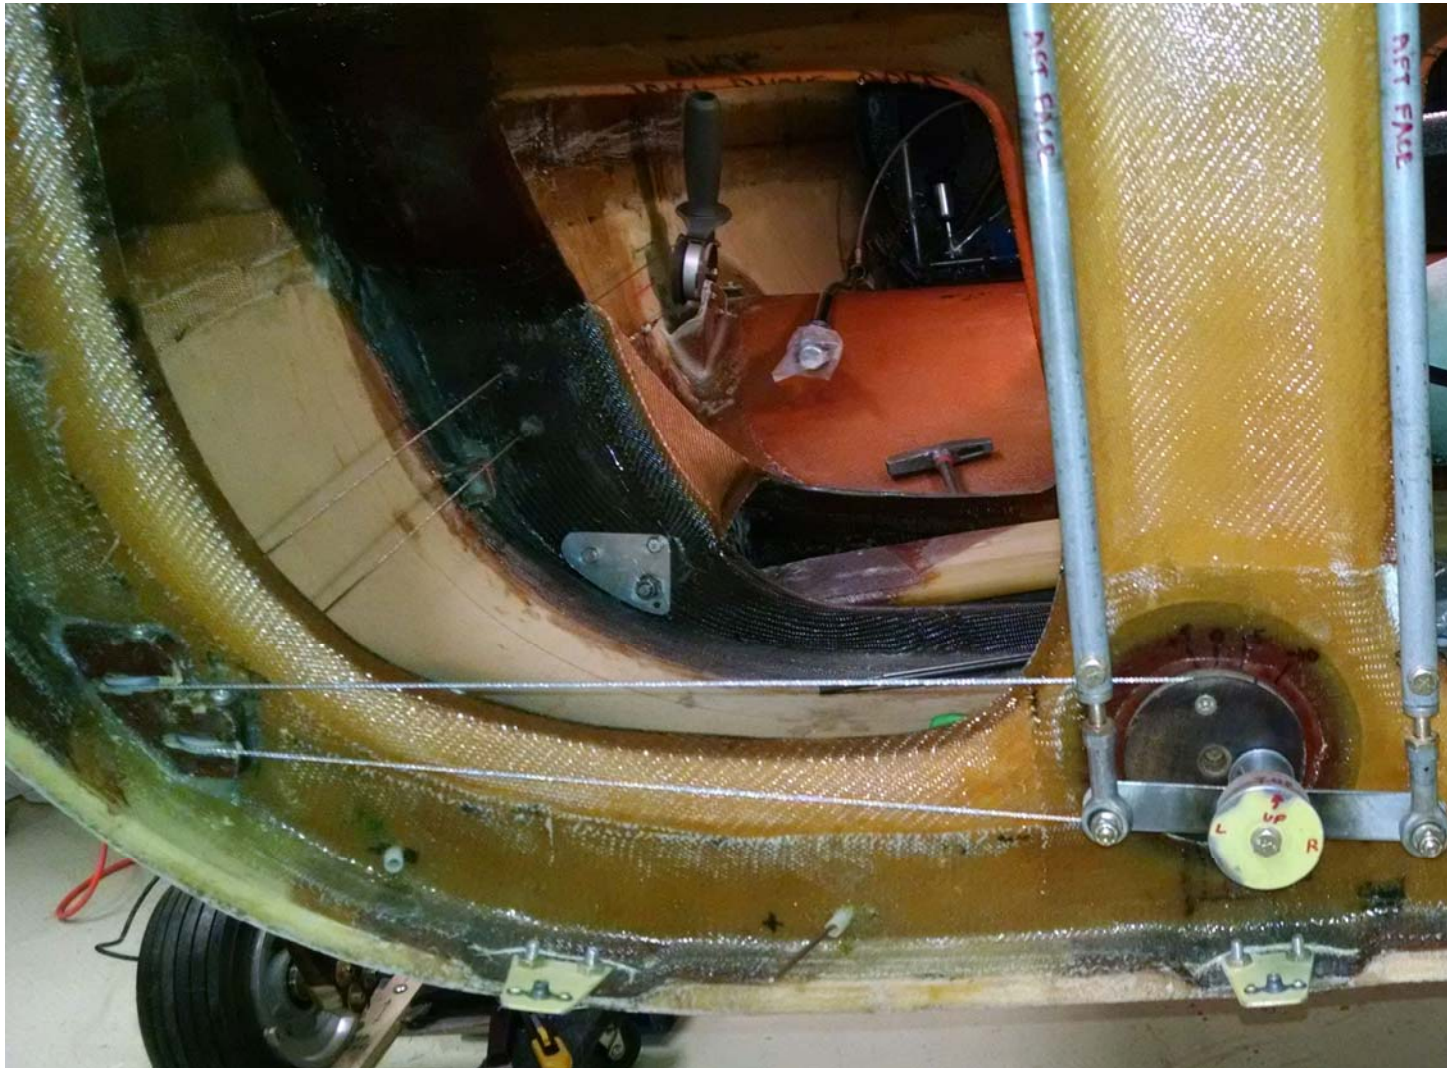
Photo shows reflexor control cables that feed through two guide pulleys retained by a reinforced phenolic mount in FS94, then on to the control pulley mounted on the reflexor-body. The cable is single continuous section that is looped around reflexor control-pulley 3 times. The tightened turnbuckle locks the cable position on the pulley by friction due to cable tension around the control pulley. Range of motion stops on control pulley are added later.

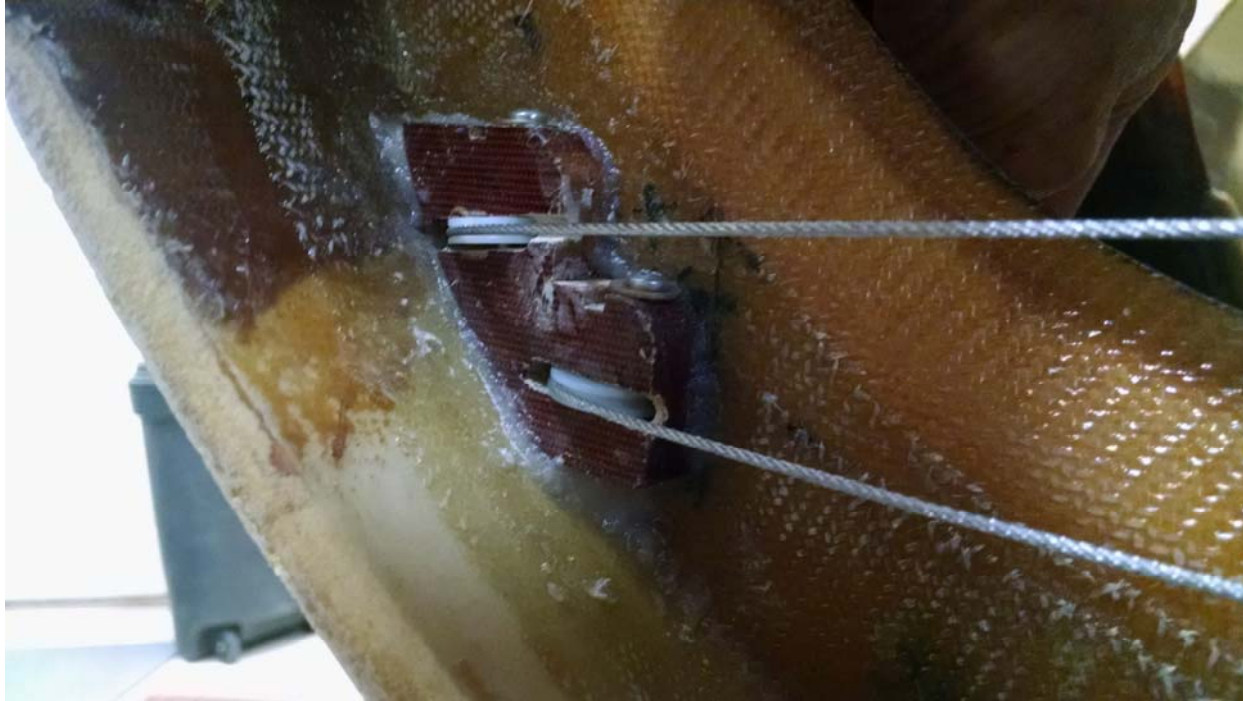
Details of reflexor control cable on guide pulleys on rear side of FS94 bulkhead (lower photo) and wrapping 3 times around control-pulley (mounted to reflexor-body). Control lever moves cable to rotate pulley/reflexor-body, adjusting reflexor setting.

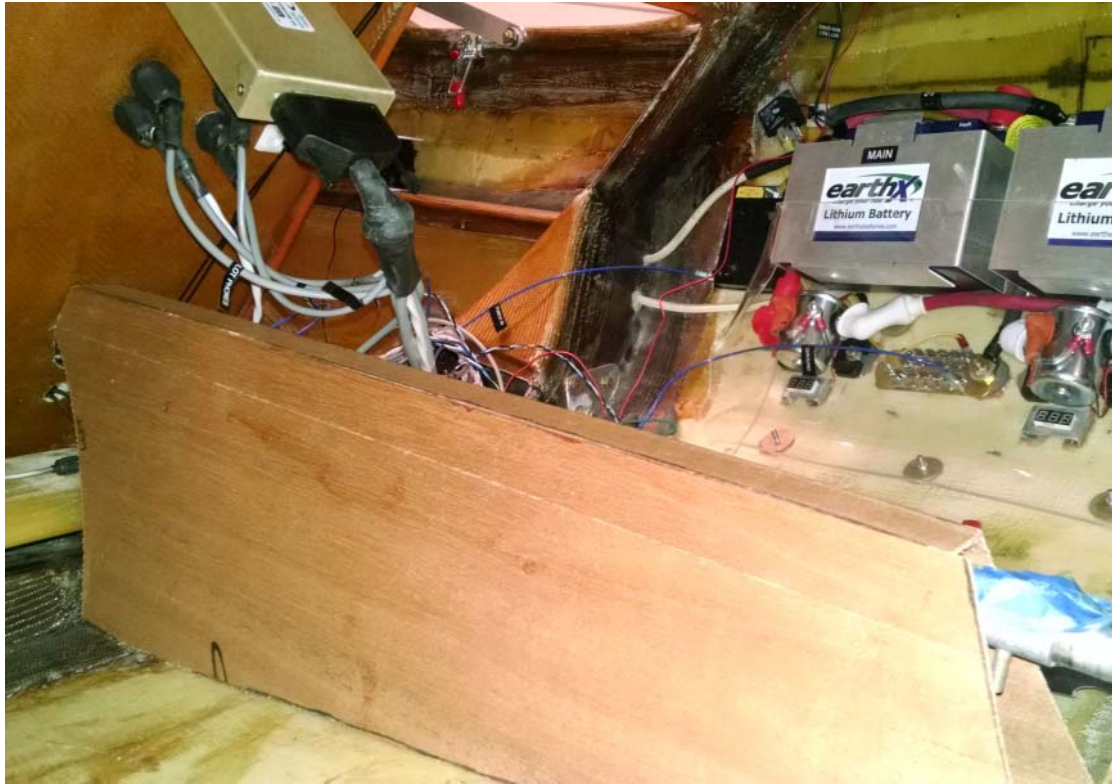
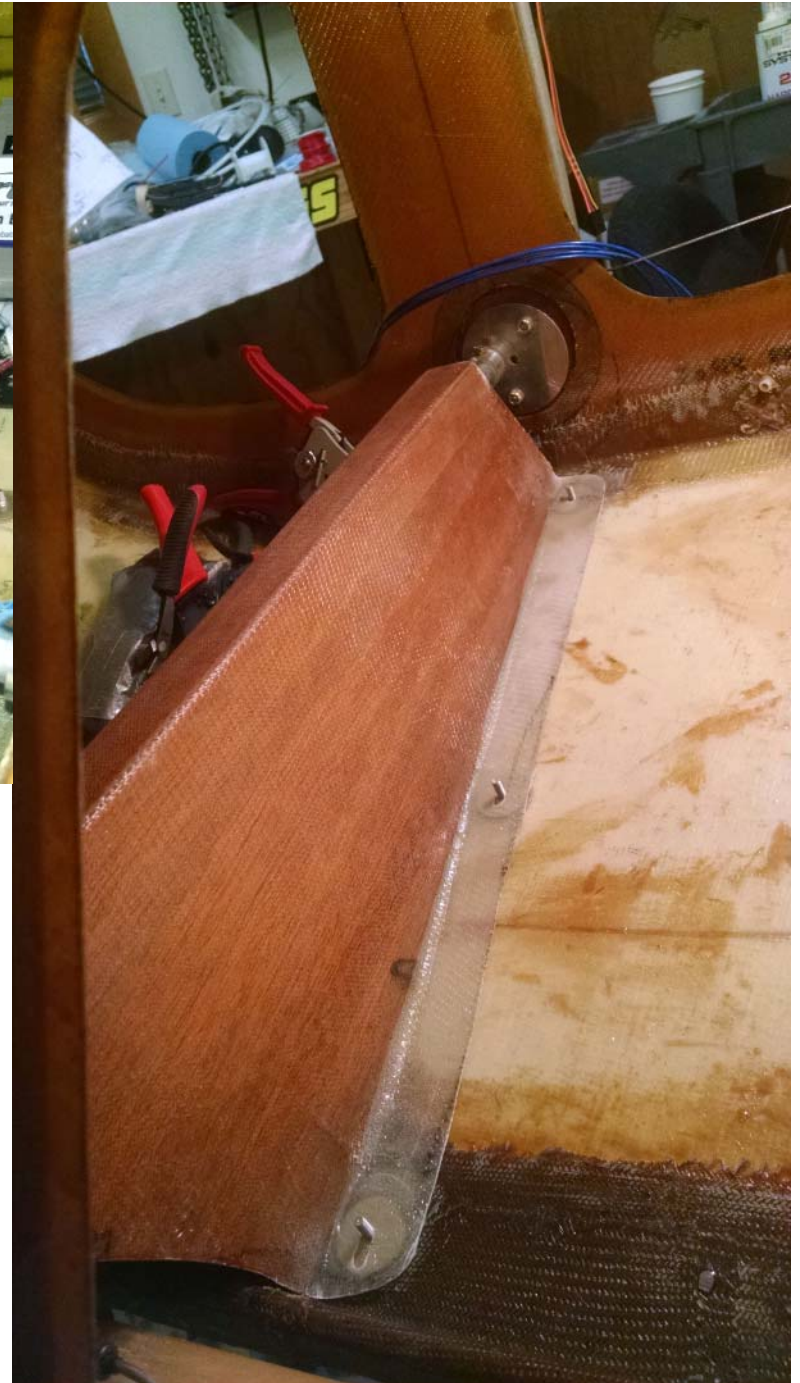
Create removable tunnel/shroud from 1/16" plywood with floc corners reinforced with 2 BID plies lapping onto floor of cargo area. September, 2015.

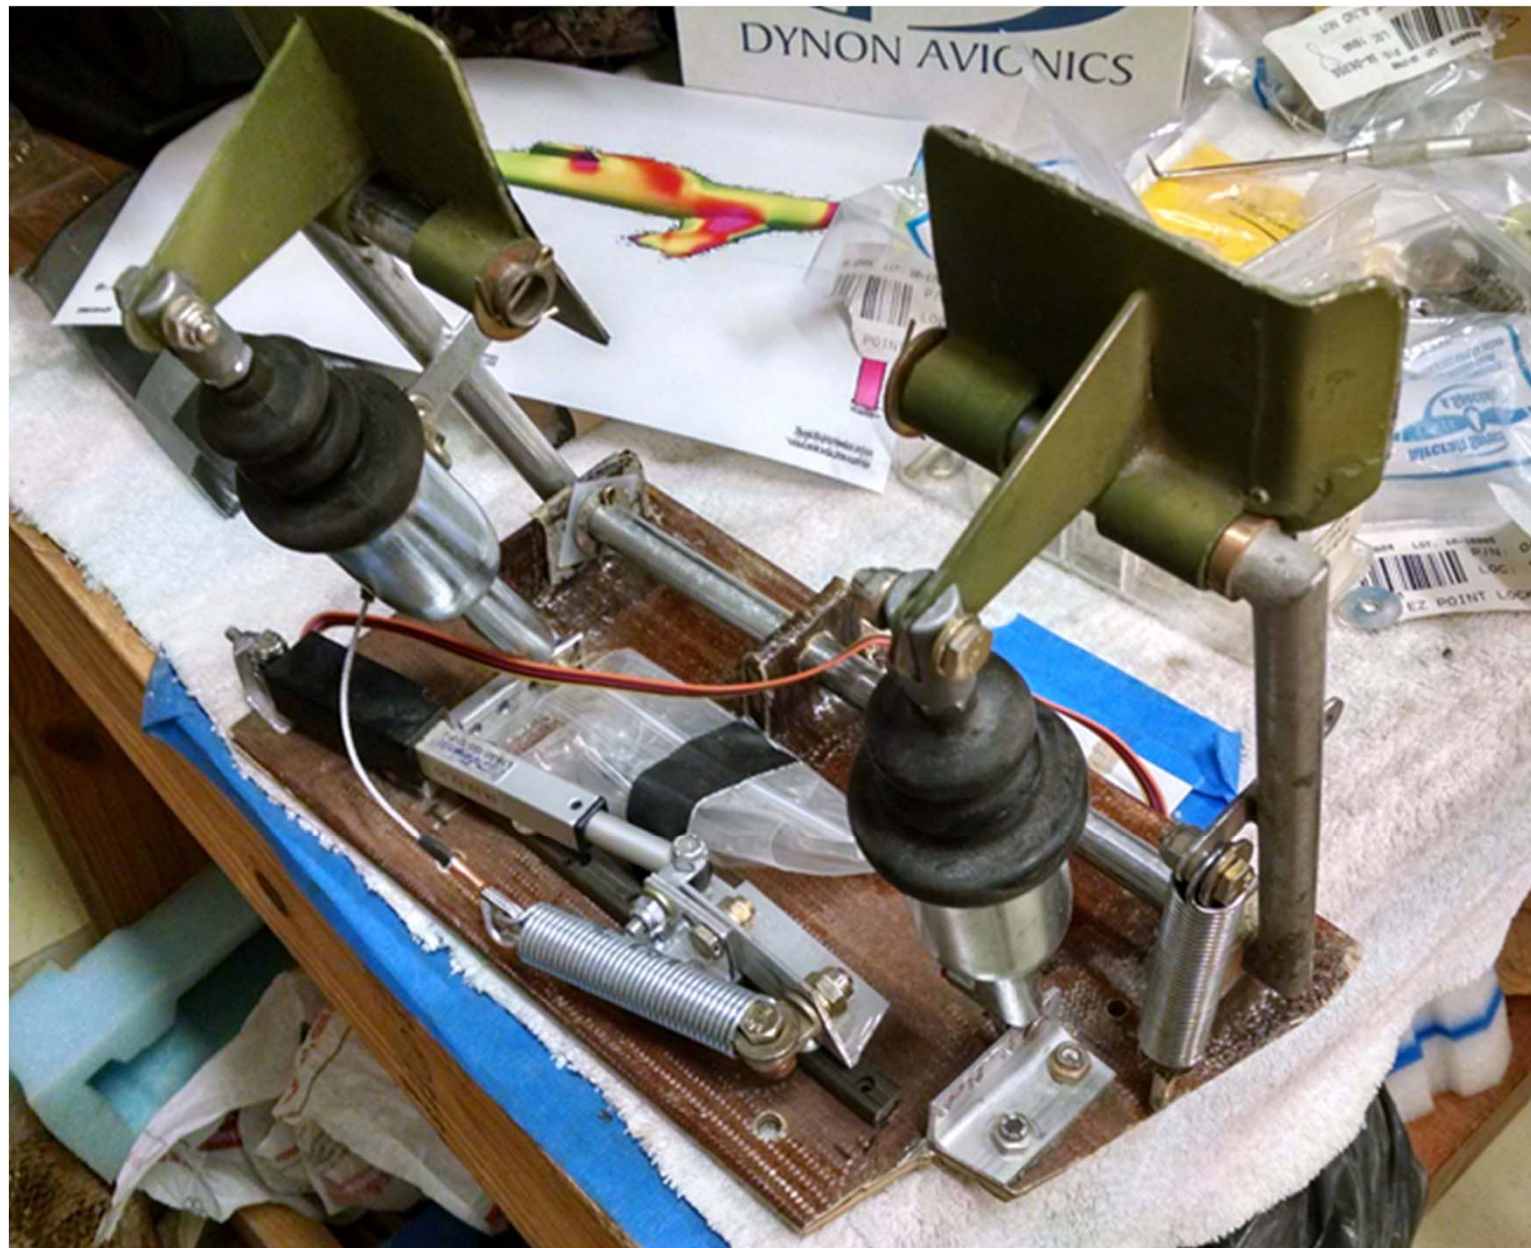
Fitting rudder pedals to brake cylinders and testing clearance and range of motion and security on brake platform.

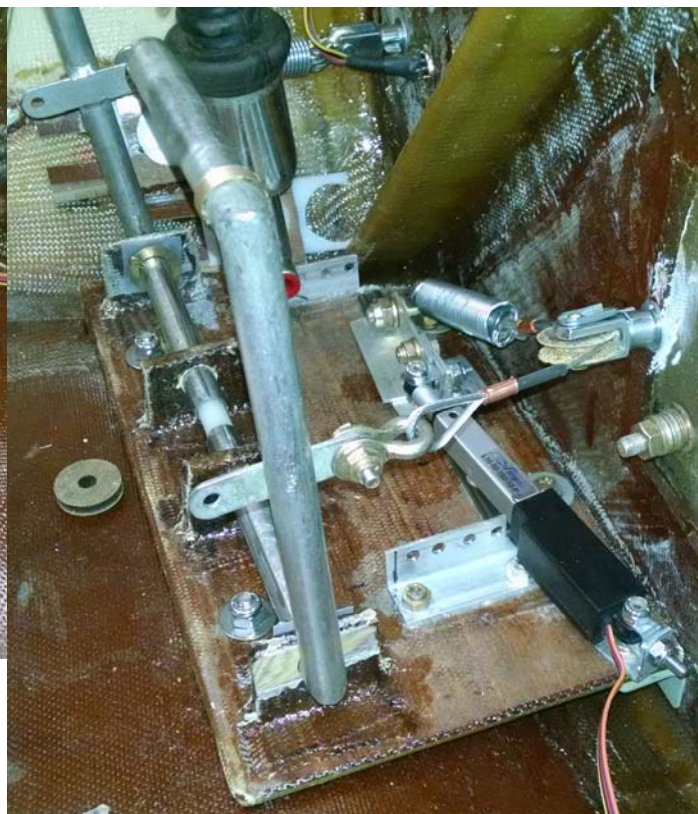
Detail views of installation geometry of rudder pedal platform and servo driven rudder trim and tension spring positioning.

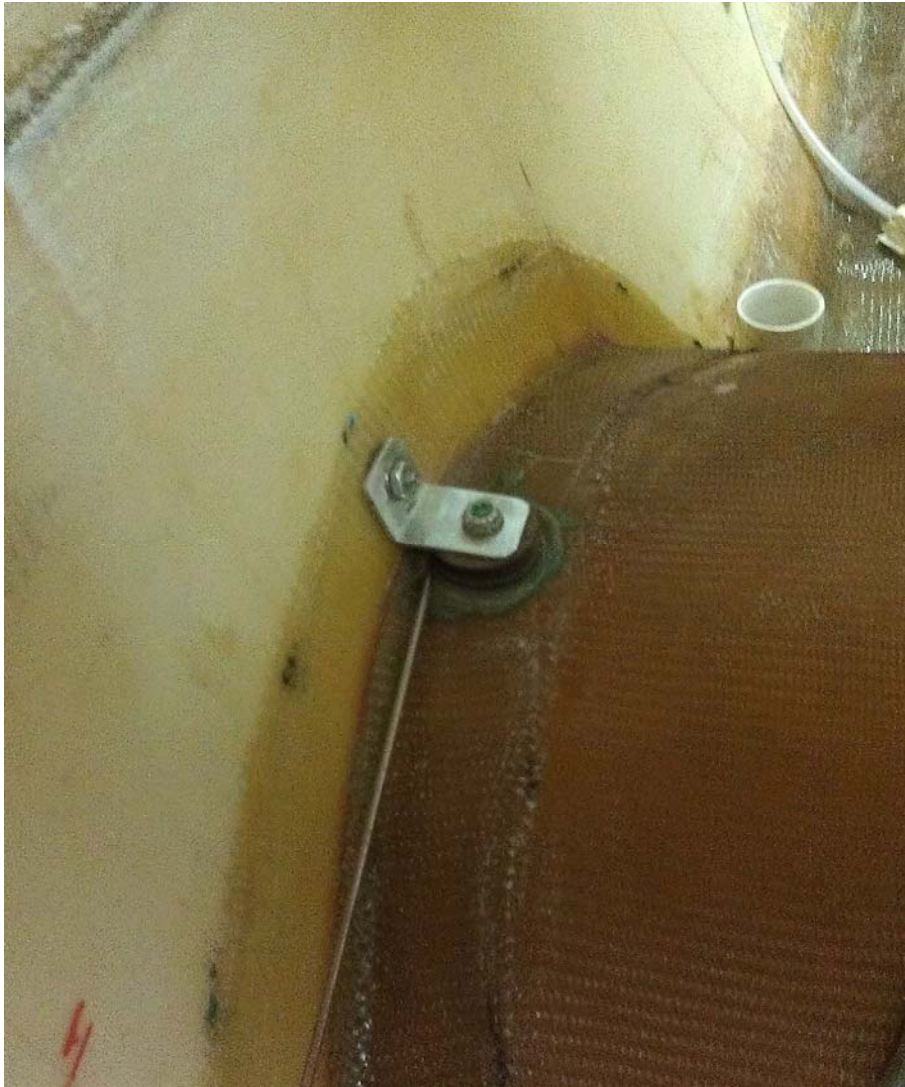
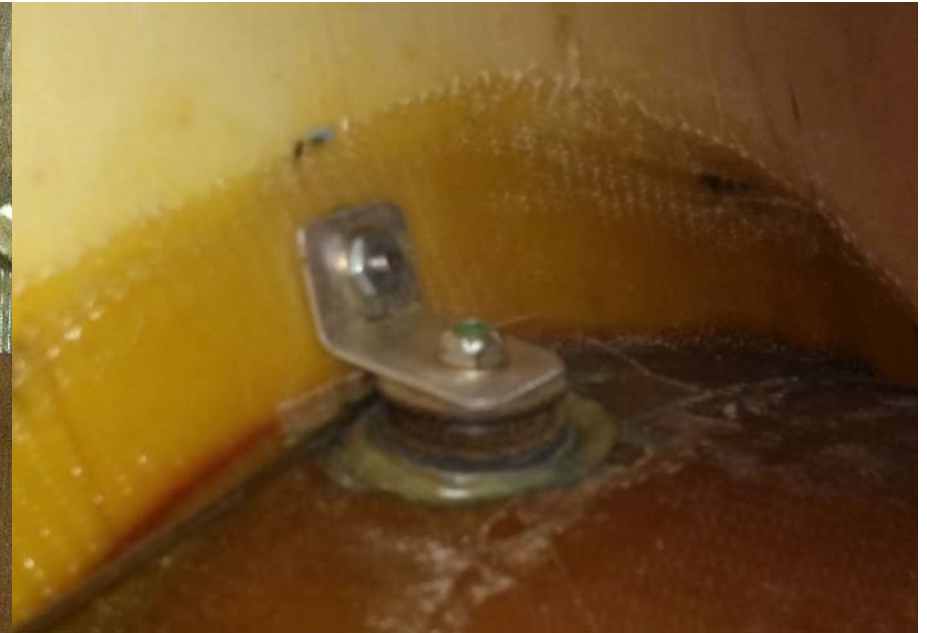
Rudder cable guide pulley mounted to side of fuselage to route cable through left side of fuselage and bulkheads.

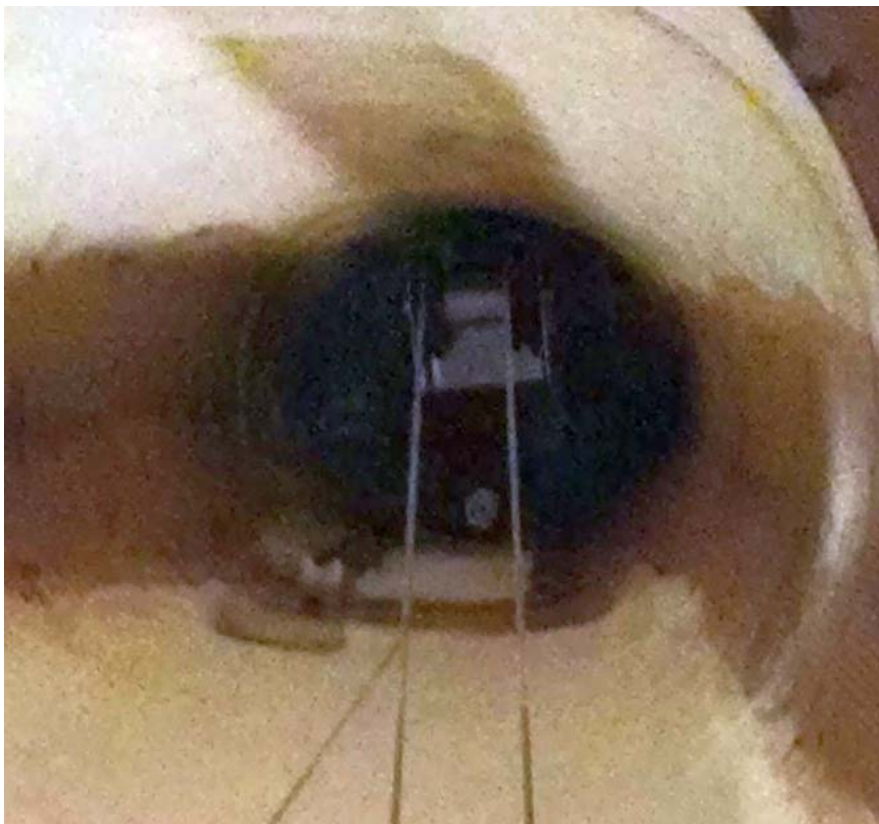
Rudder cable routing in tail cone. Pulley on FS 175 bulkhead guide cables into fairleads in tail foam core lining up with spindle on rudder torque tube (left view). The bellcrank on the right is fitted to a bronze bearing and mounted into a phenolic block anchor. Cables going forward mount in outer holes

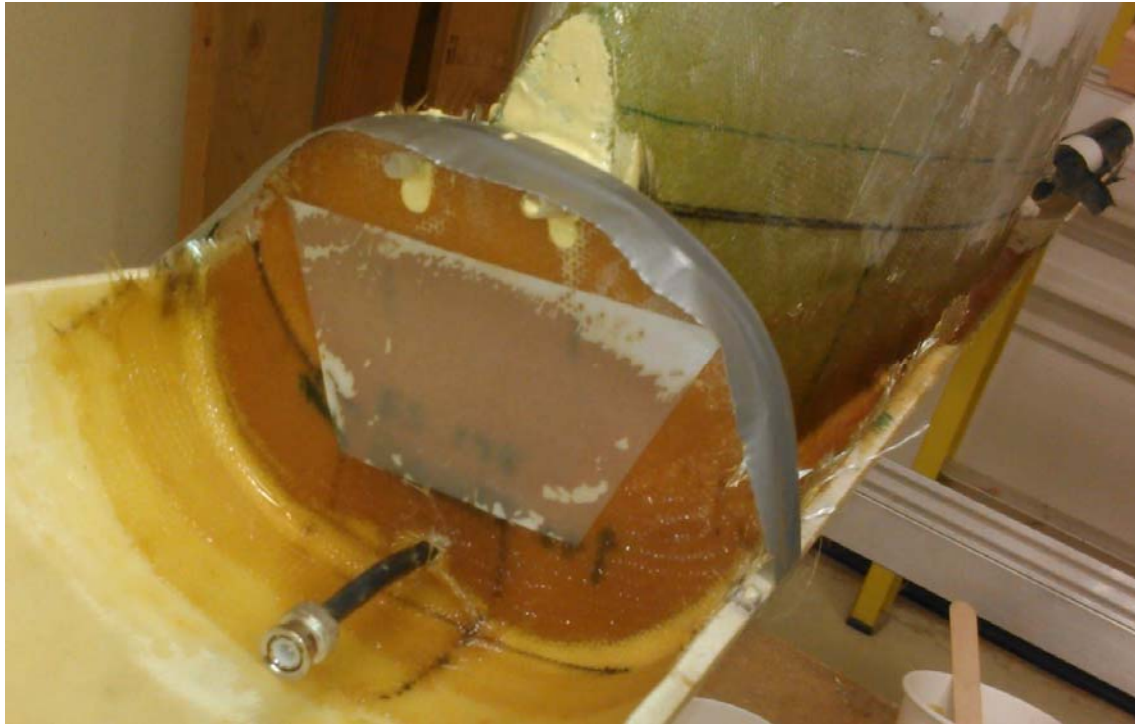
Reinforcement on forward face of FS 175 comm antenna lead is at bottom, and two nylaflo fairleads are at the top of the bulkhead. Photo below has a black line tracks the trajectory of the fairlead through the rudder core. Rear end of fairlead is shown projecting from the rudder core in the photo.

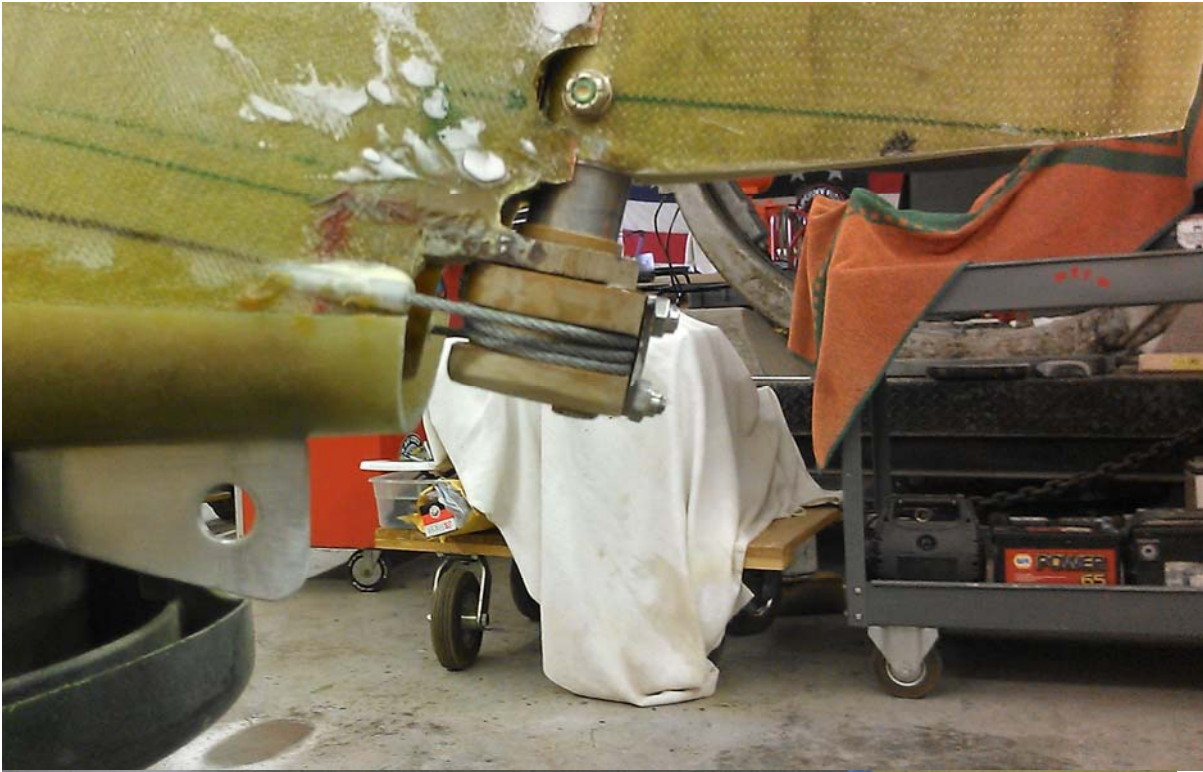
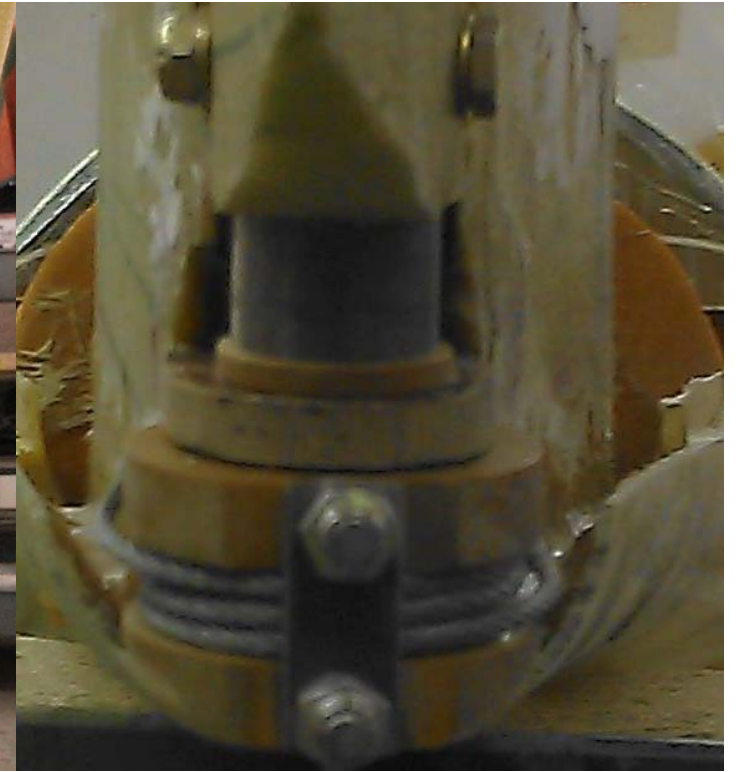
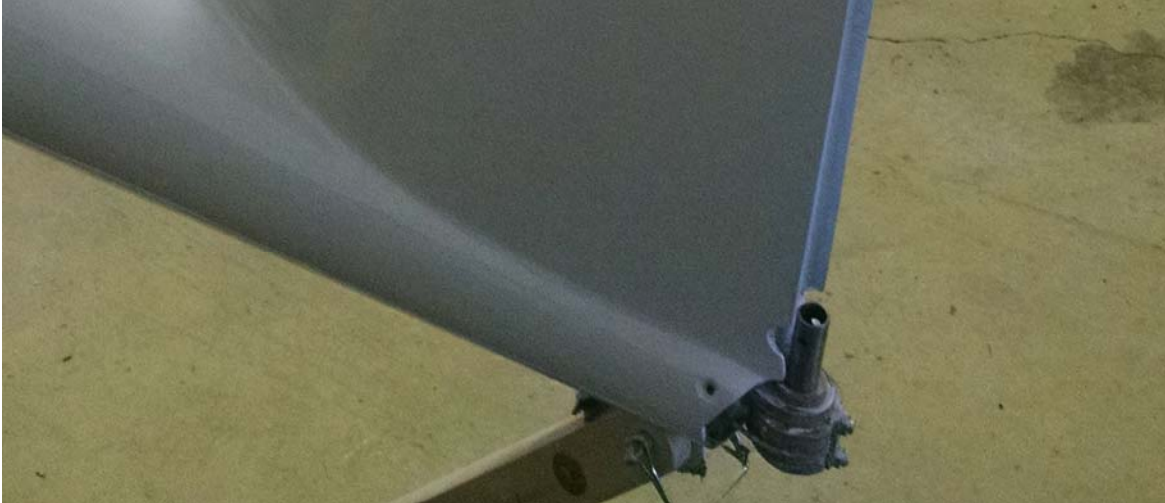
Detailed photos show routing of the rudder cable. The cable wraps 3 times around the phenolic spindle/spool and is clamped by two AN3 bolts on the rear side of the spindle. Entire rudder actuator assembly is internal to the tail.

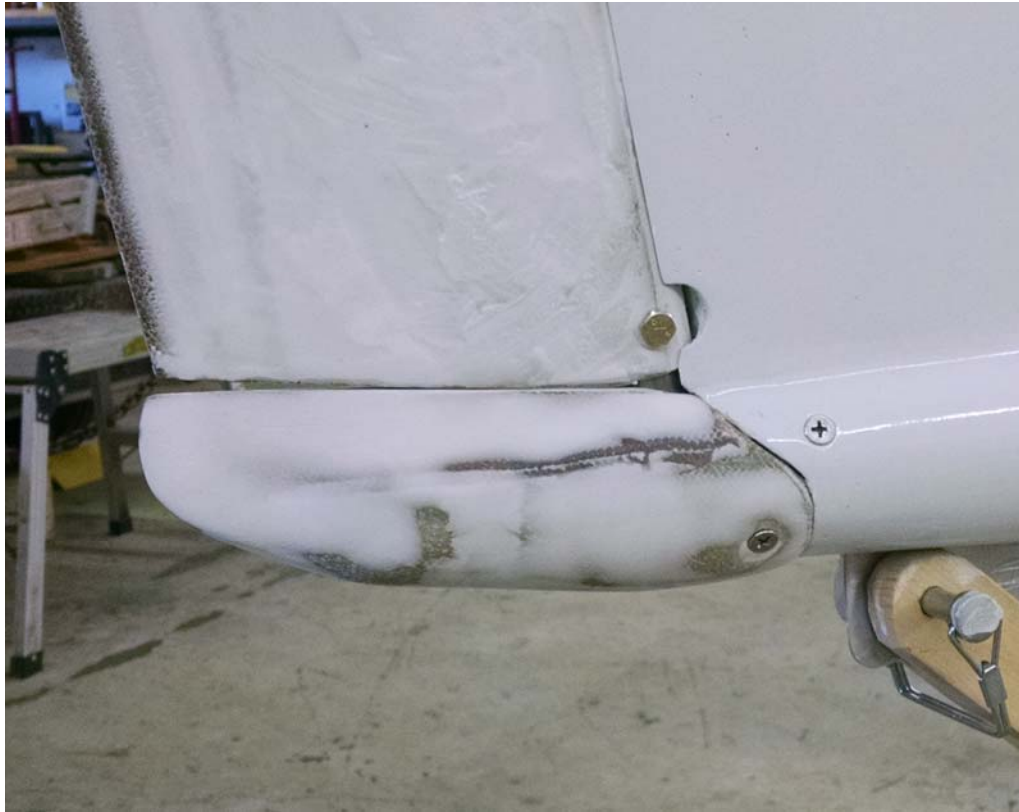
Rudder assembly with tailcone fairing fastened into position. Spindle is entirely within fairing. Verify motion and free travel. November, 2017

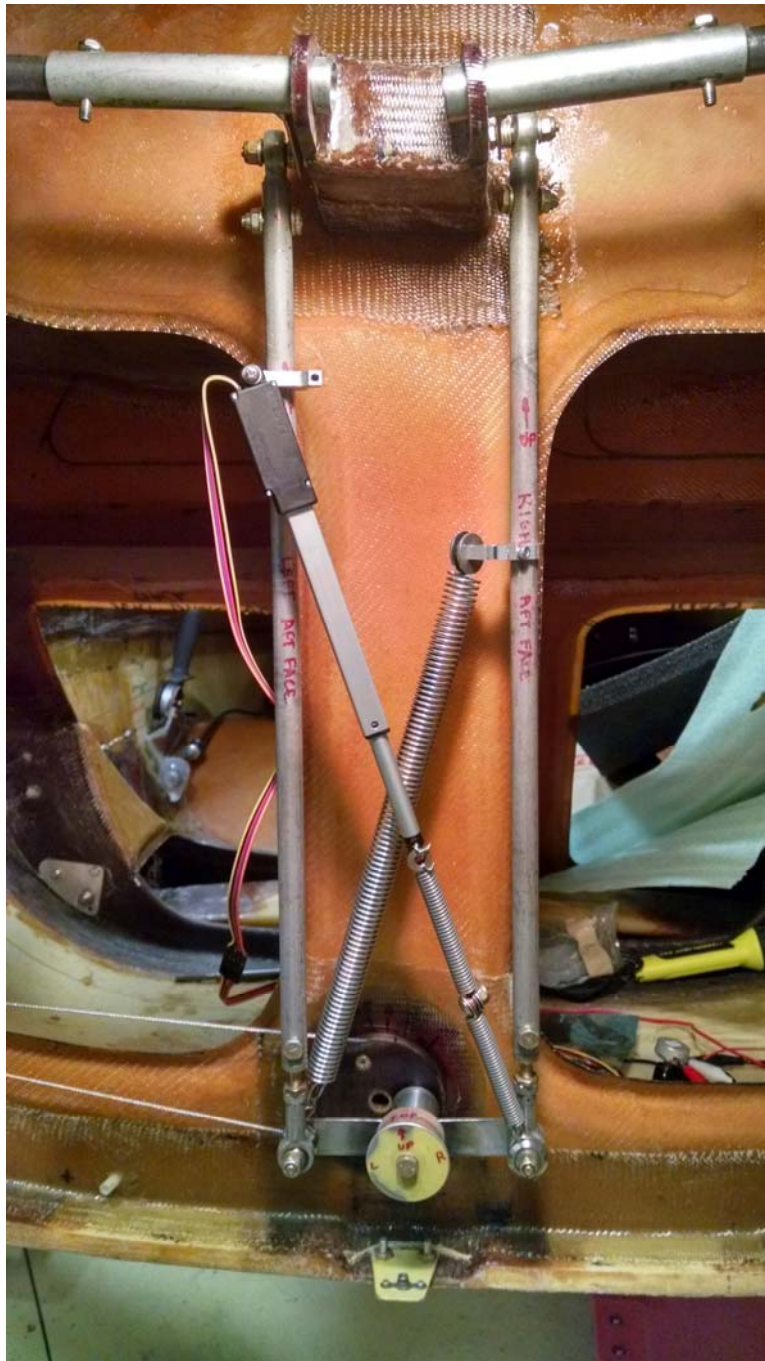
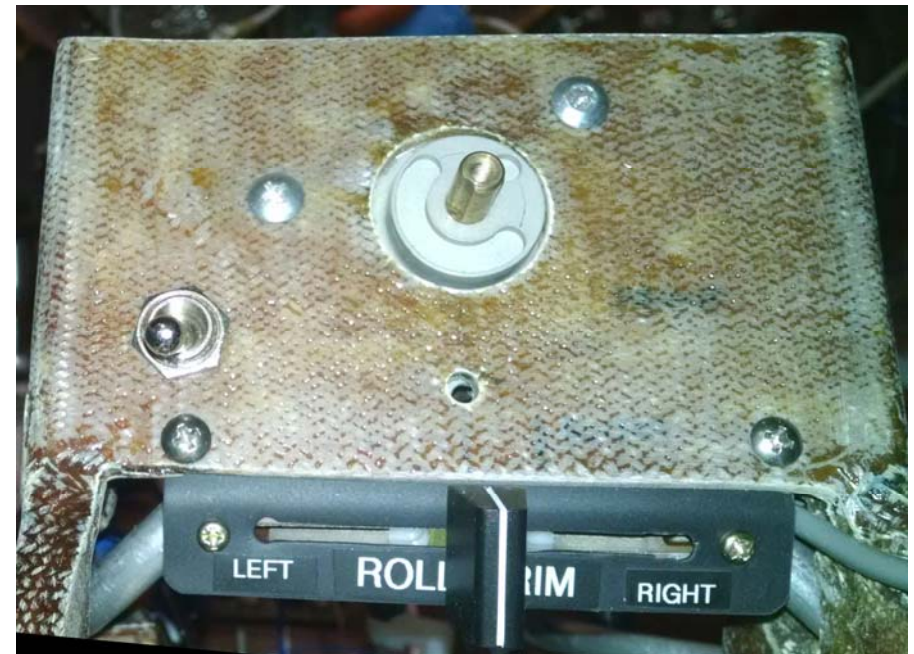
Photo above shows slide controller for roll trim mounted below fuel selector in front of control stick. March 2017.

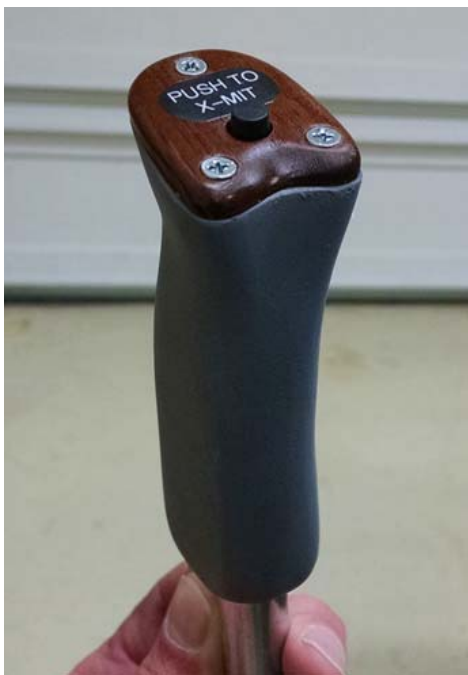
Control stick grip carved from balsa and glassed with 3 oz BID glass. Filled and painted. X-mit switch installed in top panel.

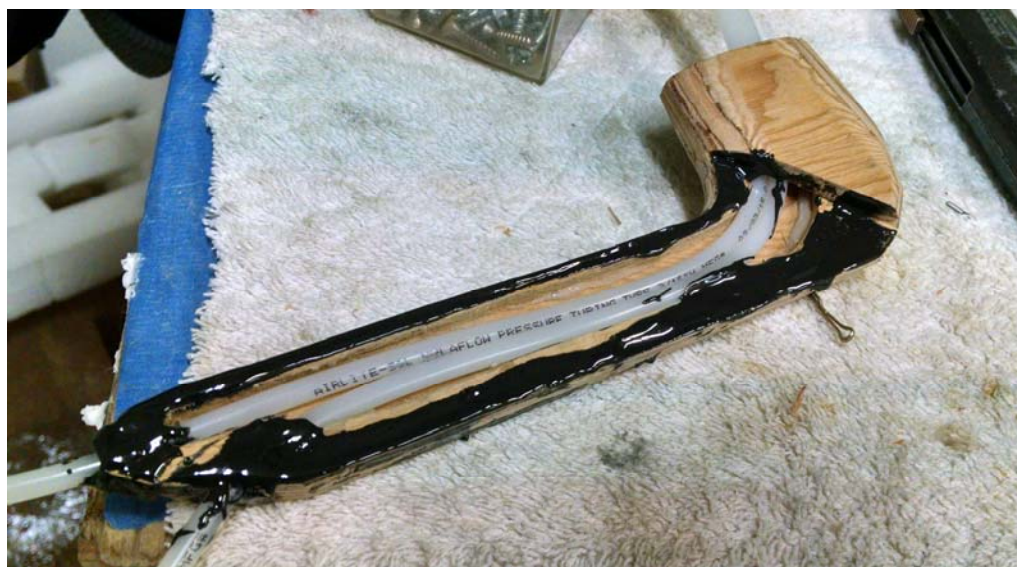
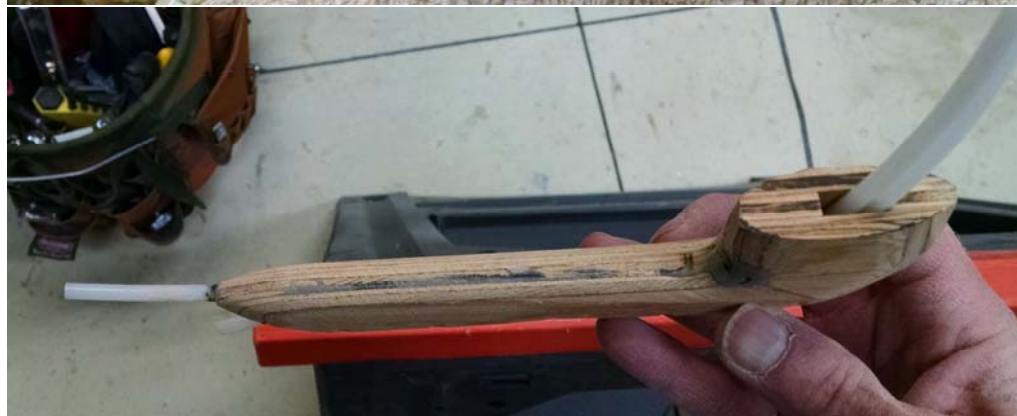
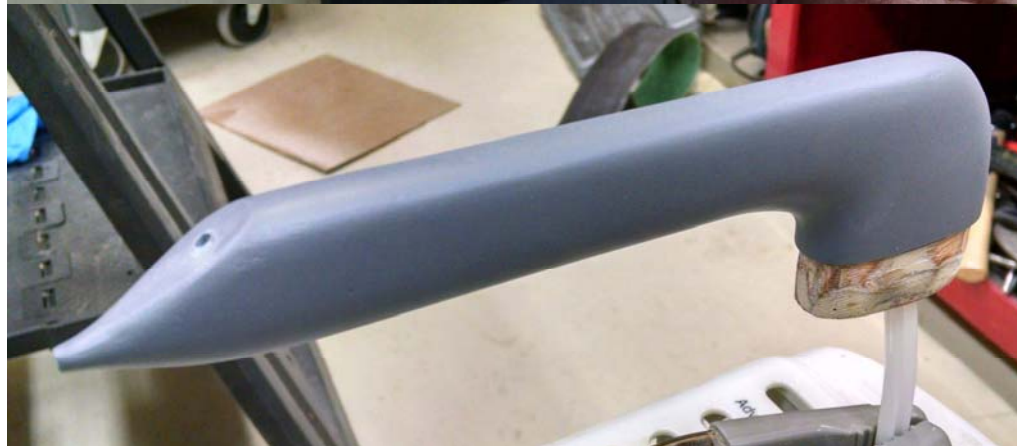
Pitot tube fabricated, carved and finished for install on mast already installed on canard.
(includes both A/S and AOA ports for Skyview ADHRS input). January 2018

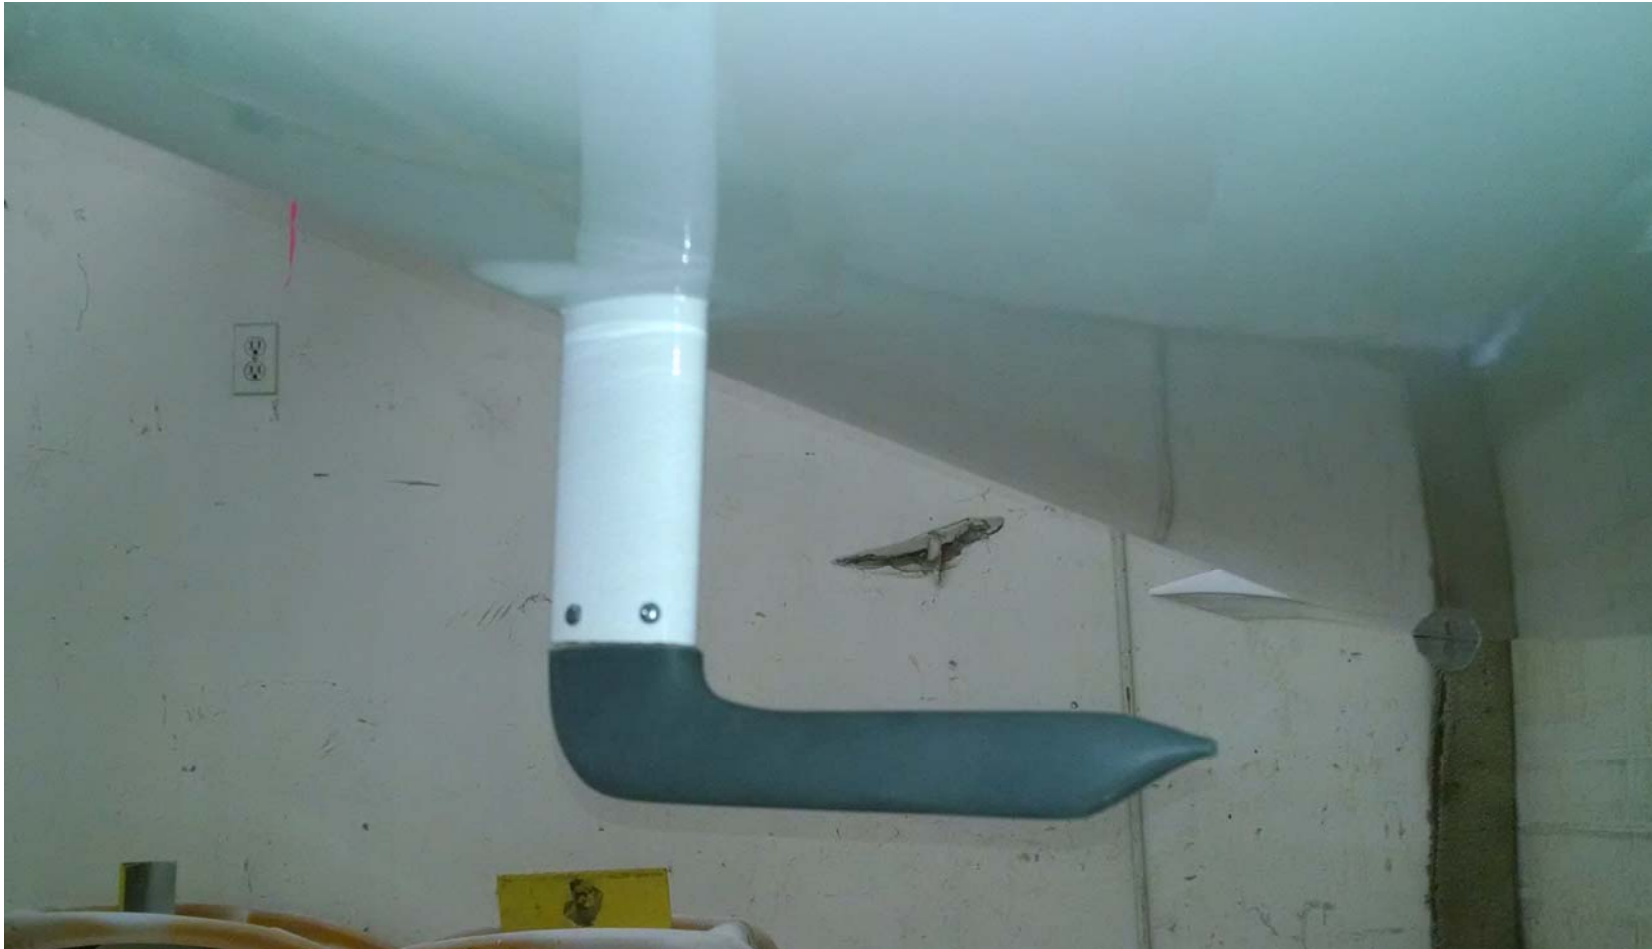
Final installation of pitot/AOA probe on steel mast on bottom of left canard. The pitot/AOA has 3/16" Nylaflow tubing and the mast contains 1/4" nylon tubing. The 3/16" tubing is friction fit into the 1/4" tubing with an airtight fit and secured with safety wire, then probe is slid into place and secured with 4 screws. February 2018.
