# Construction: Main Wing

# Mounting: Main Wing

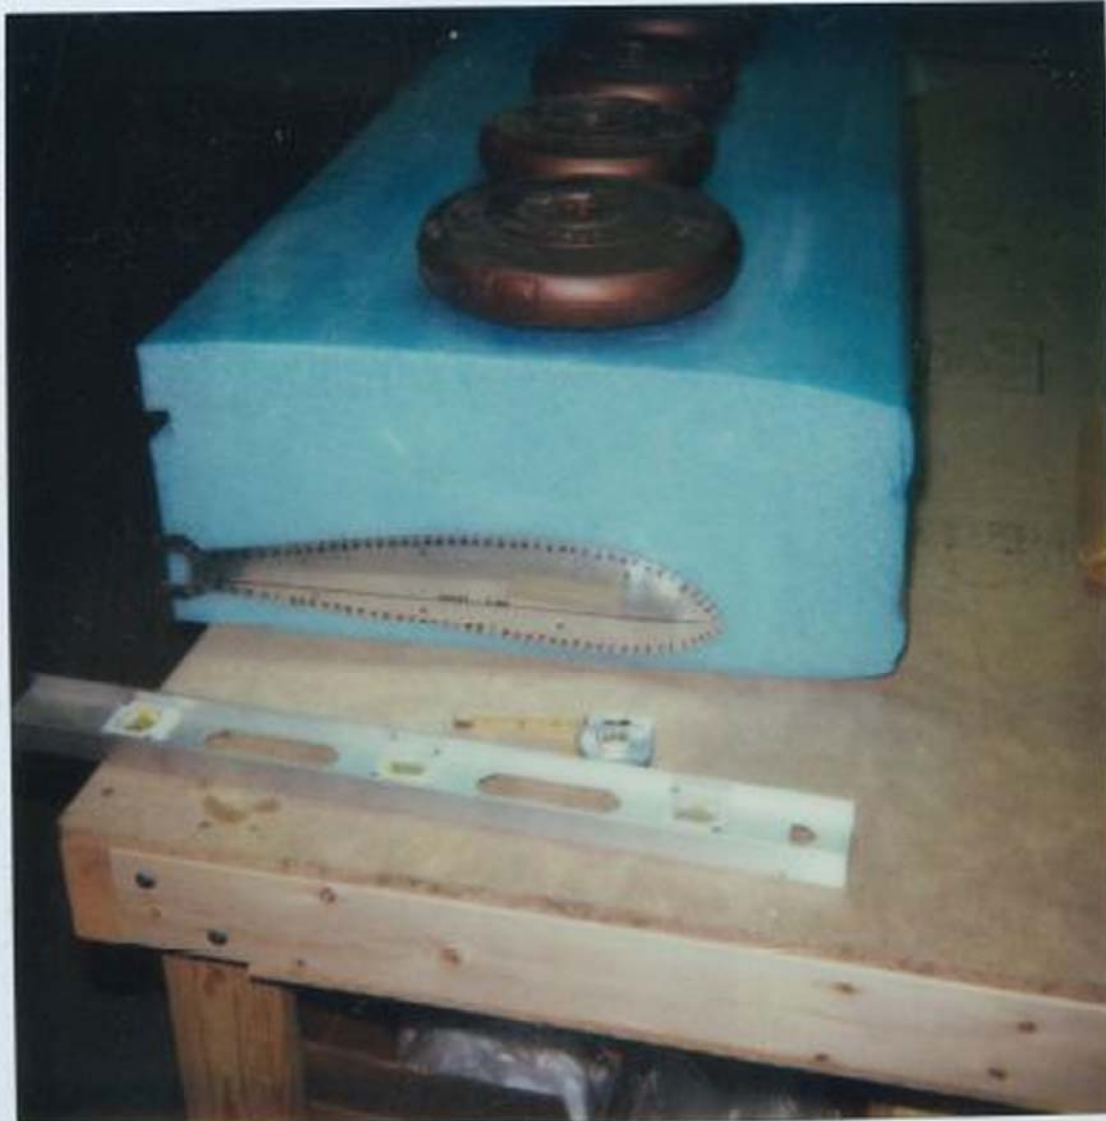
TEMPLATE AND FOAM BLOCK FOR  
HOT WIRE CUTTING OF MAIN WING.  
11/13/84

Wing, Canard, Rudder and flight surface templates made from aluminum sheet were borrowed from Rocky Mountain Quickie to do hot wiring. Wayne Johnson and Jim Talbot assisted in hotwiring which is a two man operation. All cores were cut in two sessions. Typical setup is shown to the left, per Q-2 plans instructions for hotwiring. November, 1984

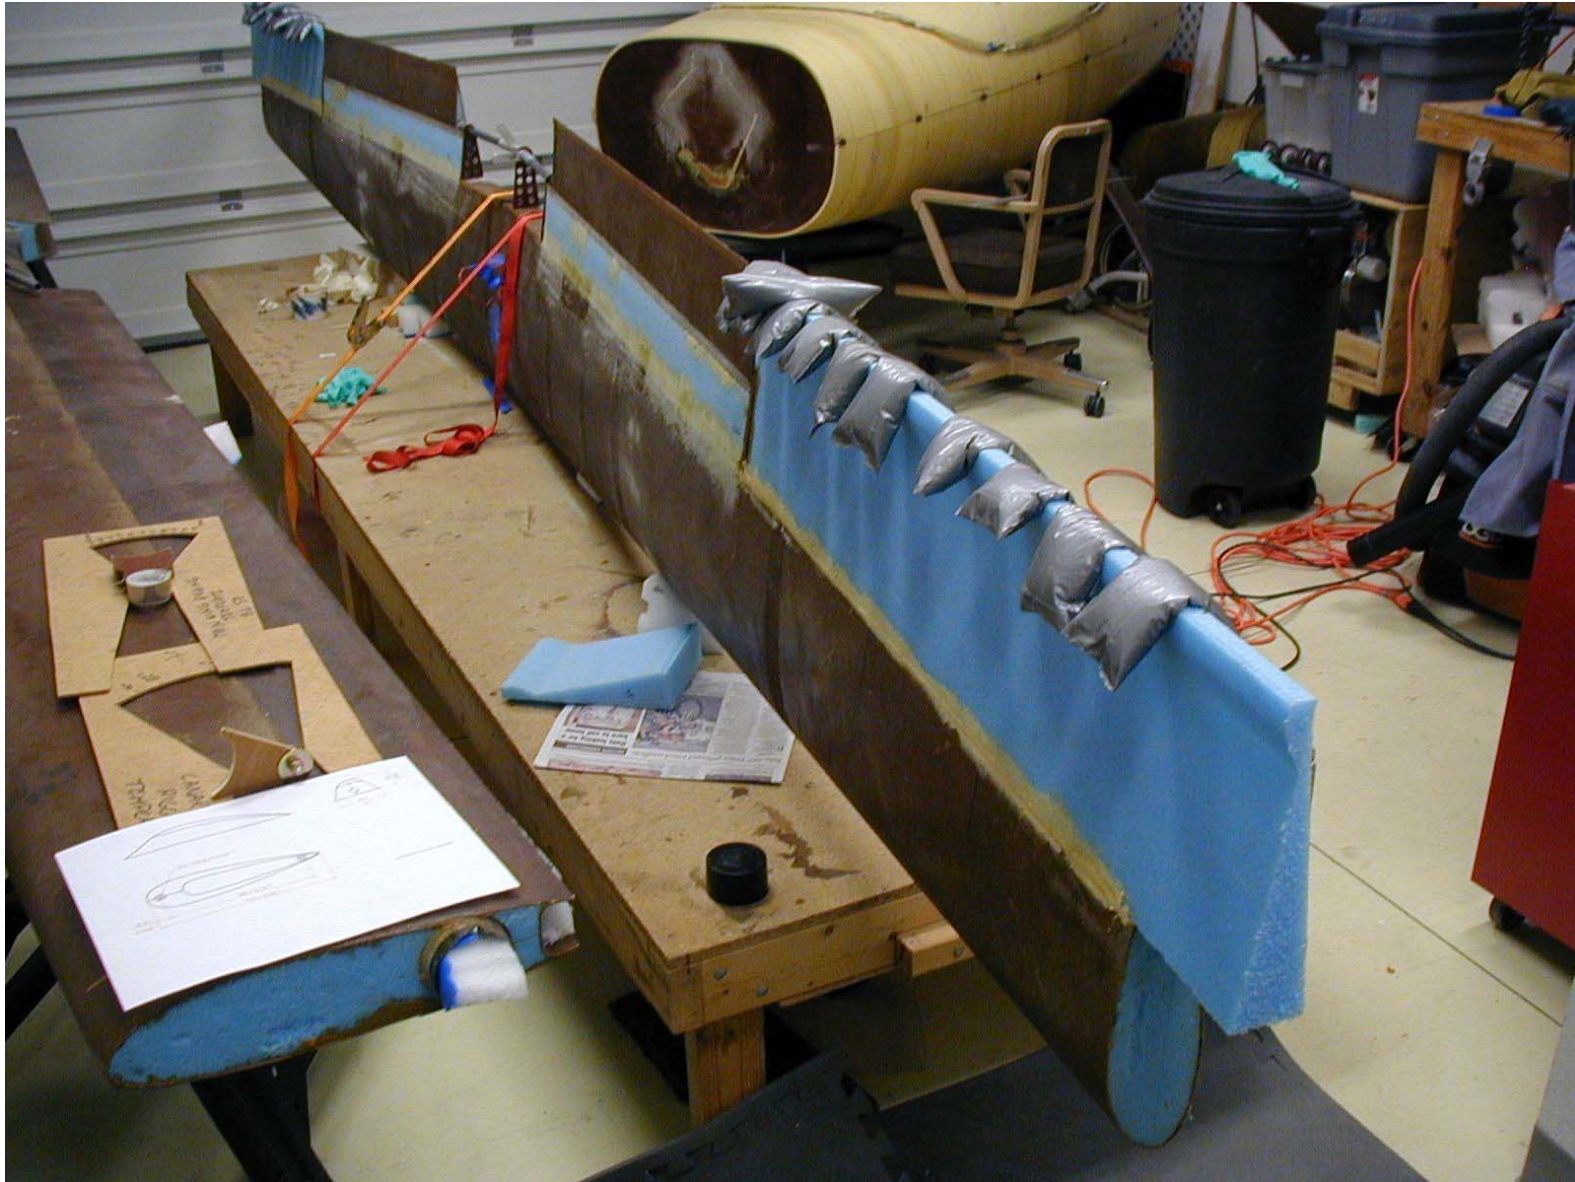
Verify alignment during cure of micro. Note the nylon wire conduit end through hole in CS6. Note installation of CS10 outboard aileron pivot, and trim of foam and sanding of slot core for glass to glass contact with out skin. October, 2011

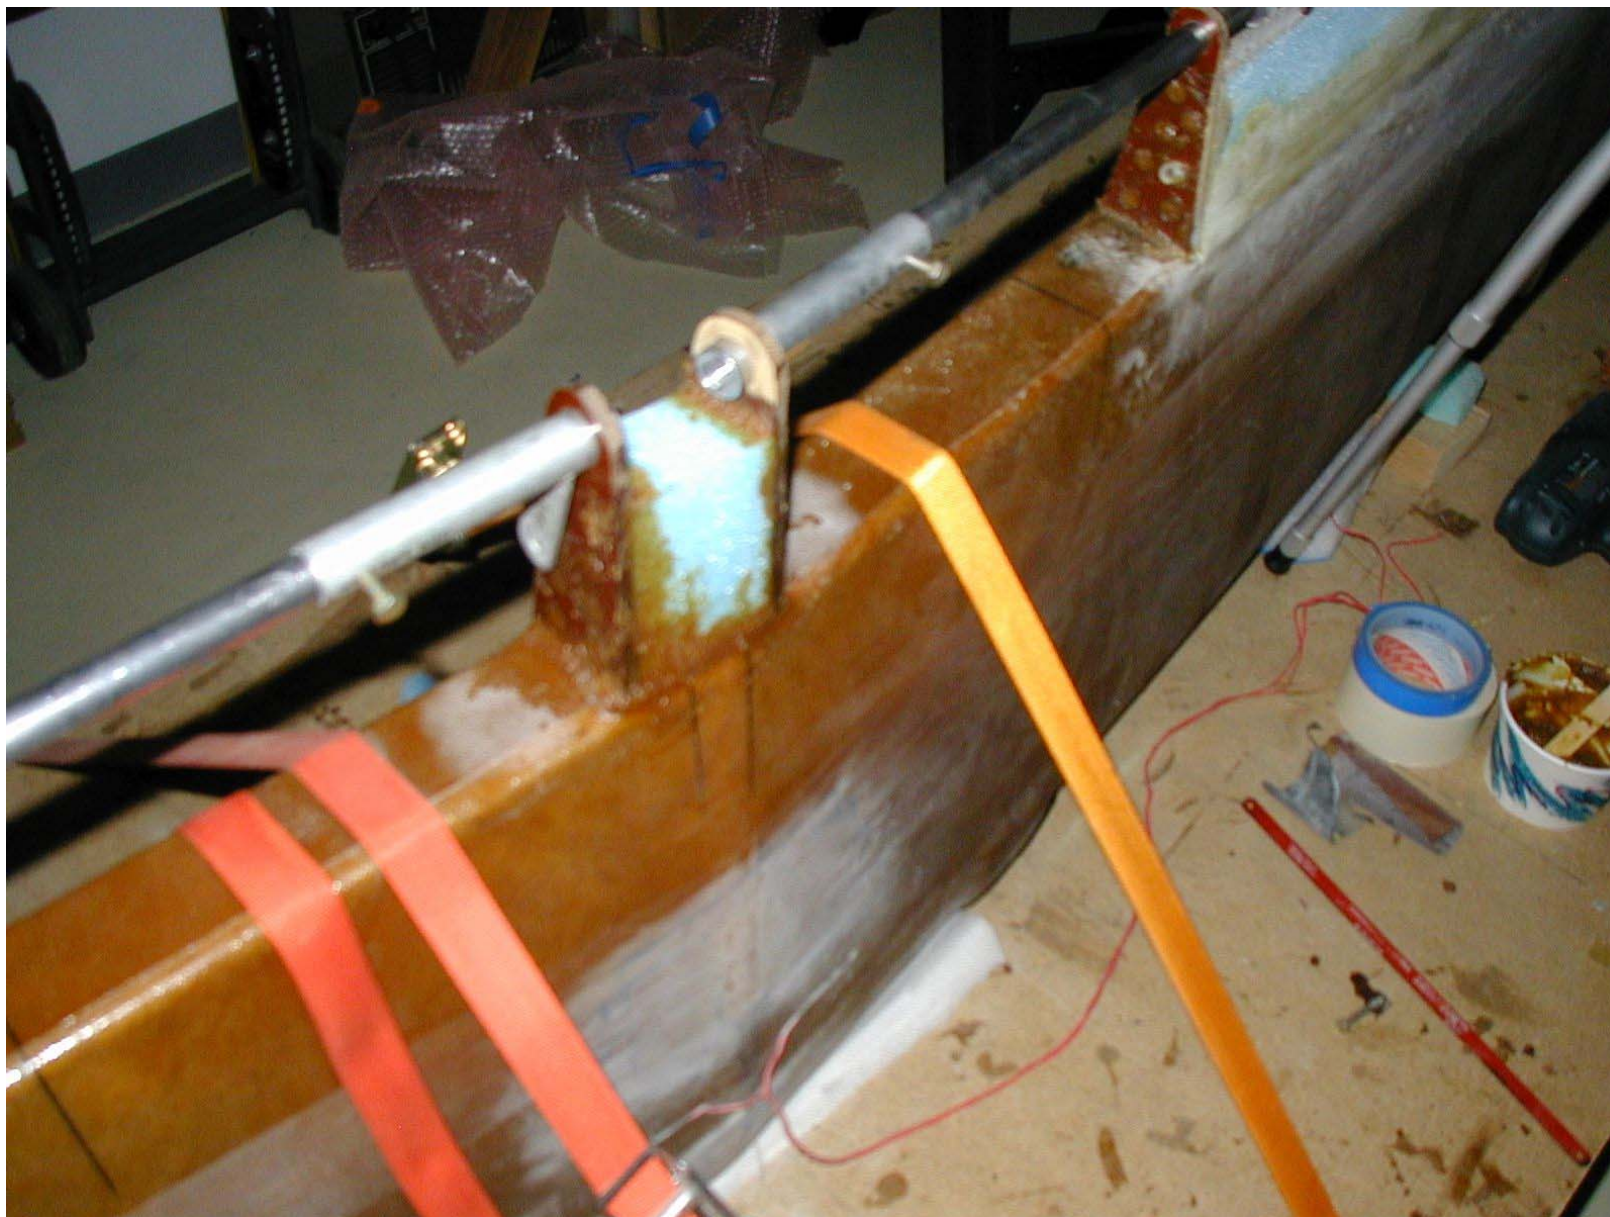
Add foam, and shape wingtips including threading wiring conduit and building plywood mount pad for wingtip lights. Fill with micro verify similarity left and right and sand smooth for glassing. November, 2011

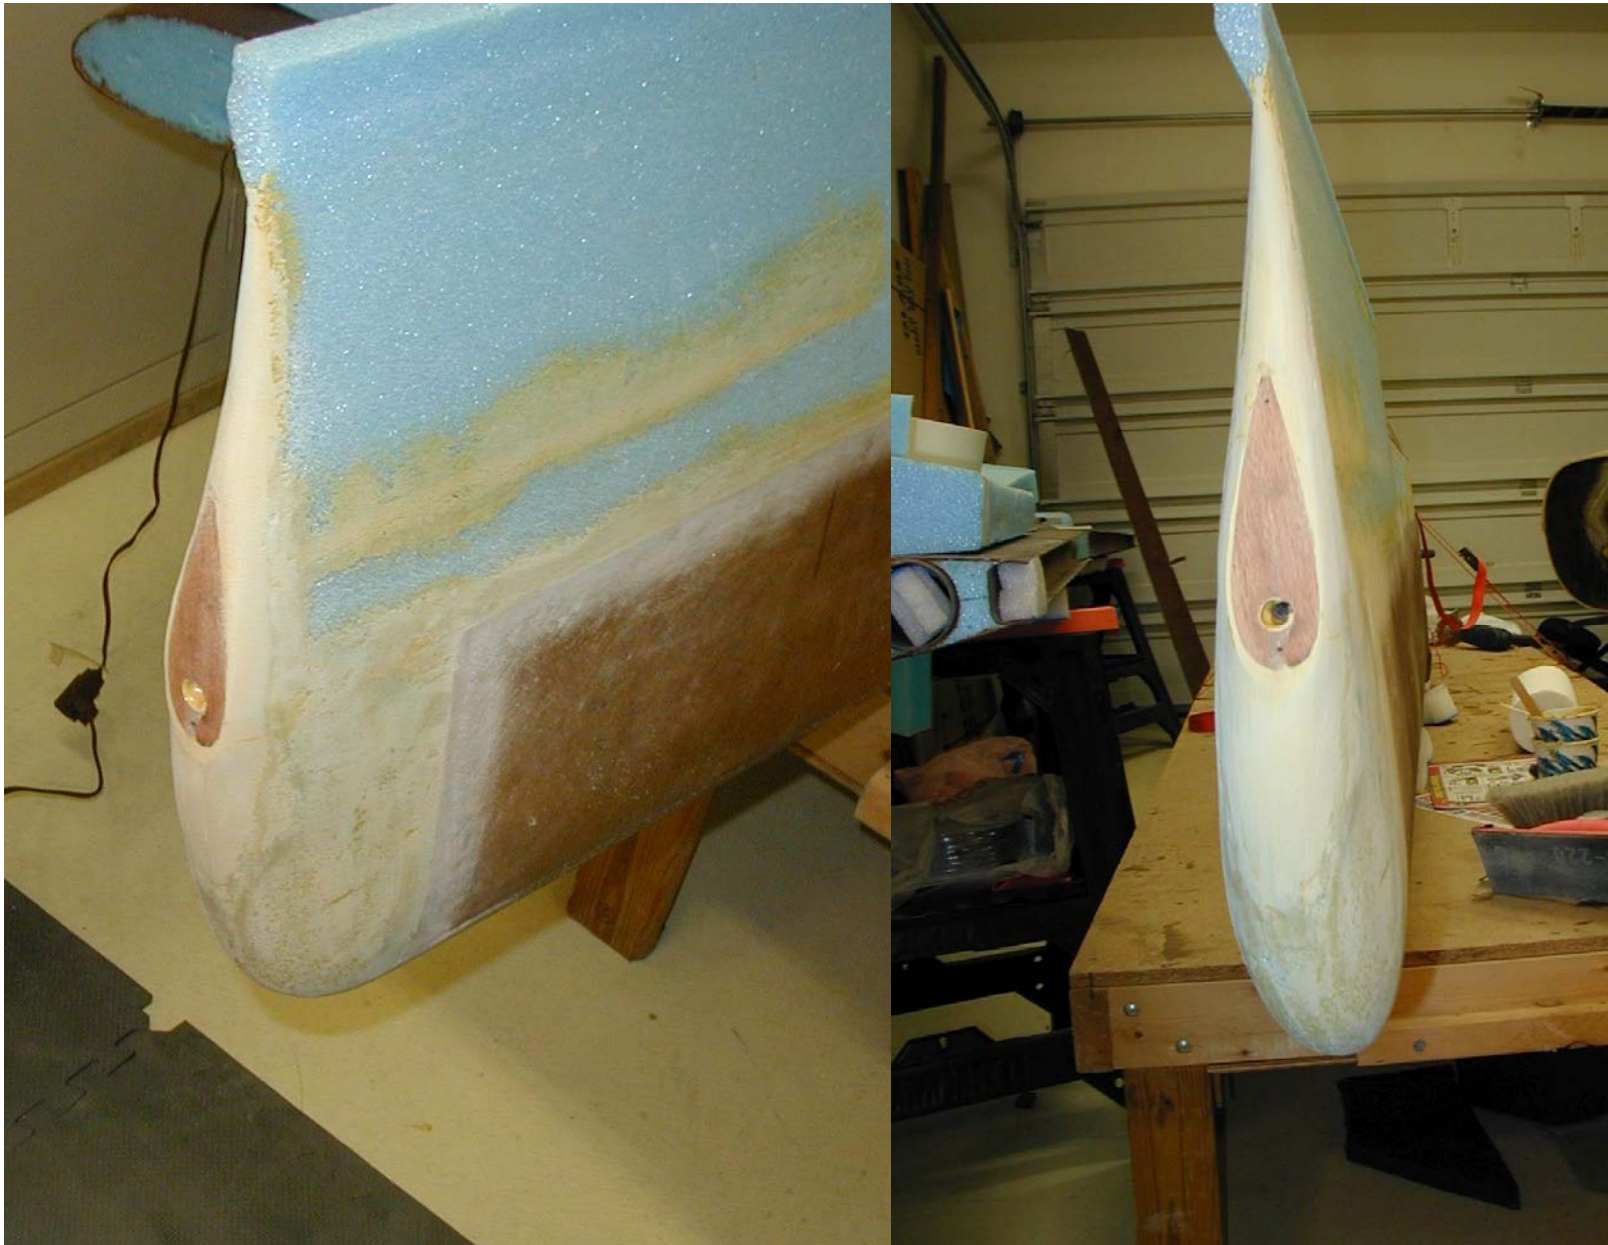
Jig wing on table and prep for glassing of slot cores and trailing edge

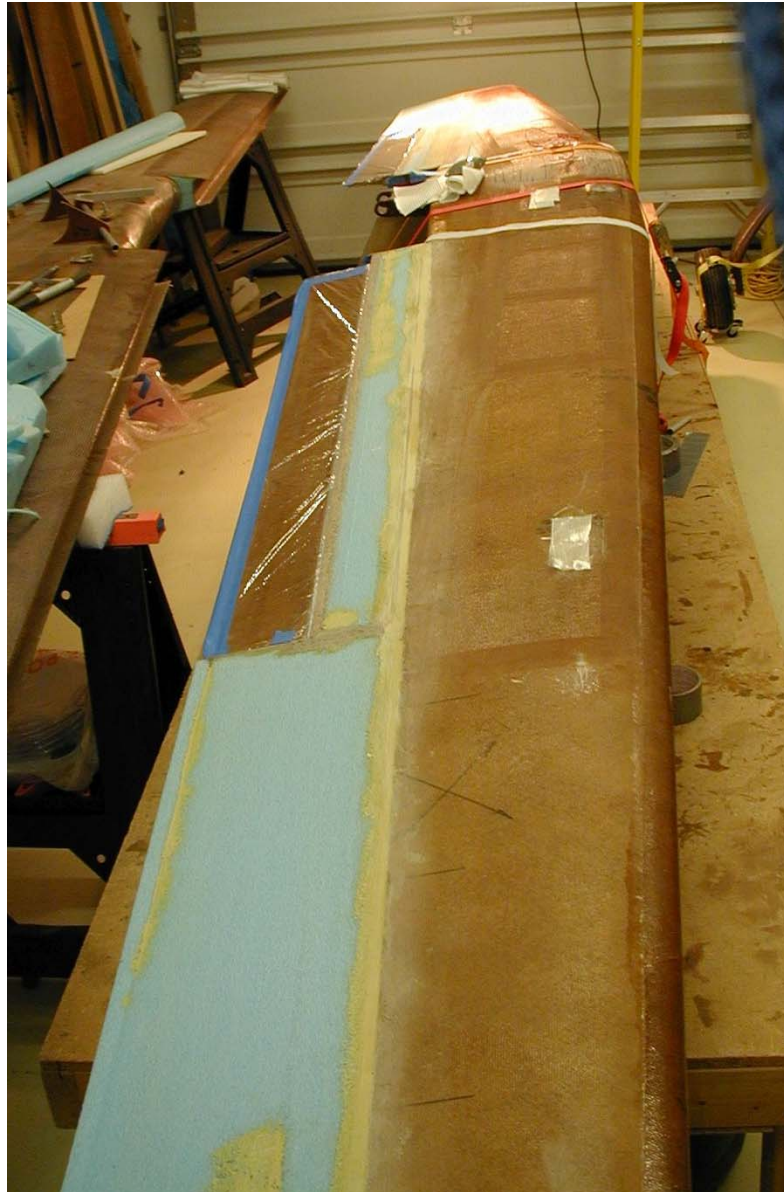
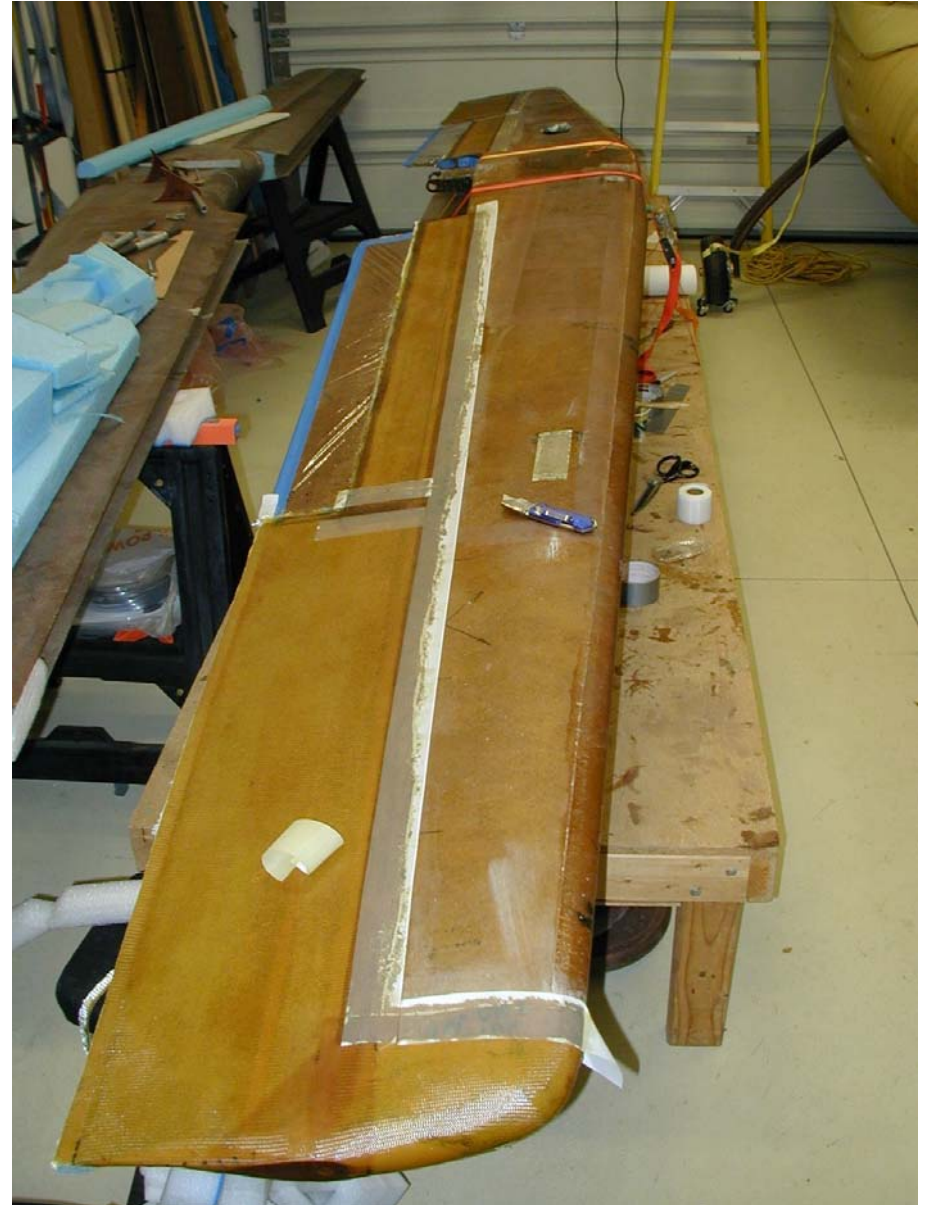
Verify glass layup on slot core and trailing edge and wingtips. Note 1/8" plywood closeout of trailing edge core for strength and rigidity. All OK, Jay Scheevel. December 2011

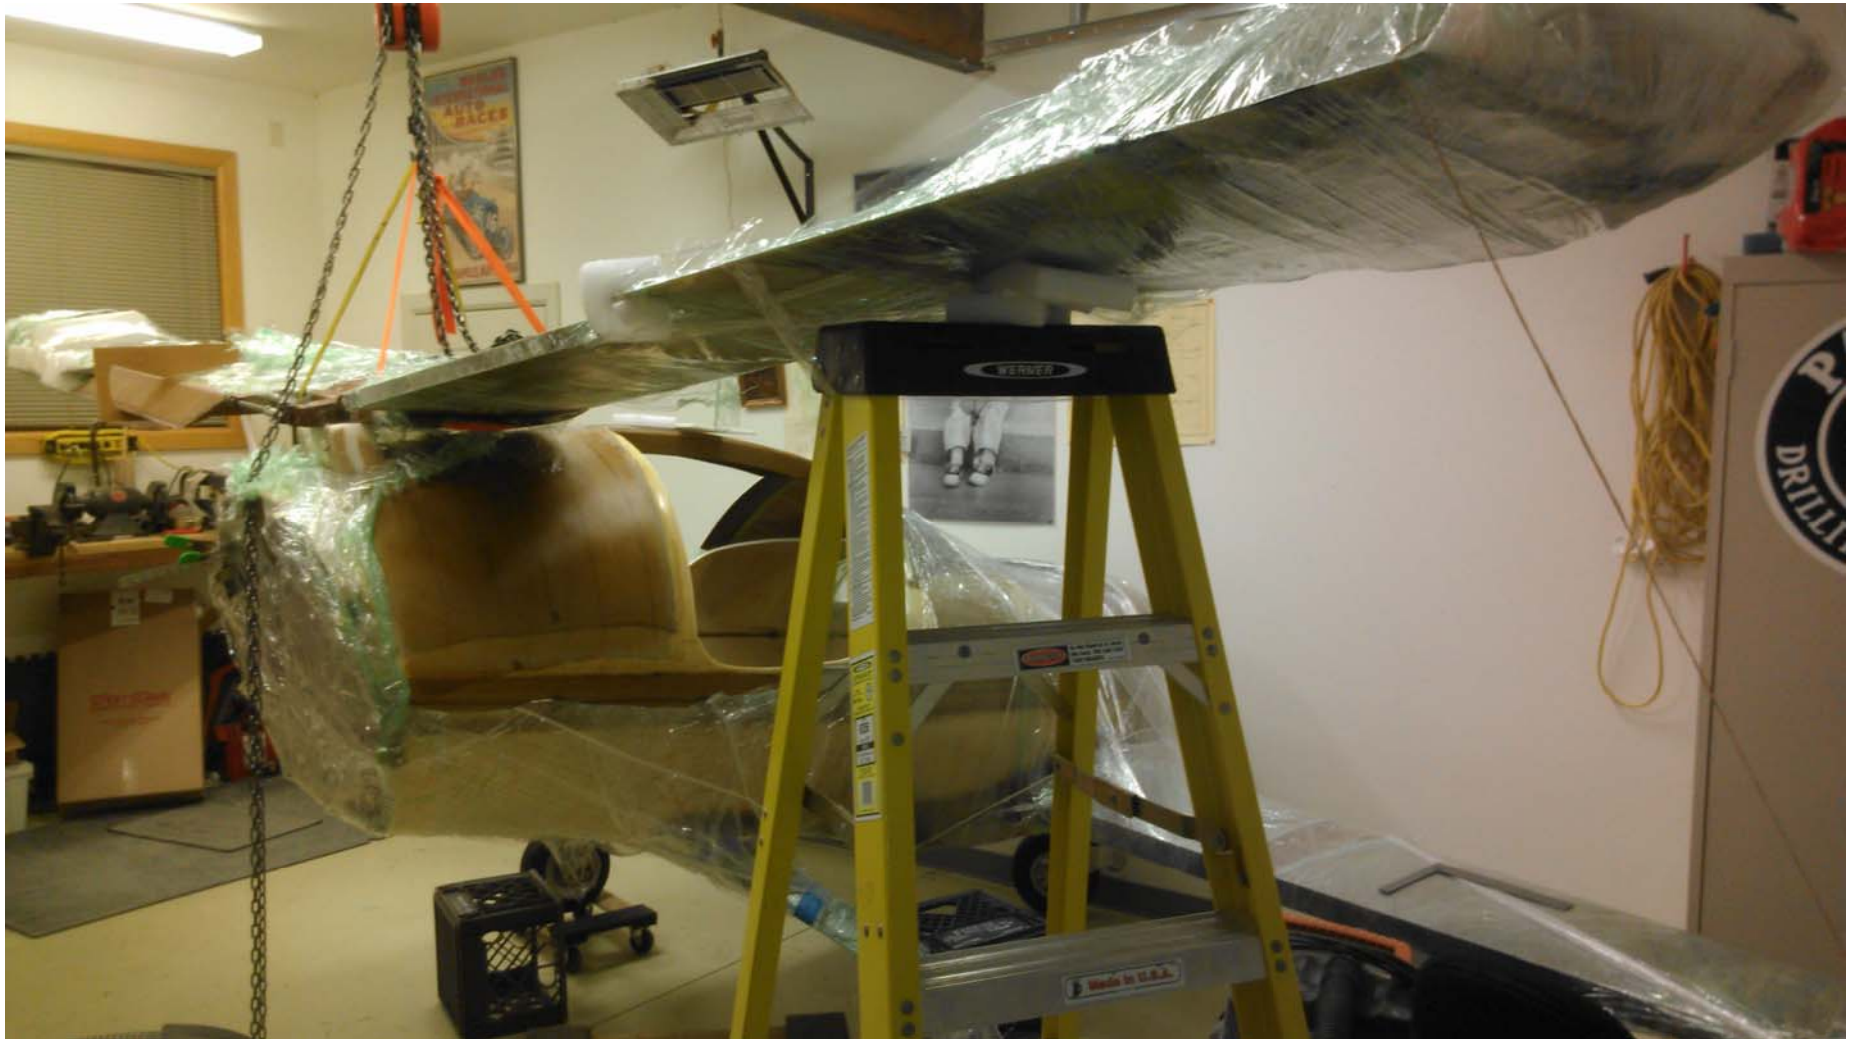
After measuring marking cut lines. Sections of turtle deck are carefully cut to remove areas allowing wing to slide through canopy opening and then moved aft into mount slot. Forward edge of wing is positioned at FS 78.5 as called for in Q-2 plans. February, 2015

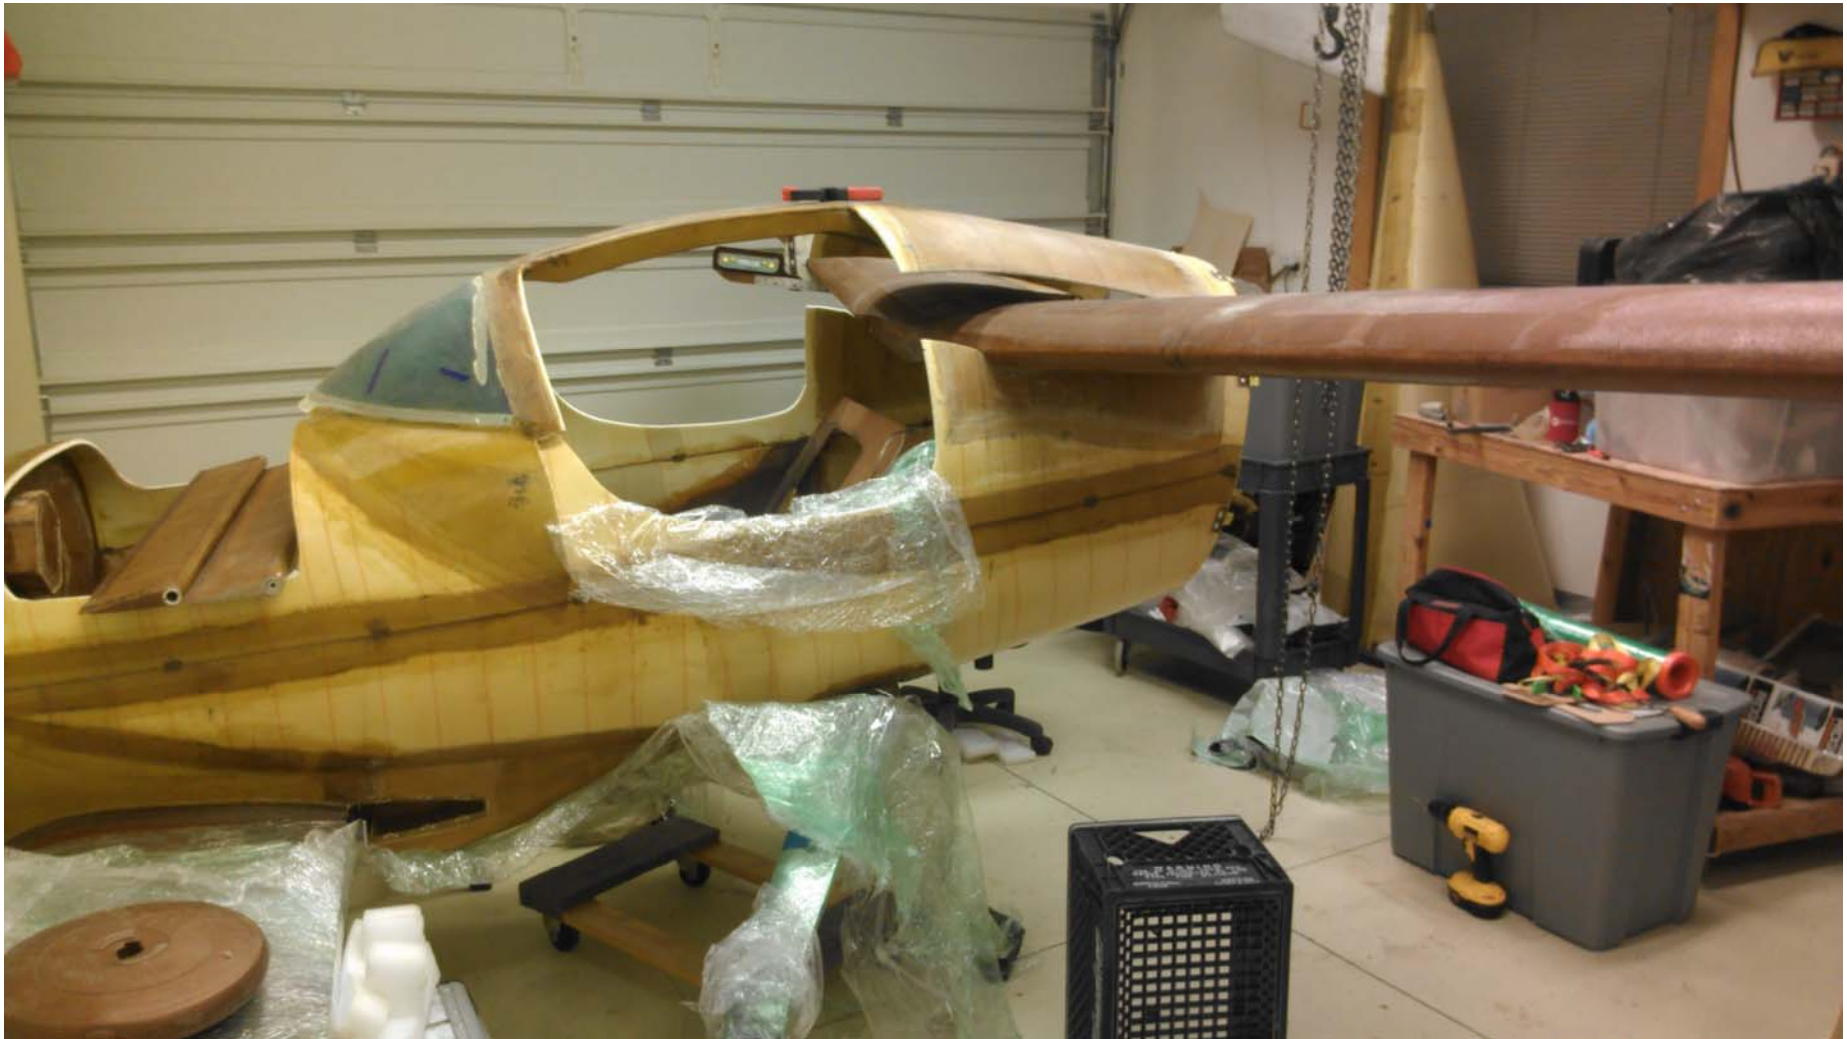
Wing is aligned left to right and levelled laterally with fuselage level (water level tubing method). The bottom of cutout slot is trimmed incrementally with sandpaper to achieve lateral level and desired angle. Decalage measuring tool, shown is used per decalage study (2009, Q-talk). Desired decalage of minus 1.8 degrees is achieved (canard is mounted per plans, so decalage is entirely determined by angle of main wing).

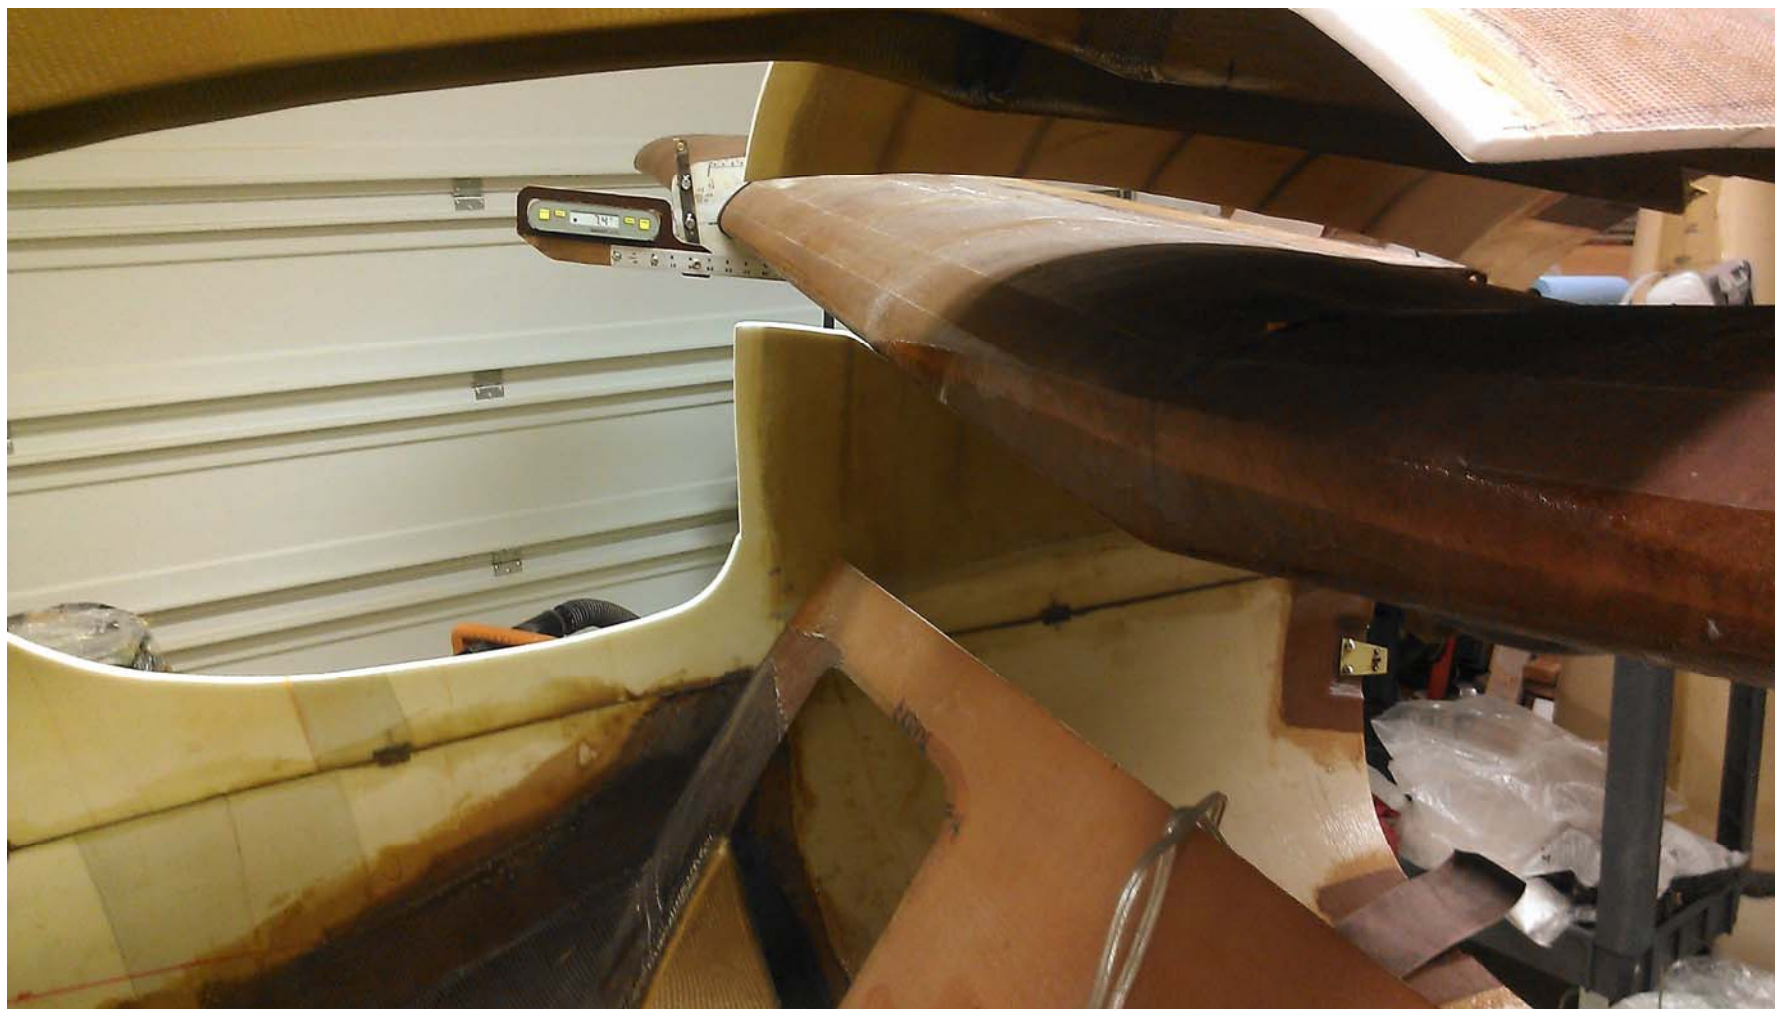
Positioning of aileron pivot mounts (CS6, etc.) are carefully positioned during mounting of main wing. Once wing is aligned and fixed in position, the cutout slot is enlarged to accommodate aileron torque tube positioning.

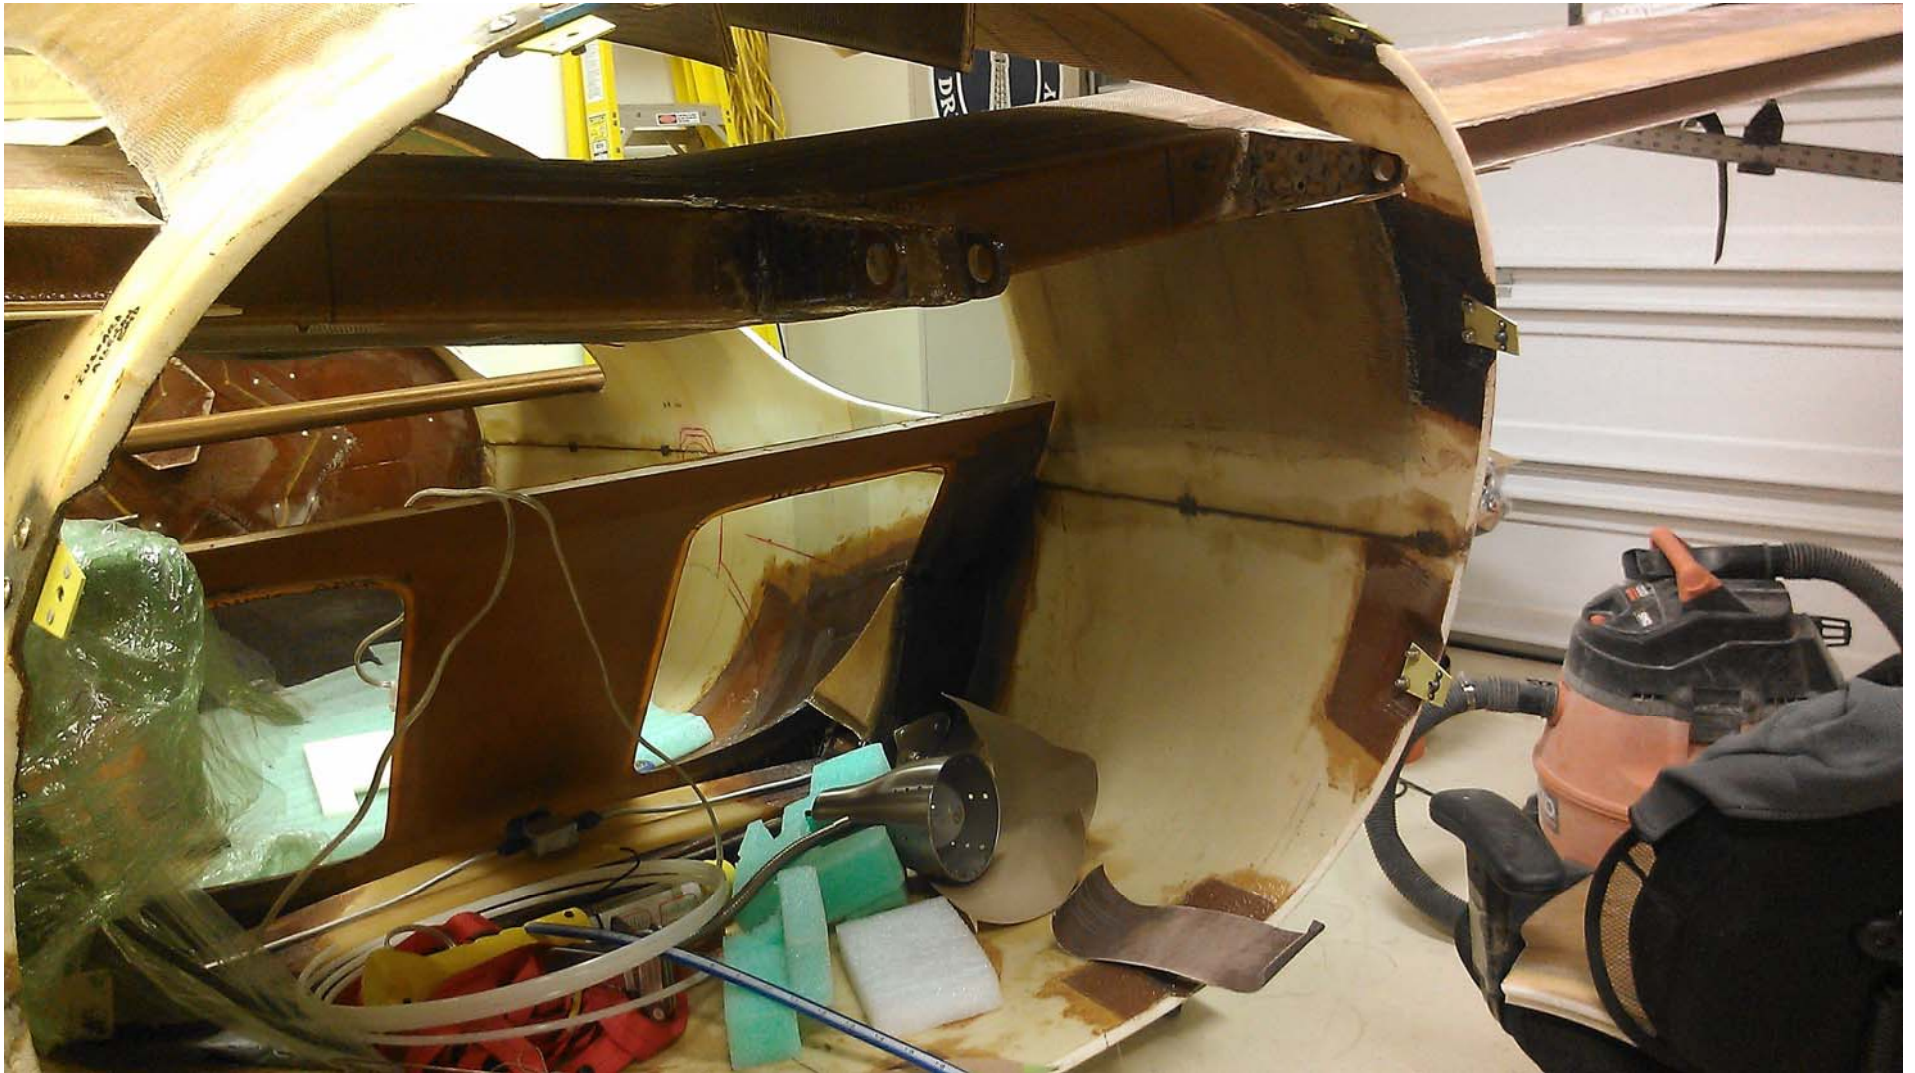
Detail of tool used to precisely measure wing angle. Can be mounted on either left or right wing and on left or right canard to determine decalage.

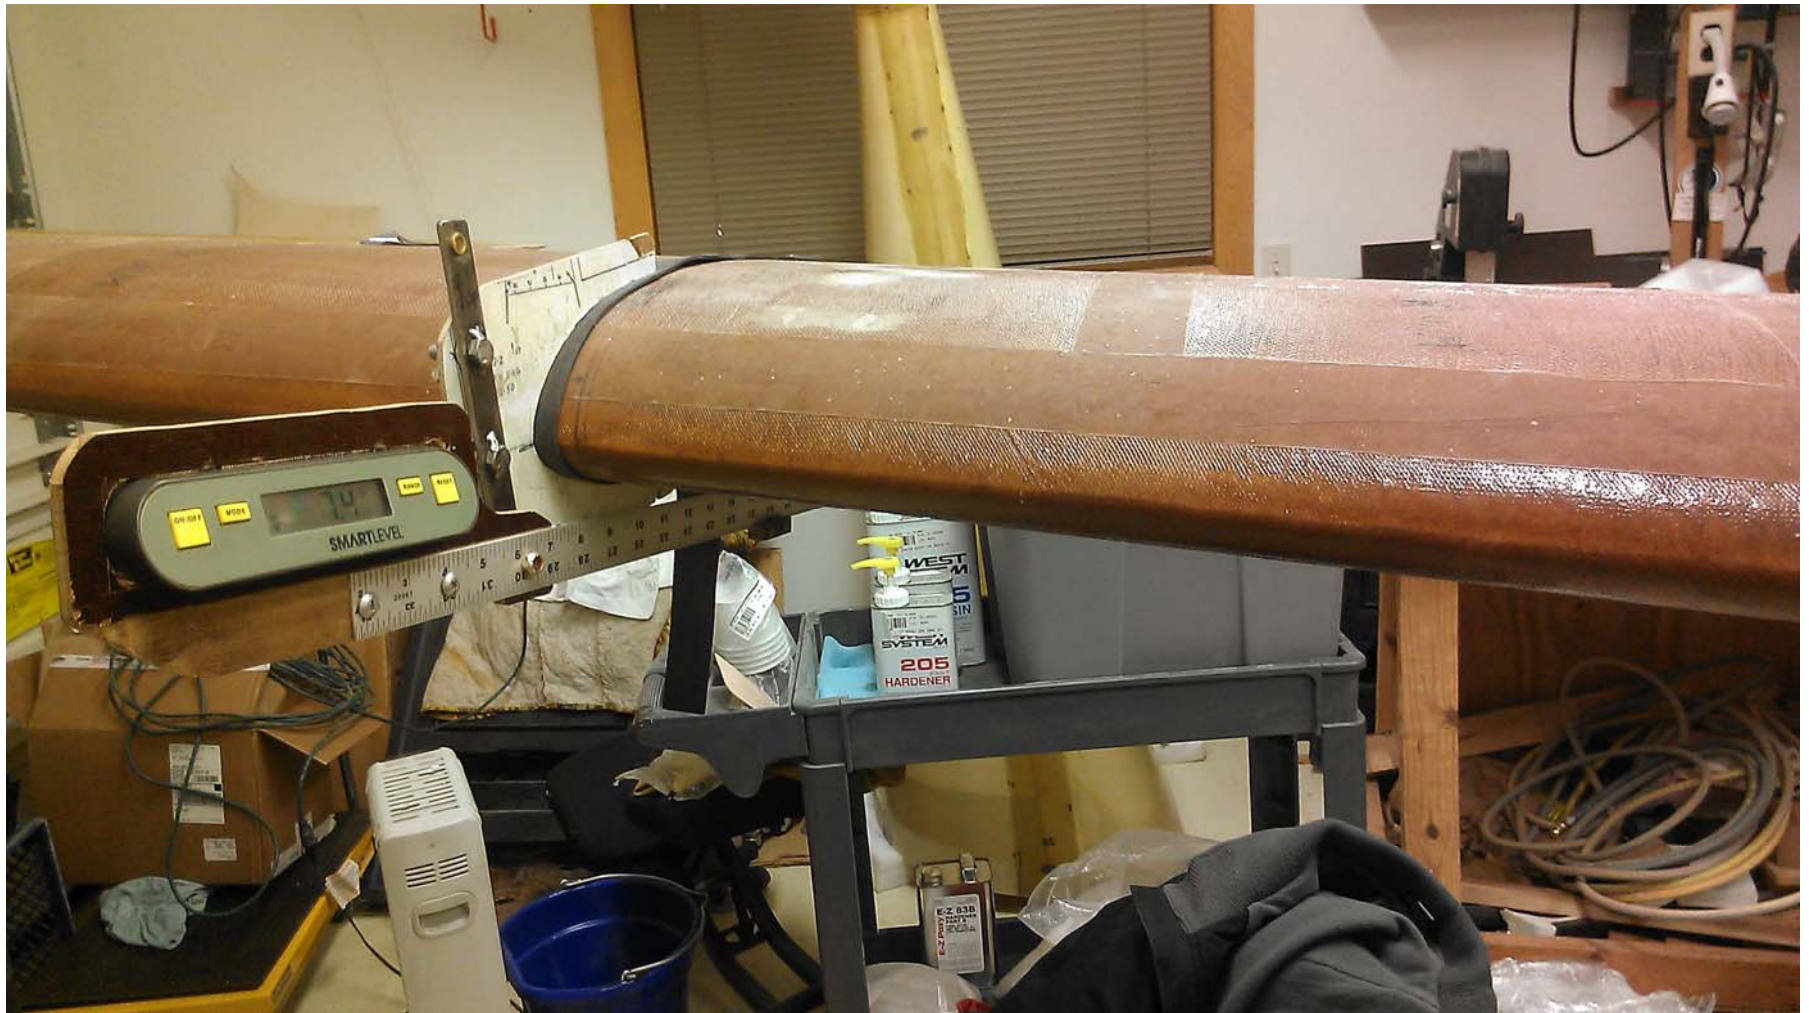
Additional view of leveling procedure. This process required approximately 8 hours to check double check and verify that wing is square relative to vertical fin (near hardware cabinets in center of photo), as well as canard and fuselage centerline.

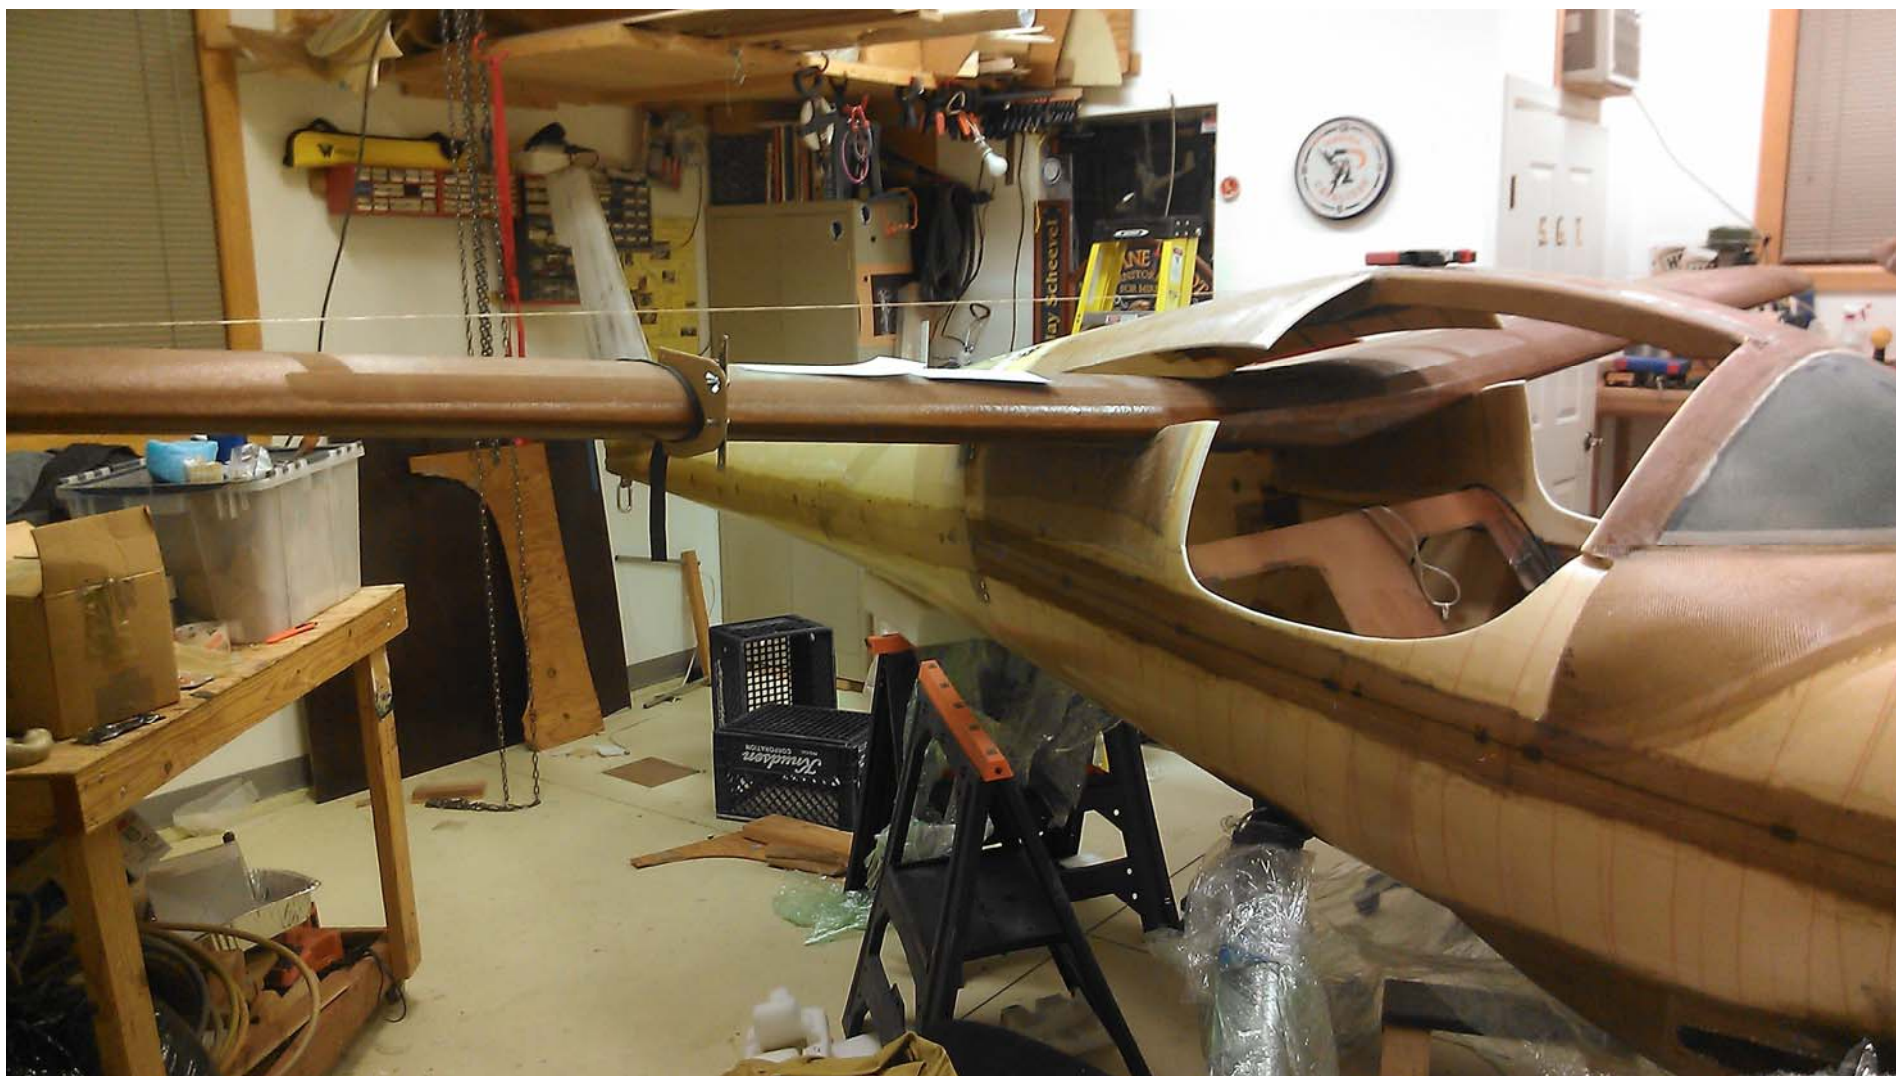
Aileron support and pivot (CS6) was milled out to 7/8" to accommodate Rulon shoulder bearing with 5/8" ID. Additional plies of glass were added to the outer perimeter of CS6 to add more strength. 3 plies of UNI were wrapped around the perimeter, with one ply of BID at 45 degrees to closeout the perimeter assembly. Photo below shows this prior to knife trim. This layup was done prior to floxing the main wing in place.

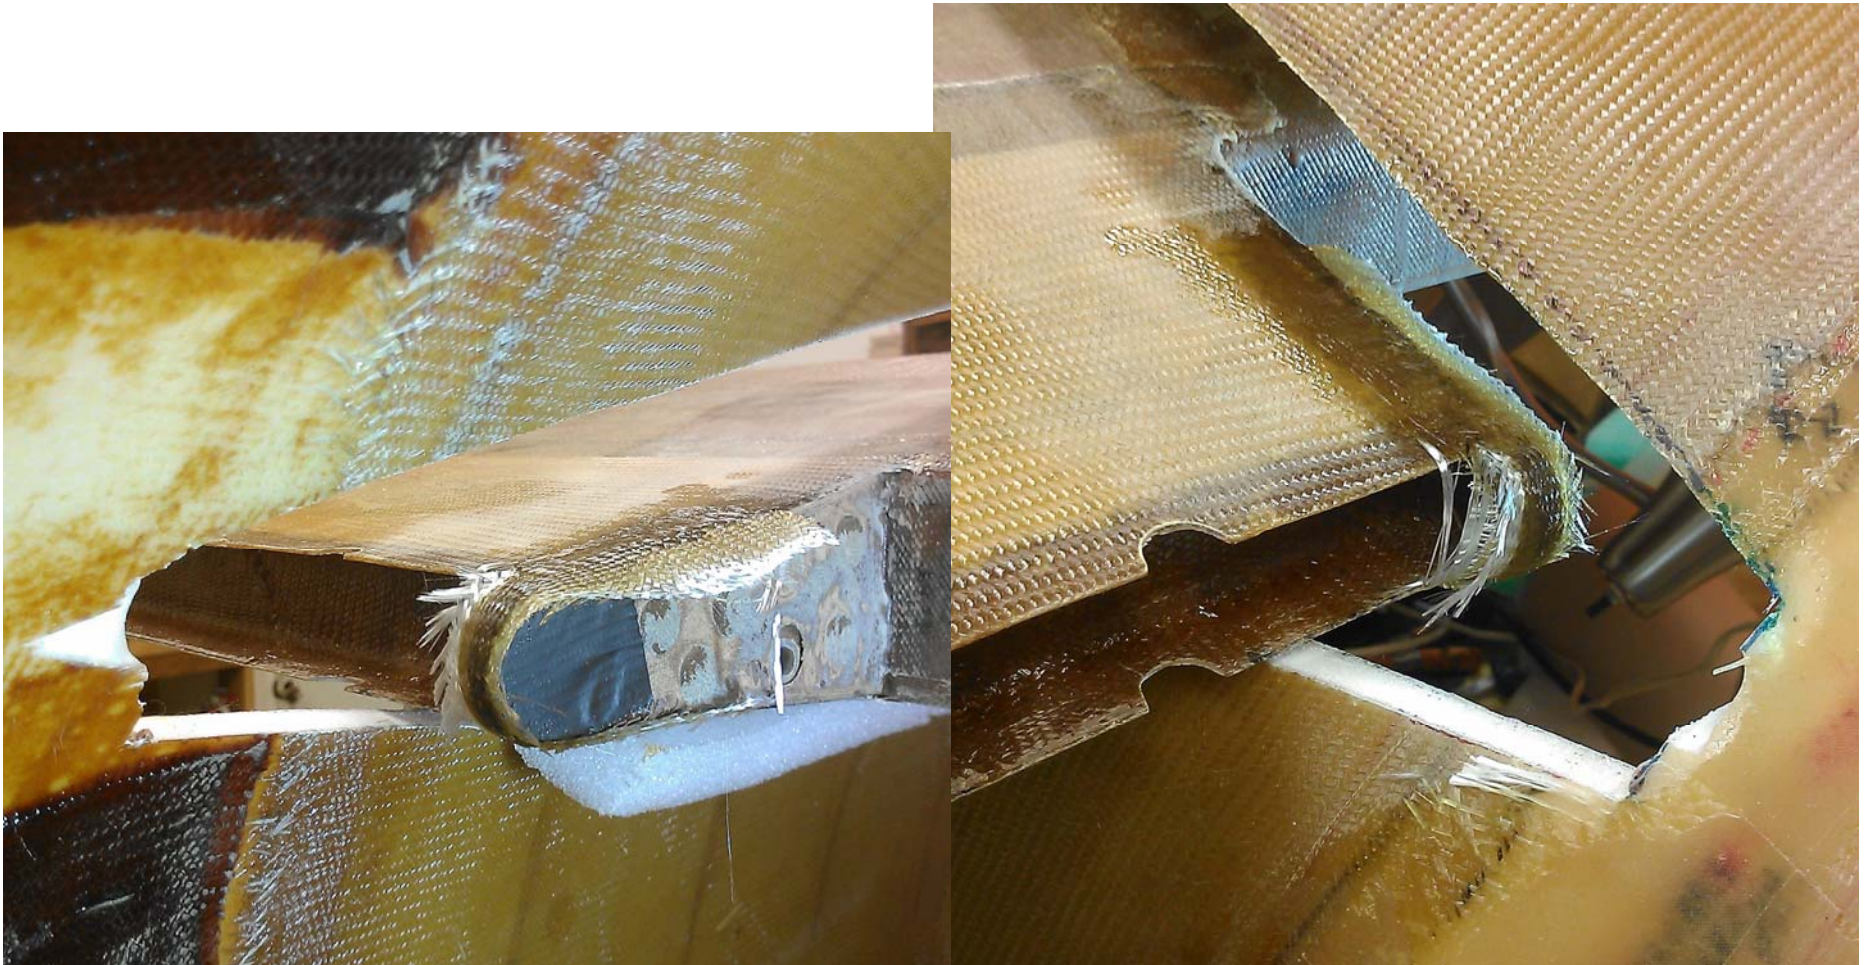
Another view of main wing position. Bottom of cutout-to-wing joint was floxed first and alignment, level and square was checked several times during flox cure. permanently. Gap on top of wing will be filled by trimmed portion of fuselage previously cut out
