# Construction: Main Wing

# Mounting: Main Wing

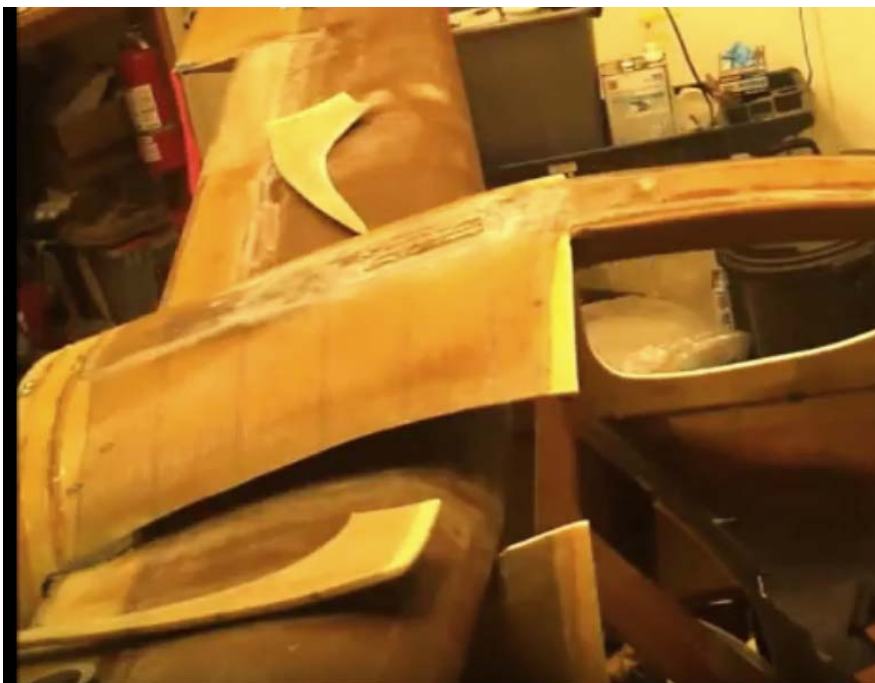
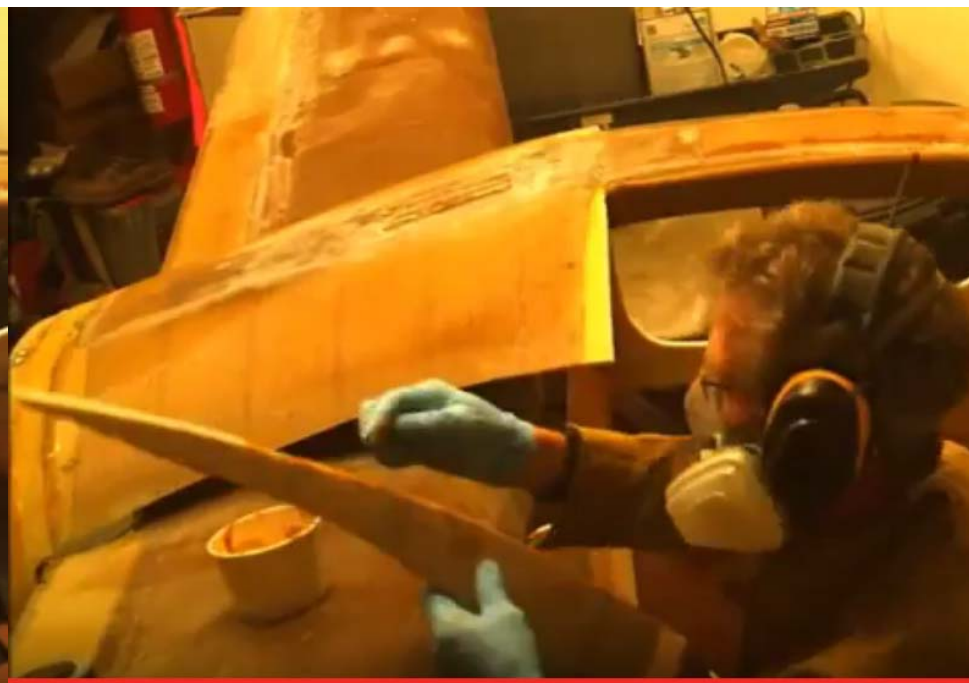
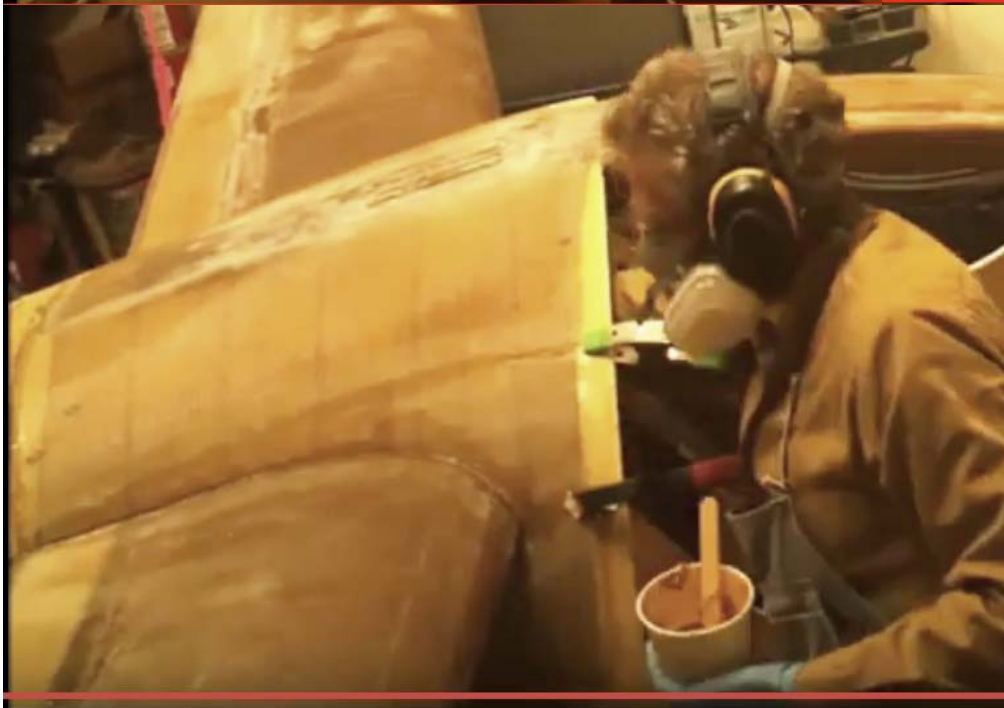
This sequence of photos shows installation of the timed fuselage cutout that was removed for installation of the main wing. The cutout is trimmed to match upper contour of wing, then floxed into position as shown.

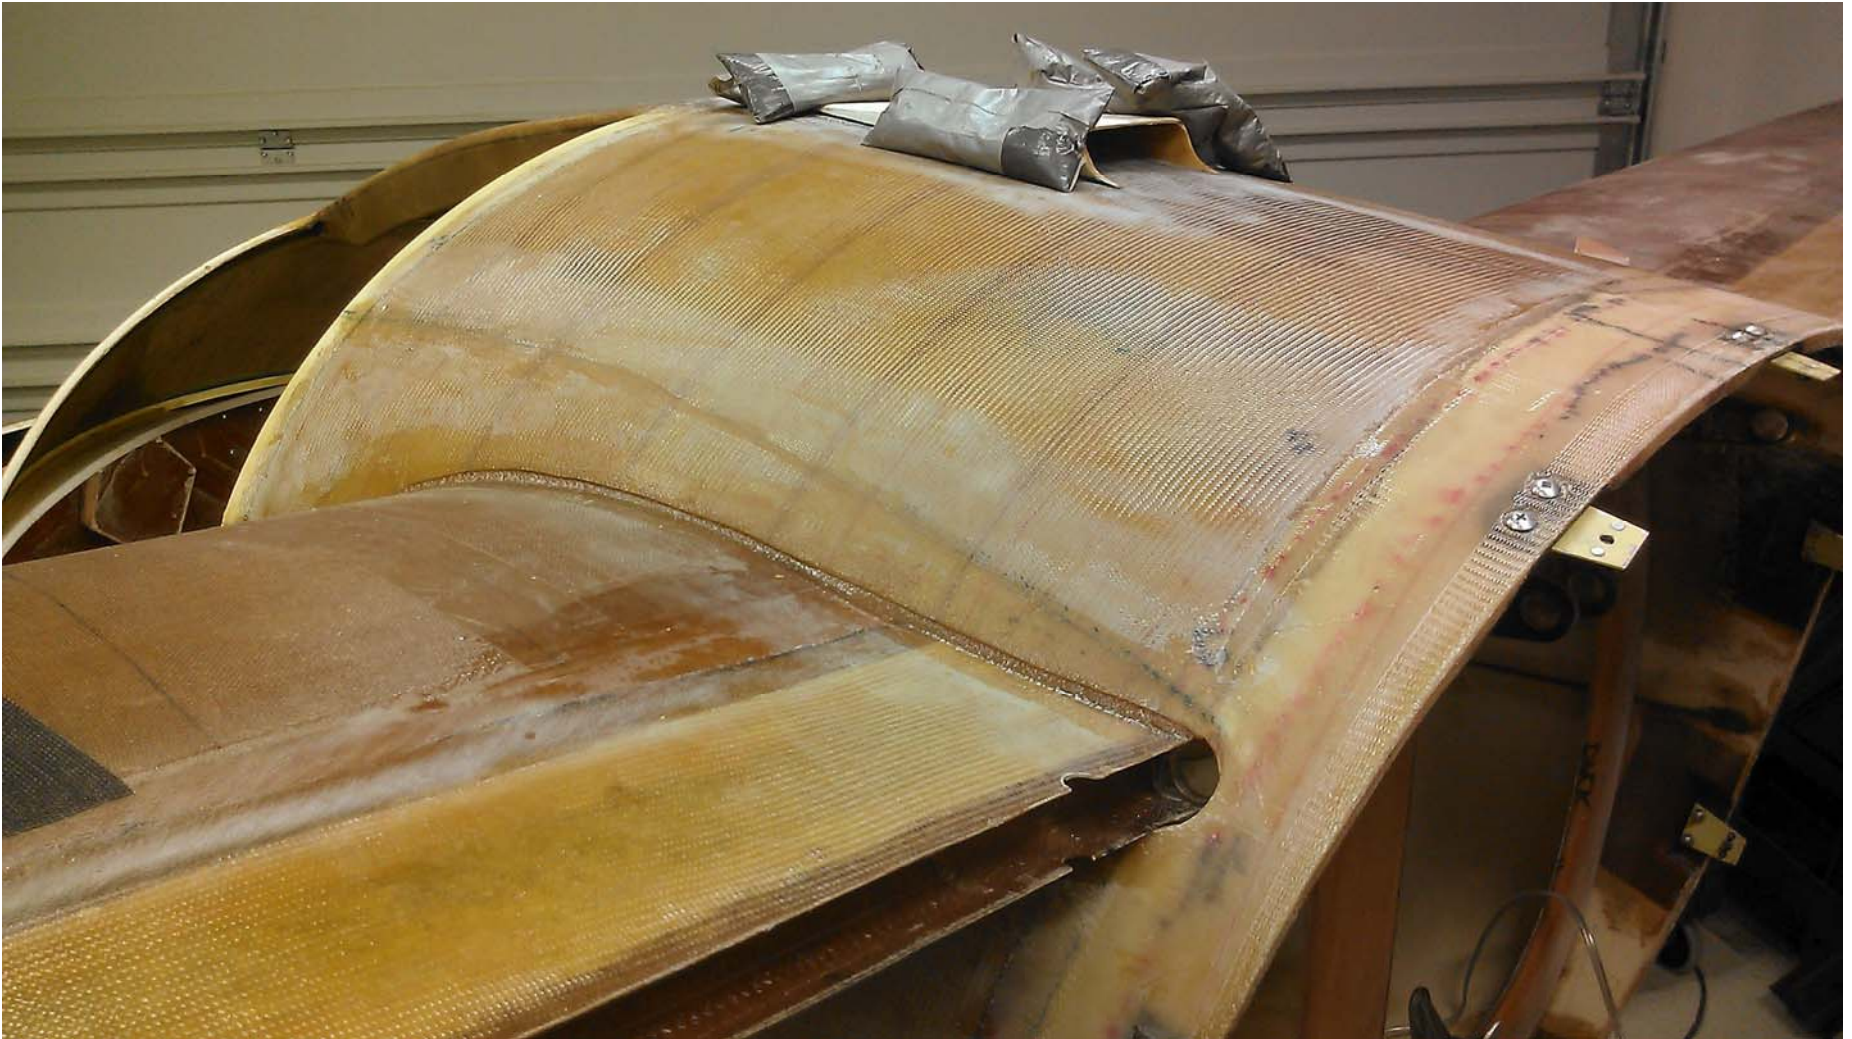
Floxed seam of upper wing skin to fuselage cutout and cutout bonded back into its original position. On top of fuselage, the exit air vent housing is also floxed into position and held in place by shot bags.

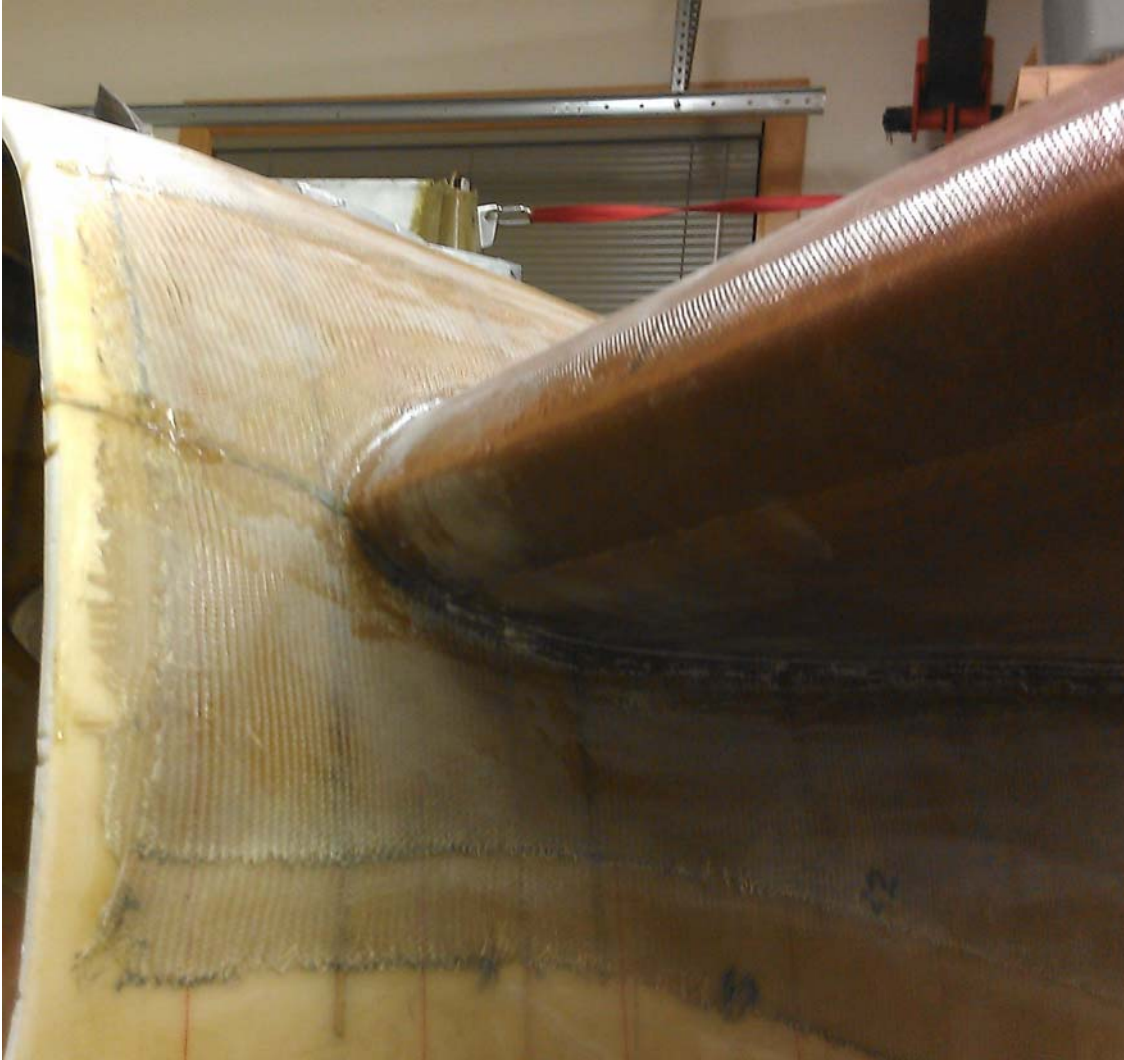
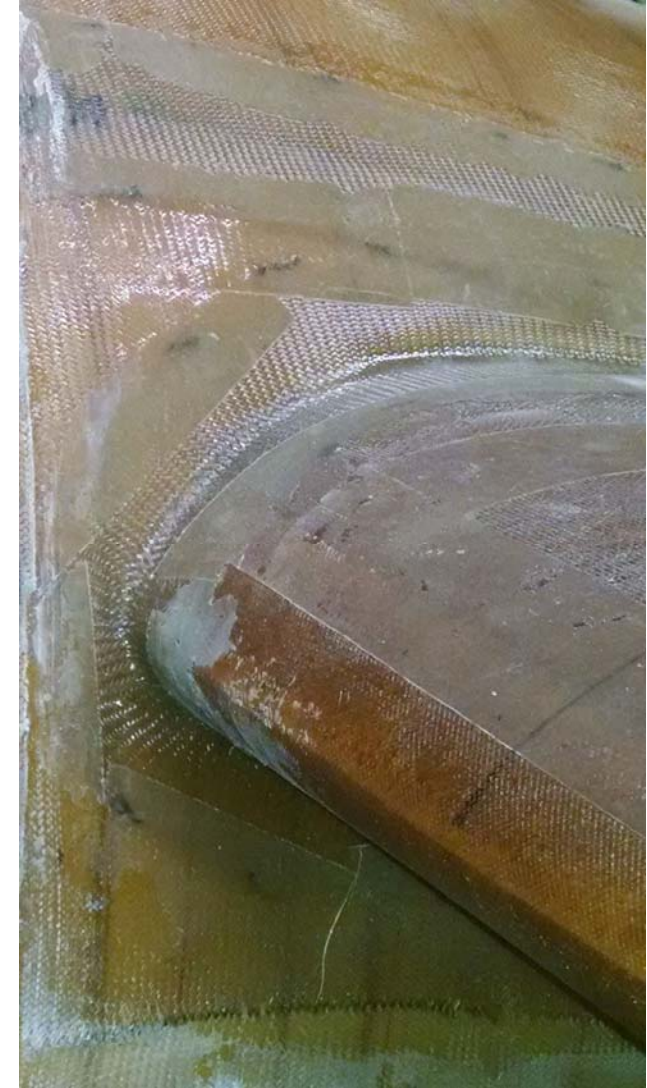
Flox fillet on main wing to fuselage seam is sanded and fuselage and wing skin sanded and prepped (left photo) for 2 BID tapes per Q-2 plans section 12-1. (final bond after peel ply has been removed is shown on the right photo. 2BID tapes are also laid over the upper seam of the fuselage cutout to the fuselage.

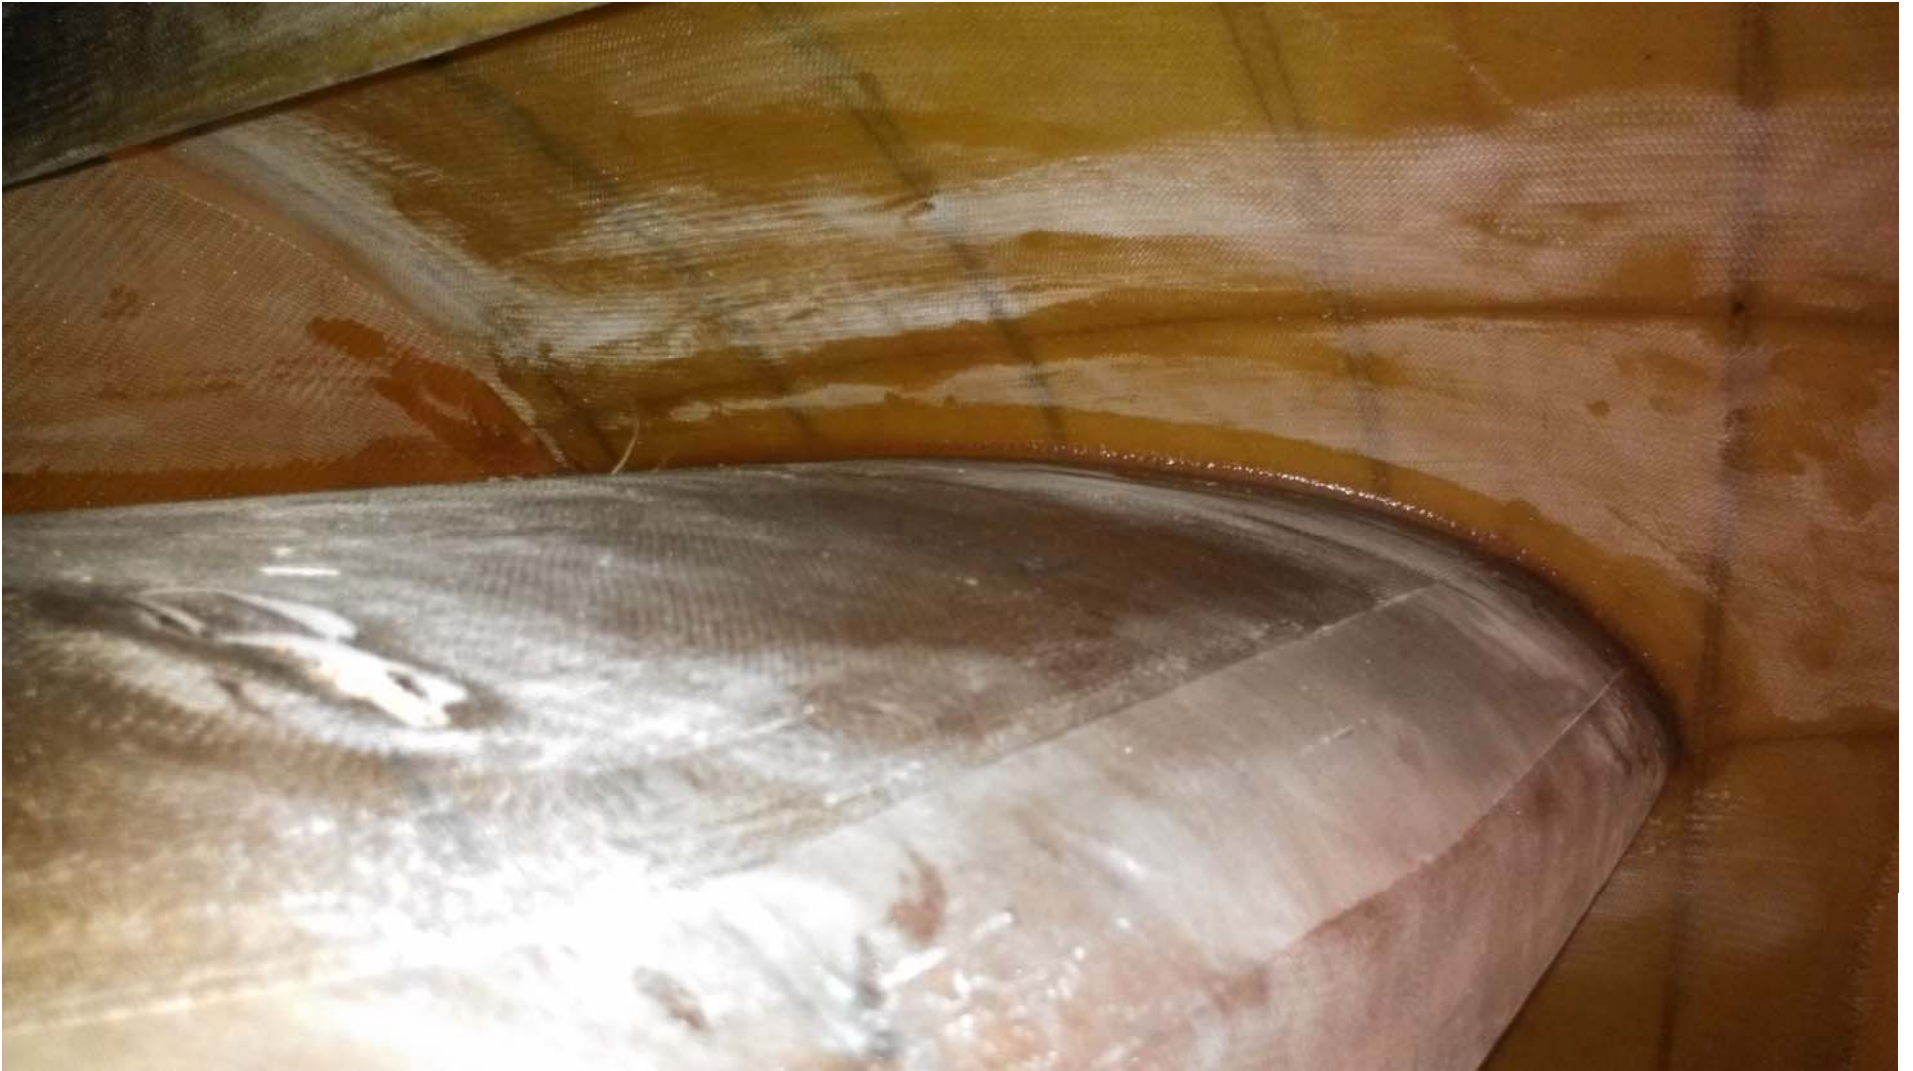
The interior of the fuselage also has flox seams at wing and upper edge of fuselage cutout. These seams are prepped and bonded with 2 BID tapes per plans.
